LiDAR Quality Assurance (QA) Report  
Louisiana LiDAR ARRA Project - Region 2  
October 11, 2011

Submitted to:  
USGS

**Dewberry**

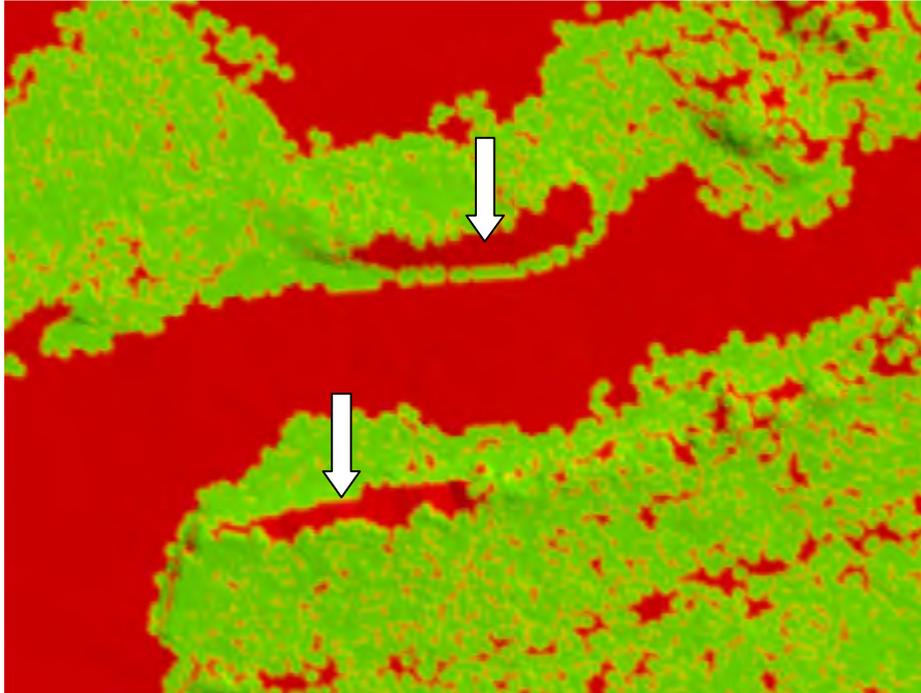
Misclassification calls in this document imply that LiDAR points are unclassified in the delivered dataset when they should be classified to ground. In other words, this call indicates that points that are unclassified (Class 1) should be moved to the ground (Class 2). One specific type of misclassification call is aggressive classification. This occurs when too many ground points are removed from the ground resulting in a loss of definition to the surface. This predominantly occurs along ridge tops or where there are significant changes in slope. Misclassification in the data was adequately corrected in the second delivery. Two examples of these calls and their corrections can be found below from Figure 4 to Figure 7.

Figure 4 – 1<sup>st</sup> delivery. Ground density model of tile 16RBT715130 showing areas of red where points are removed from the ground model.

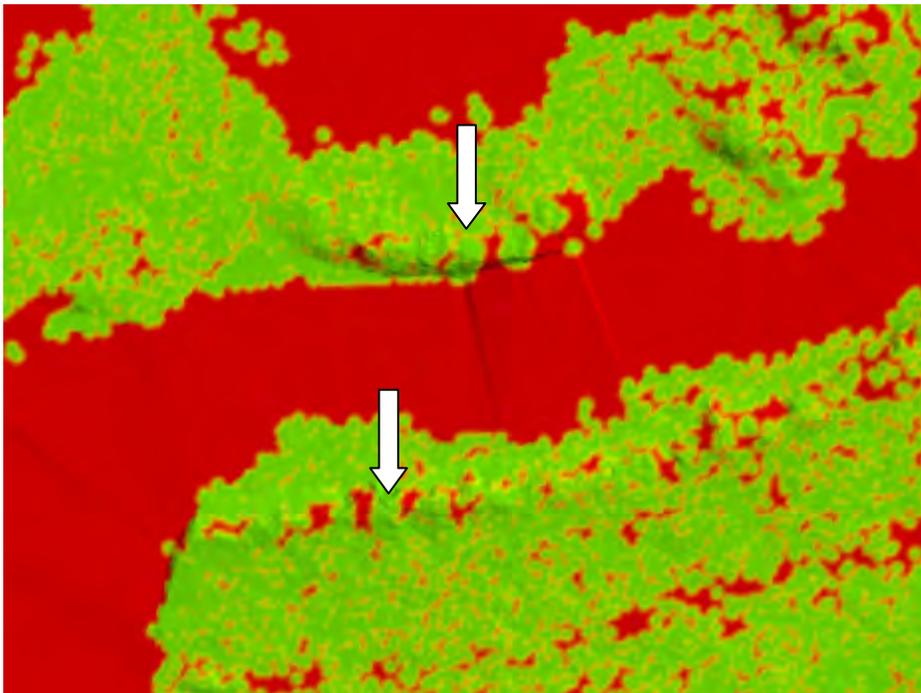
Figure 5 – 2<sup>nd</sup> delivery - corrected. Tile 16RBT715130, second delivery. As many ground points as possible were moved from unclassified into ground class. The ground density model displays significantly less red in the marked features and is a better depiction of the true ground surface.

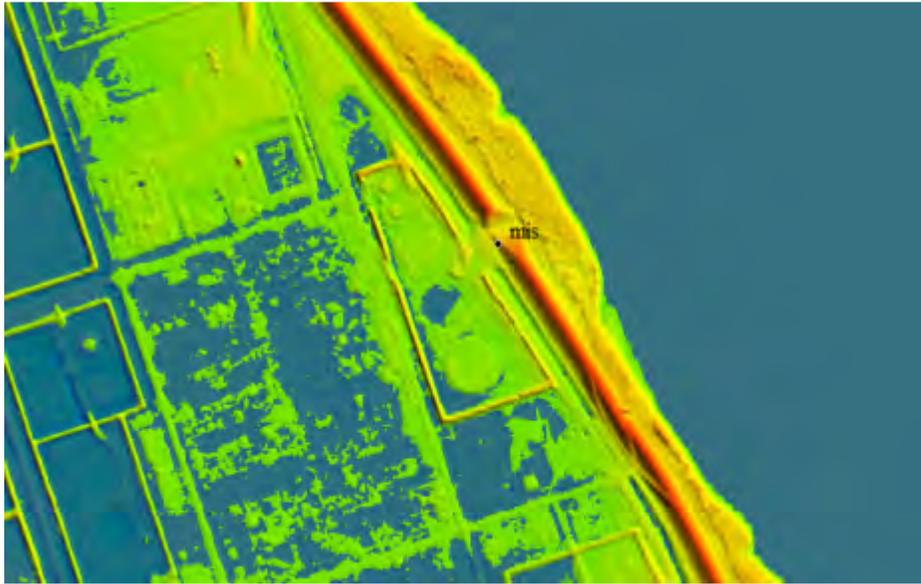
Figure 6 – 1<sup>st</sup> delivery. Ground elevation model DEM of tile 16RBT115865 showing an area that is misclassified (move Class1-unclassified to Class 2-ground).

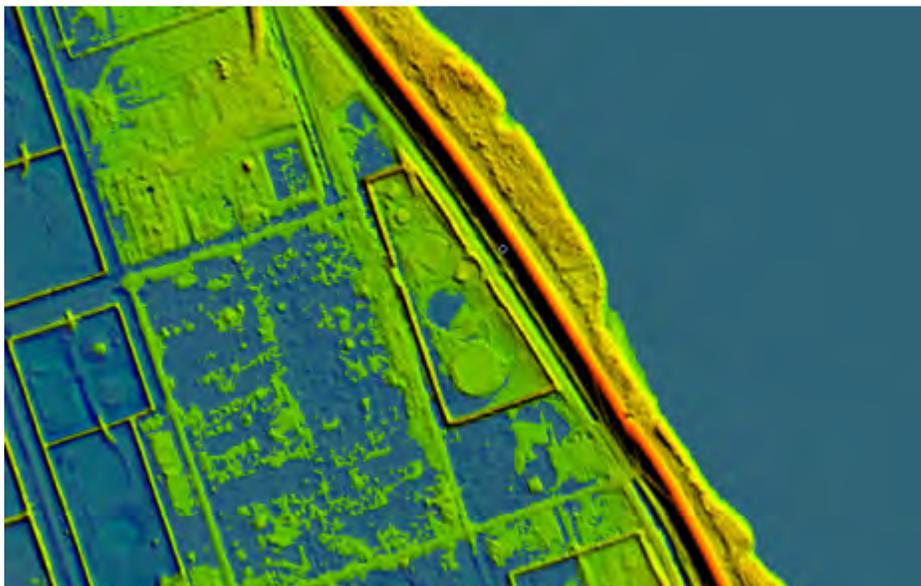
Figure 7 – 2<sup>nd</sup> delivery - corrected. Digital elevation model of tile 16RBT115865, second delivery. Missed ground points have been correctly classified for the second delivery. The feature no longer breaks at the point of the marker.

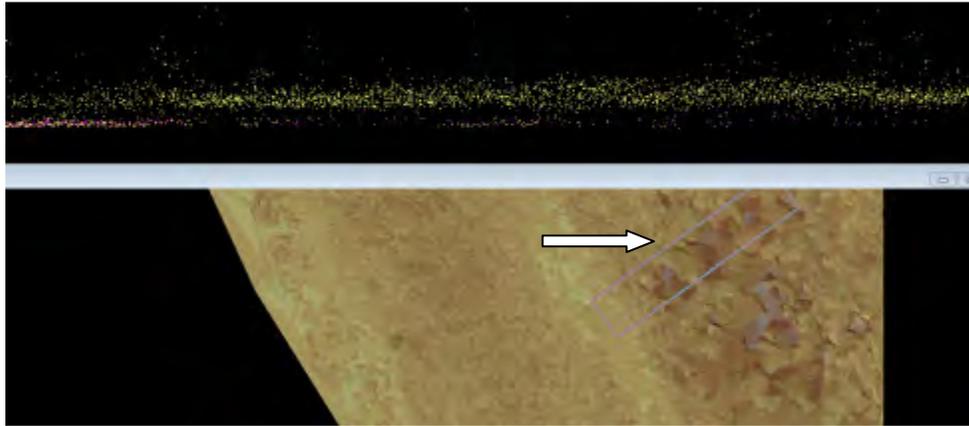
Artifacts are features that are left in the ground model that should be removed. A few vegetation artifacts that were found in the project area where found in the original delivery and were corrected for the second delivery. Examples can be found below from Figure 8 to Figure 11.

Figure 8 – 1<sup>st</sup> delivery. Full point cloud of tile 16RBT115940.las showing a vegetation artifact that is left in the ground model.

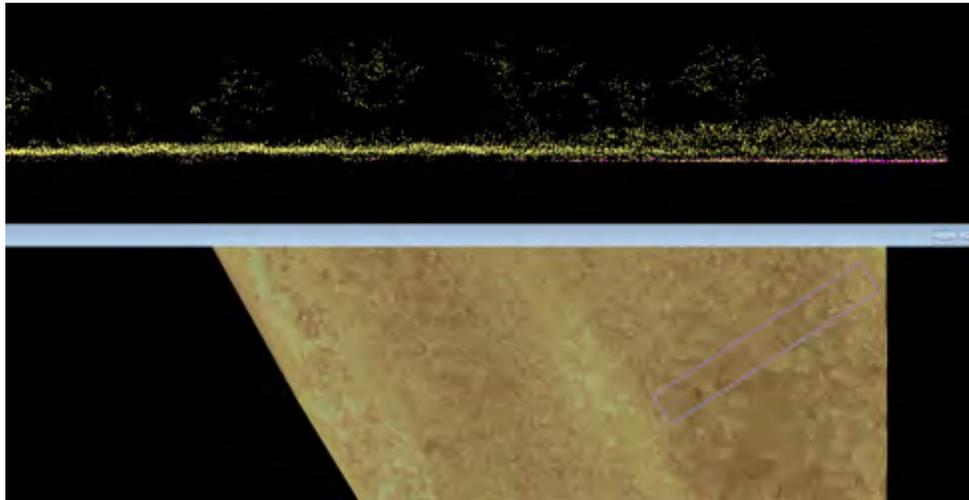
Figure 9 – 2<sup>nd</sup> delivery - corrected. LAS tile 16RBT115940, second delivery. Vegetation artifacts in the area of the profile have been removed. Ground points, shown in purple in the cross section, now contain only those points low enough to be considered ground. The ground model appears smoother.

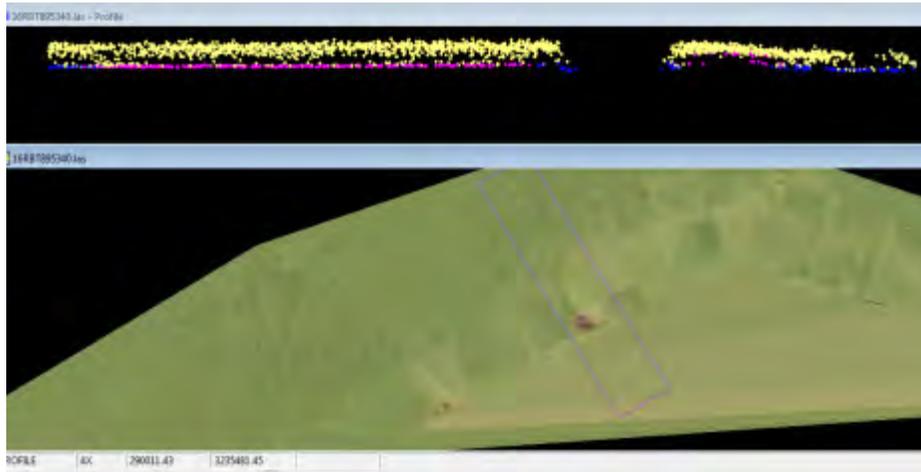
Figure 10 – 1<sup>st</sup> delivery. Full point cloud of tile 16RBT895340.las showing a vegetation artifact that is left in the ground model.

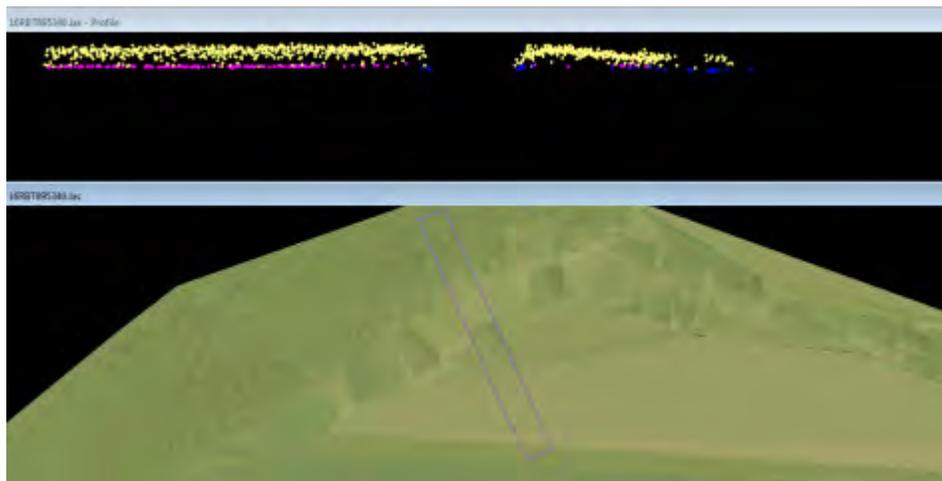
Figure 11 – 2<sup>nd</sup> delivery - corrected. Full point cloud LAS tile 16RBT895340. The vegetation artifact has been removed. No ground points (purple) are seen to be misclassified in the profile.

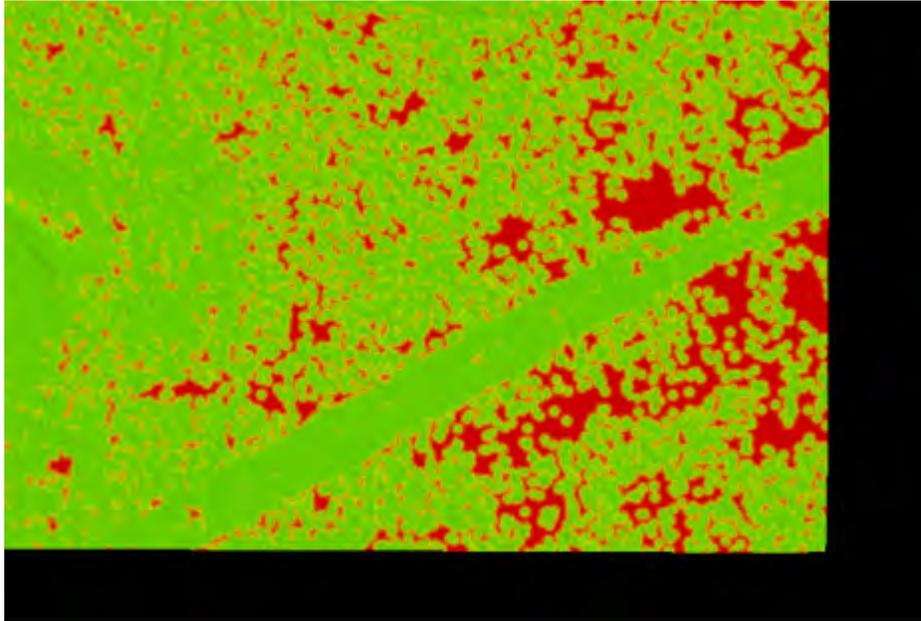
Data voids were identified in two areas resulting in 7 original calls. The voids seem to be related to areas where the intensity values are very dark (Figure 13). This error involves an anomaly with the LiDAR collection process. As seen in Figure 14 (the full LAS point cloud) no points were collected in the void areas. It would be costly and inefficient to fully correct for the void areas as the location would most likely need to be re-flown. Woolpert was unable to further correct the pictured tile below in the second delivery. However, Dewberry feels that because the voids are not widespread and are not of concerning size, they do not significantly impact the ground model. The void areas should be noted by the user but do not jeopardize the ground model or other LiDAR products.

*Figure 12 - Ground density model of tile 16RBU550480. The areas of red in this tile are data voids.*

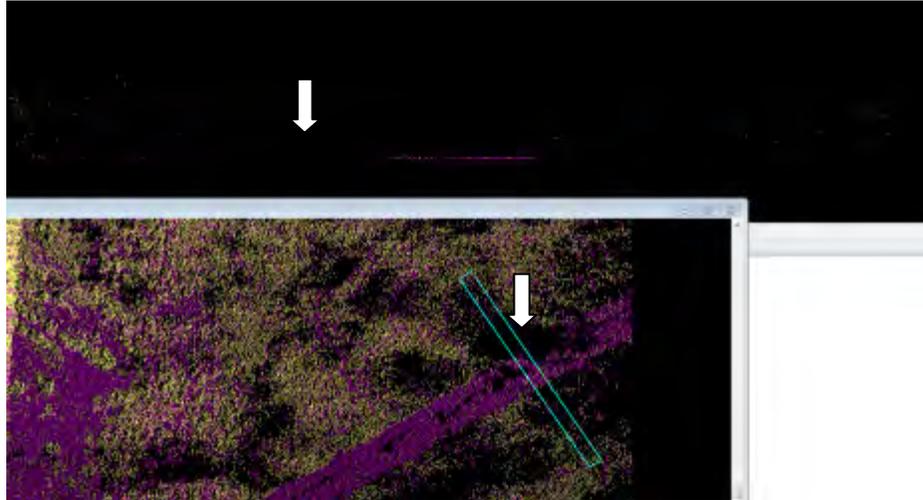
Figure 14 - Full point cloud image of tile 16RBU550480 colored by classification. The profile and map view both show the data voids.

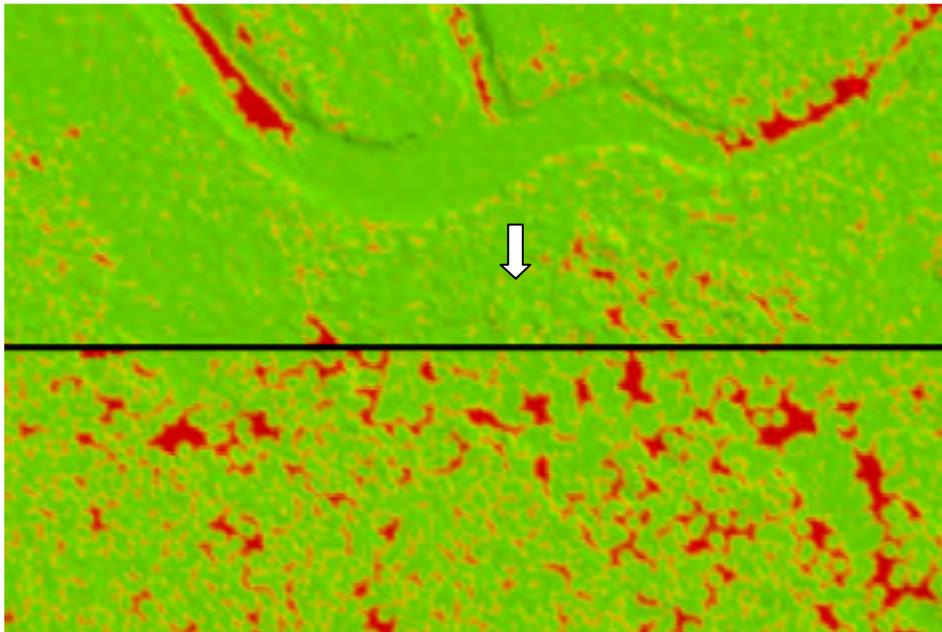
Inconsistent editing occurs only along boundaries between tiles. In these areas, the same automated-classification routine was not applied consistently to the same feature or different LiDAR classification analysts interpreted the feature differently (Figure 15 and Figure 16). Calls were placed on the tile that required editing. These issues were addressed in the 2<sup>nd</sup> delivery.

Figure 15 – 1<sup>st</sup> delivery. Ground density model of tiles 16RBT775265 and 16RBT775280 showing inconsistent editing between tiles. The tile on the right is more aggressively classified than the tile on the left.

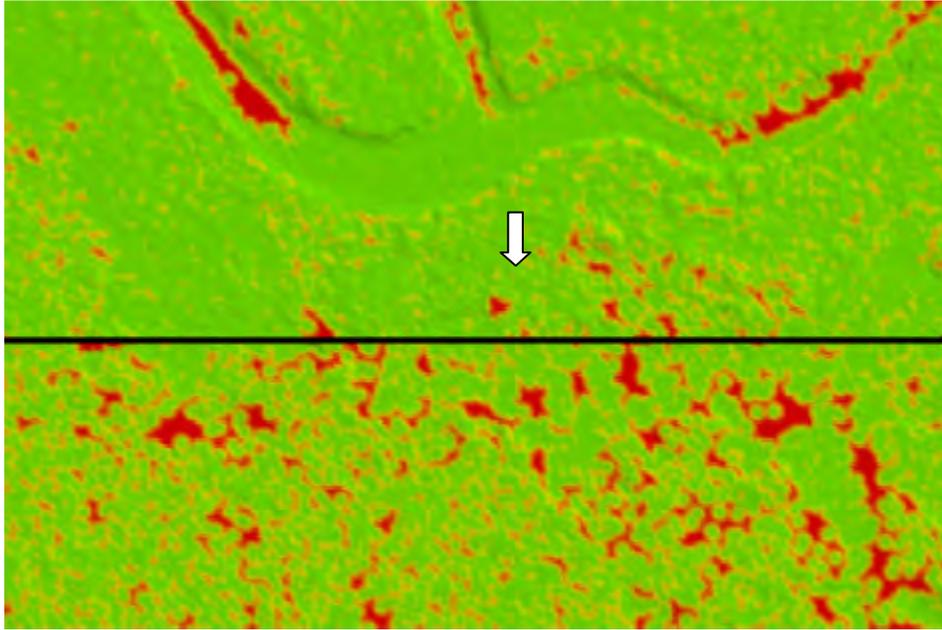
*Figure 16 – 2<sup>nd</sup> delivery - corrected. Ground density model of tiles 16RBT775265 and 16RBT775280, second delivery. A moderate amount of artifact points were removed from the area shown by the arrow making the tiles more consistent.*

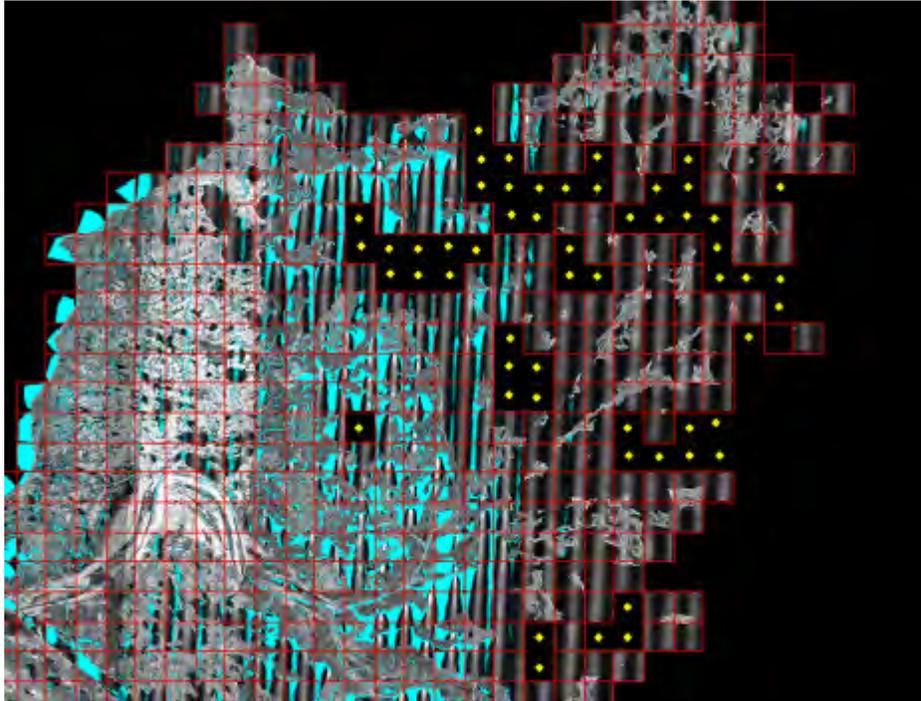
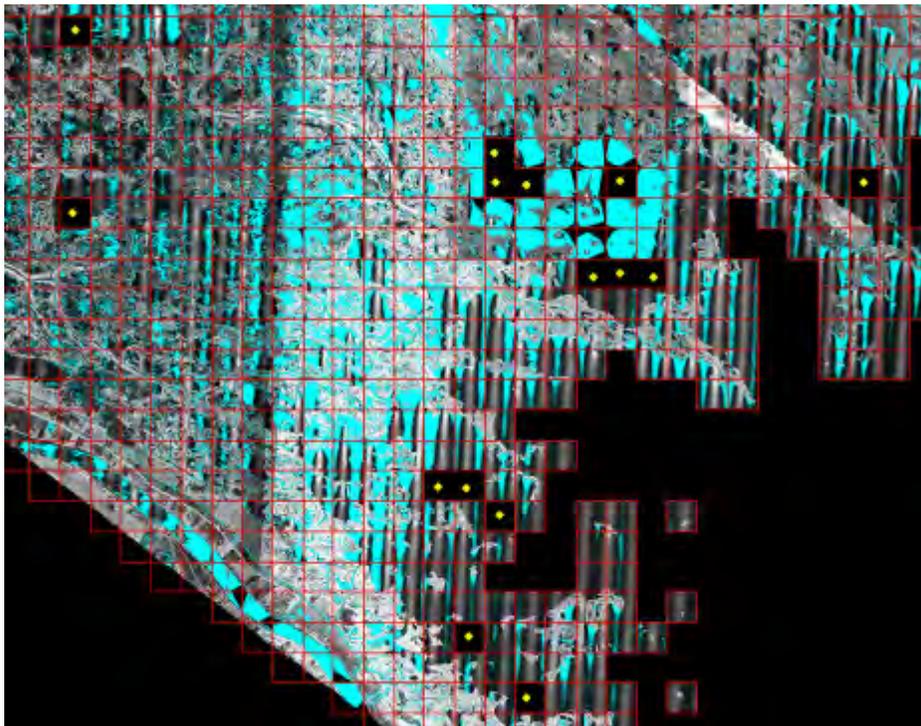
The data delivered to Dewberry in the first delivery appeared to be missing 74 tiles. Dewberry assumes all these tiles were not delivered because they Woolpert believed they contained no ground (i.e. are entirely water). Dewberry recommended that Woolpert send these tiles any subsequent deliveries so that Dewberry can confirm these tiles do not contain ground that is misclassified.

Figure 17 - Yellow dots show tiles that Dewberry recommends Woolpert deliver to ensure there is no ground.

Figure 18 - Yellow dots show tiles that Dewberry recommends Woolpert deliver to ensure there is no ground.

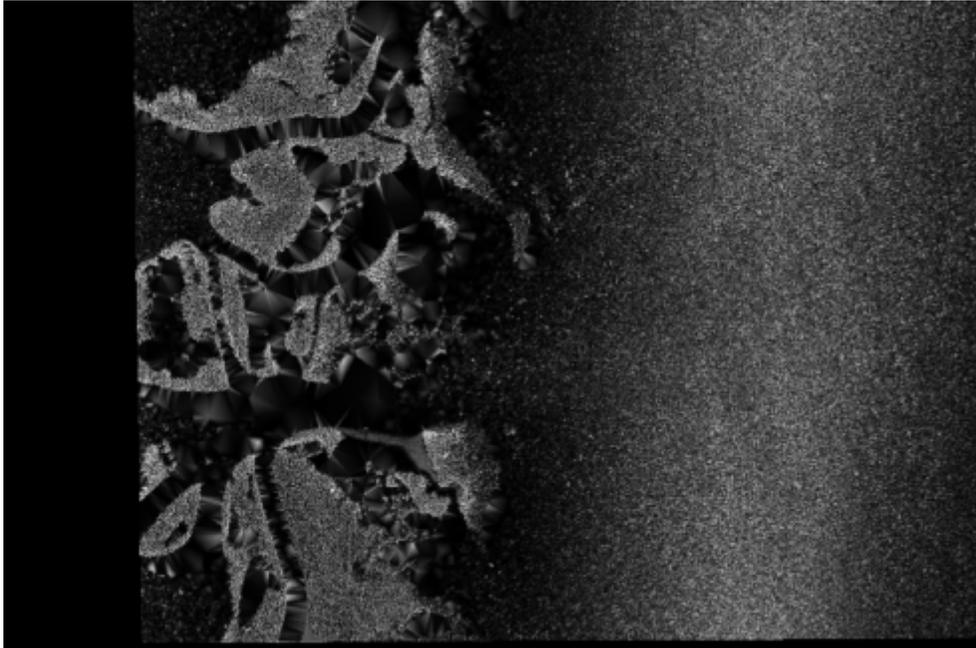
ground that is under the zero elevation does exist in a select few of the 74 tiles, particularly tiles 16RBT92310 and 16RBT535535.

*Figure 19 – Full point cloud model with LiDAR intensity values of tile 16RBT92310, second delivery. This tile was not included in the original delivery. Land clearly exists, however all the land seen above has an elevation that is below zero and is therefore not required to be classified as ground.*

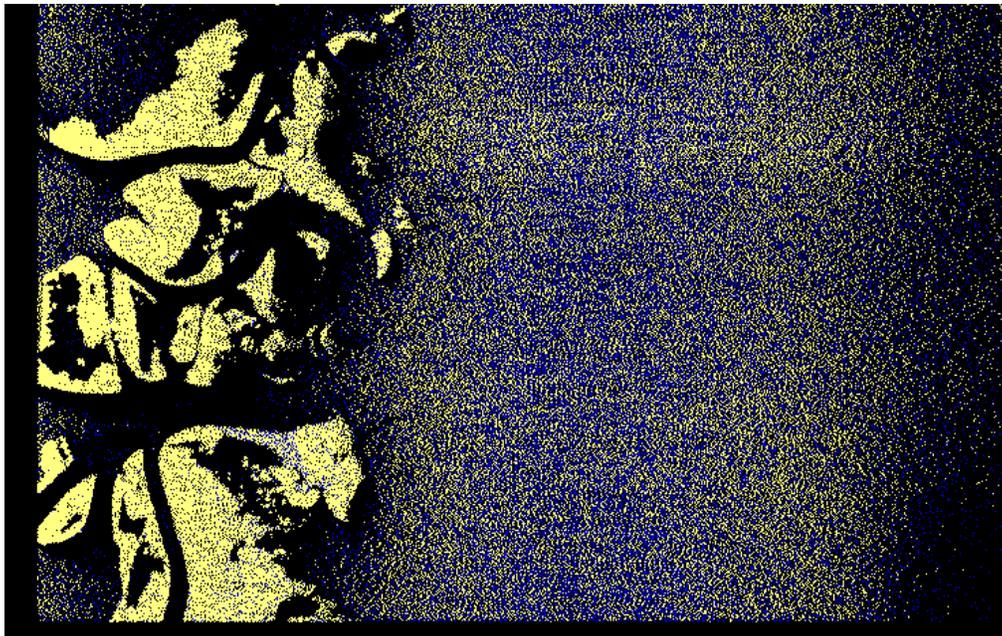
*Figure 20 – LAS point cloud of tile 16RBT92310 colored by classification where blue is class 9, water, and yellow is class 1, unclassified. The below zero ground has been placed in class 1.*

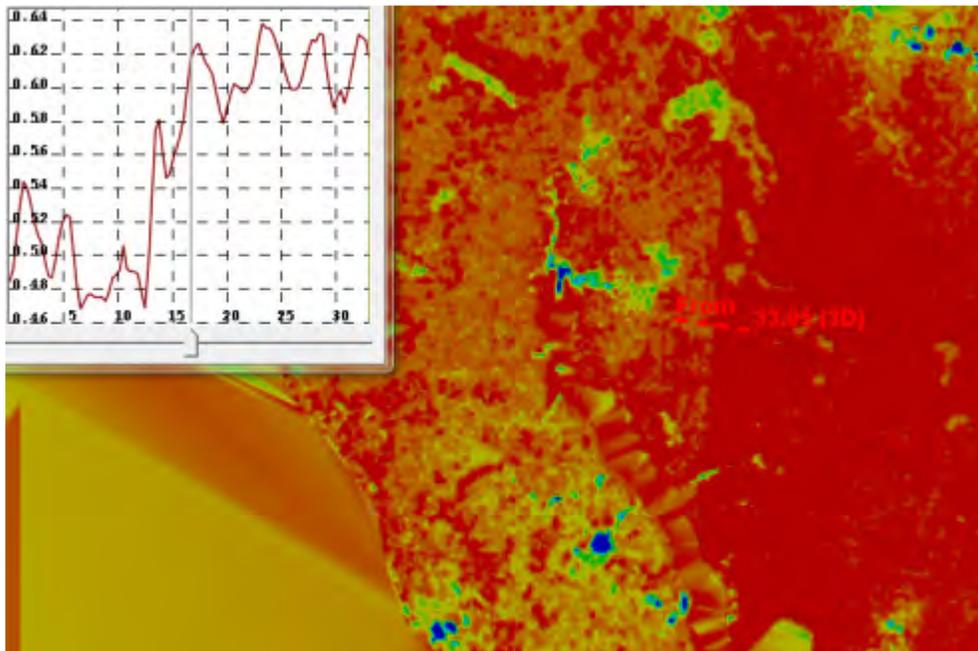
Several flight line ridges were originally identified in the Louisiana Region 2 LiDAR dataset. The ridges are caused by a vertical mismatch between two adjacent flight lines. Elevation differences along adjoining flight lines range from 10 cm up to 50 cm. Figure 21 and Figure 22 show a flight line ridge before and after corrections. The scope of work indicates that the acceptable criterion for flightline ridges is 10 cm. Dewberry provided a polygon shapefile that delineates areas that exceed project specifications for flight line ridges. The majority of the flight line ridges were adequately corrected by Woolpert for the second delivery. Three flight line ridges ranging from 10 to 30 cm were not fully corrected and are still visible in ground models of tiles 16RBT340940, 16RBT445595 and 16RBU220045. While over the specification of 10 cm, these remaining ridges are localized and overall the data meets project specifications.

Figure 21- 1<sup>st</sup> delivery. Ground elevation model of tile 16RBT520940 showing a ~20 cm flight line ridge.

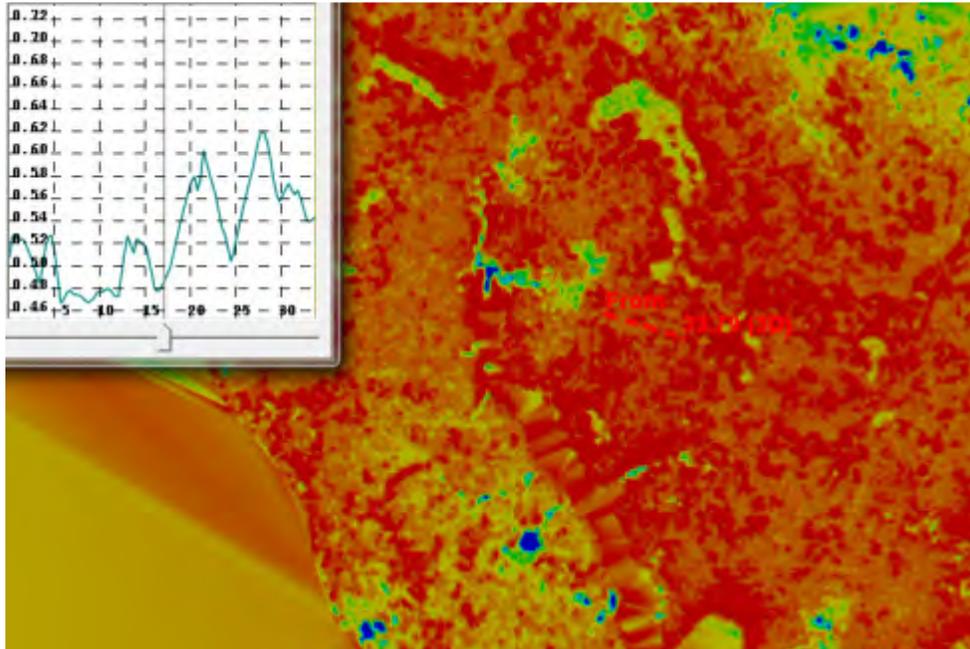
Figure 22 – 2<sup>nd</sup> delivery - corrected. Ground elevation model of tile 16RBT520940, second delivery. The flight line ridge has been corrected.

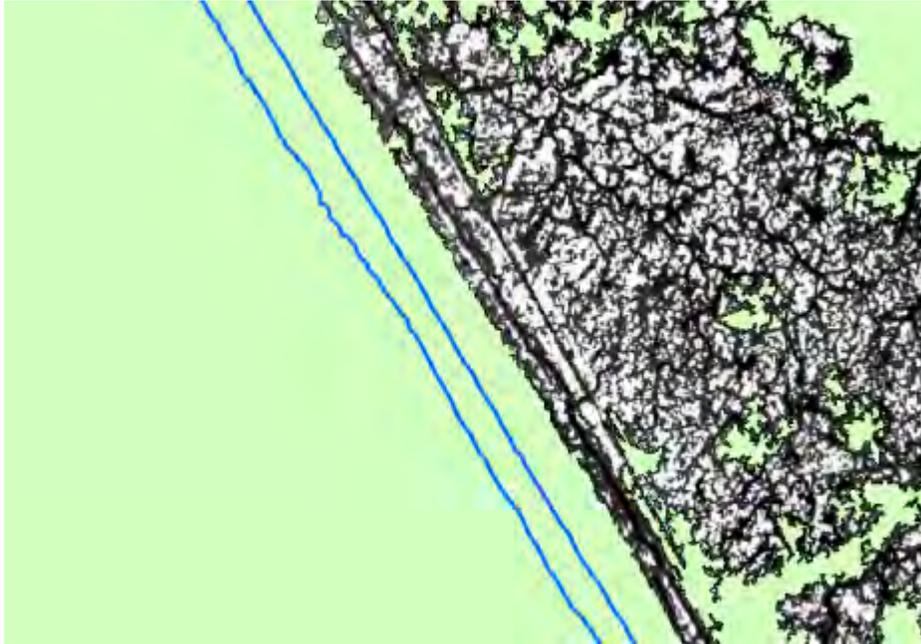
In the first delivery, the islands breaklines were not clipped at the extent of the streams breakline. This issue was fixed in the second breakline delivery. An example of the error and its correction is below in Figure 23 and Figure 24.

Figure 23 – 1<sup>st</sup> delivery. Full point cloud intensity image of tile 16RBU190135. The green area is the islands breakline and the two blue lines delineate a stream breakline. The islands should be clipped at the stream lines.

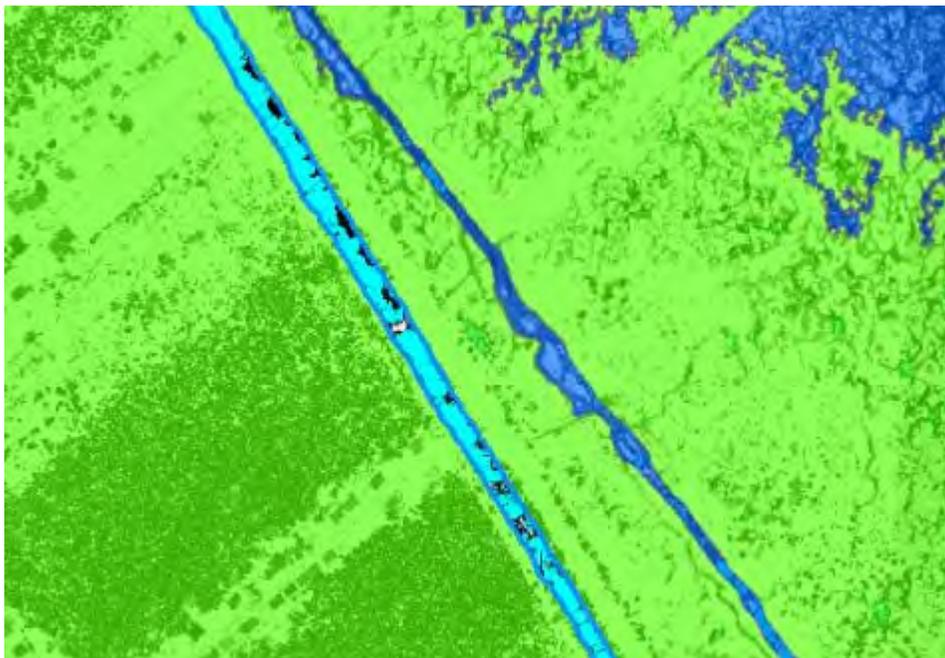
Figure 24- 2<sup>nd</sup> delivery - Corrected. Full point cloud intensity image of tile 16RBU190135 with the second delivery breaklines. The two blue lines delineate a stream breakline. The islands breakline has now been correctly clipped to the streams breakline.

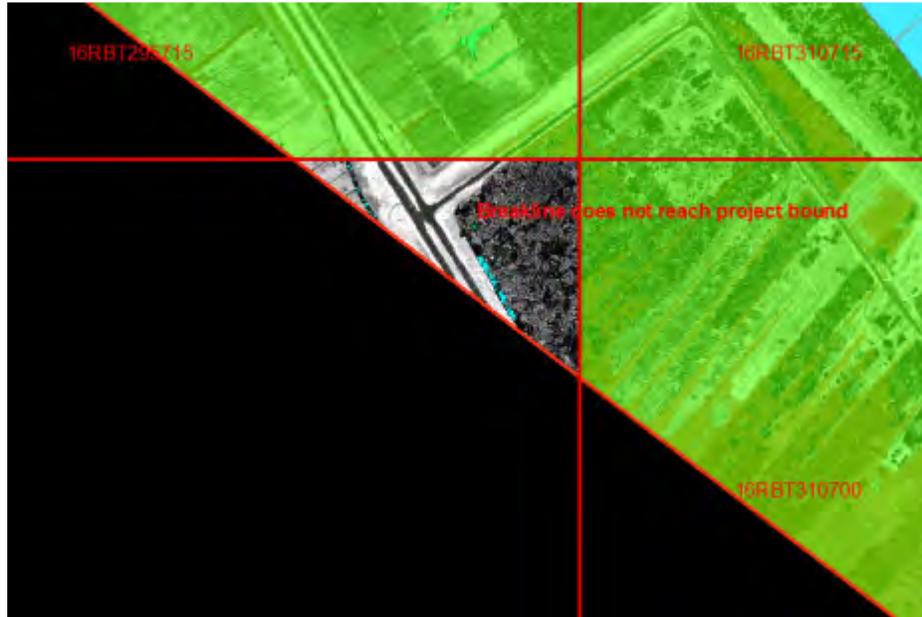
Figure 25 – 1<sup>st</sup> delivery. Full point cloud intensity image of a tile where the breaklines do not extend into. The green area is delineated as an island.

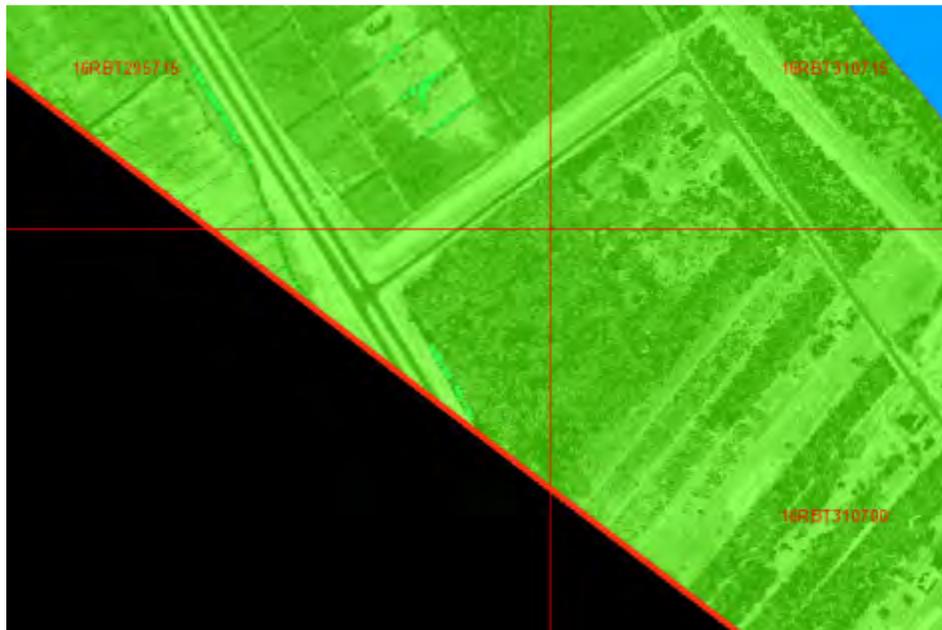
Figure 26 - 2<sup>nd</sup> delivery - Corrected. Full point cloud intensity of the same image as Figure 25 showing that the breaklines in the second delivery were extended to the project boundary.

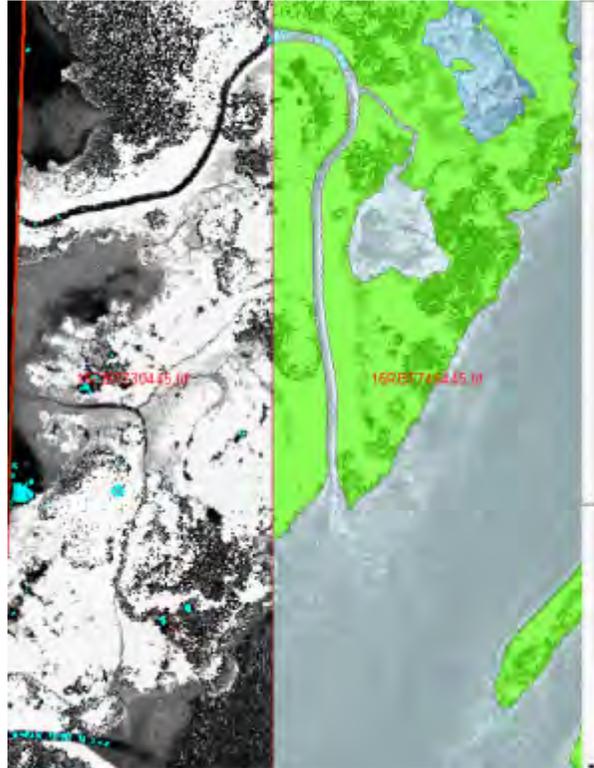
Figure 27 – 1<sup>st</sup> delivery. Full point cloud intensity image showing that breaklines do not extend into the tile on the left. The area in green are delineated as islands and the areas in blue are tidal waters.

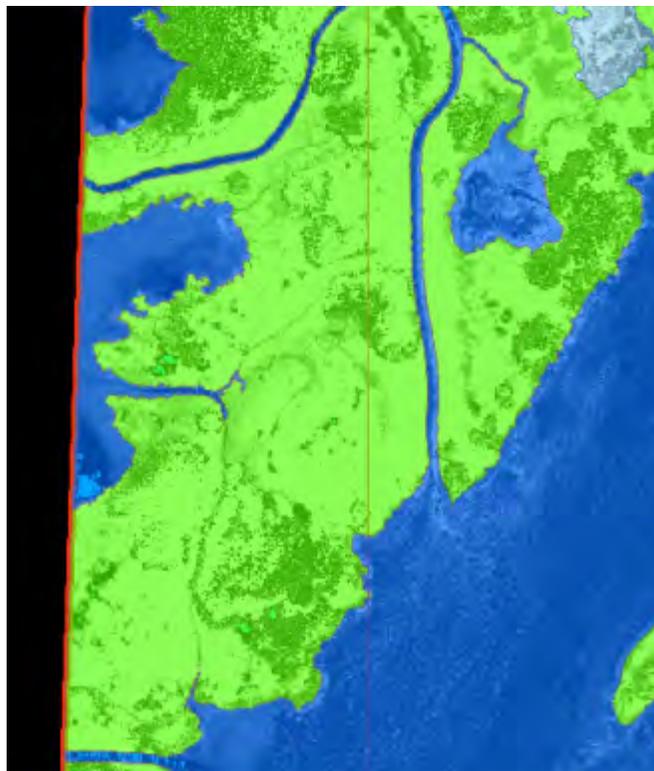
Figure 28 – 2<sup>nd</sup> delivery - Corrected. Full point cloud intensity image showing that the breaklines in the second delivery have been corrected and now extend all the way to the project boundary.

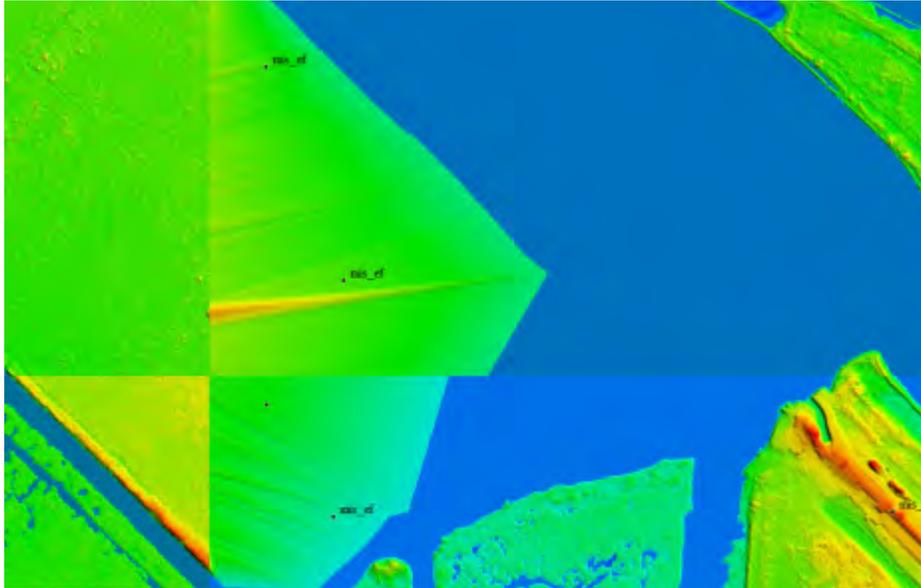
One serious issue was identified in the first delivery where ground points are classified to Class 9 (water). Issues with the data used to classify the points could cause ground, which was correctly identified during the breakline review, to be moved to Class 9. The issue and its correction in the second delivery are shown below.

Figure 29 – 1<sup>st</sup> delivery. Ground elevation DEM of tiles 16RBU250150 and 16RBU250135 showing an area that contains no ground data. As evident below the points are classified as water when they are actually ground.

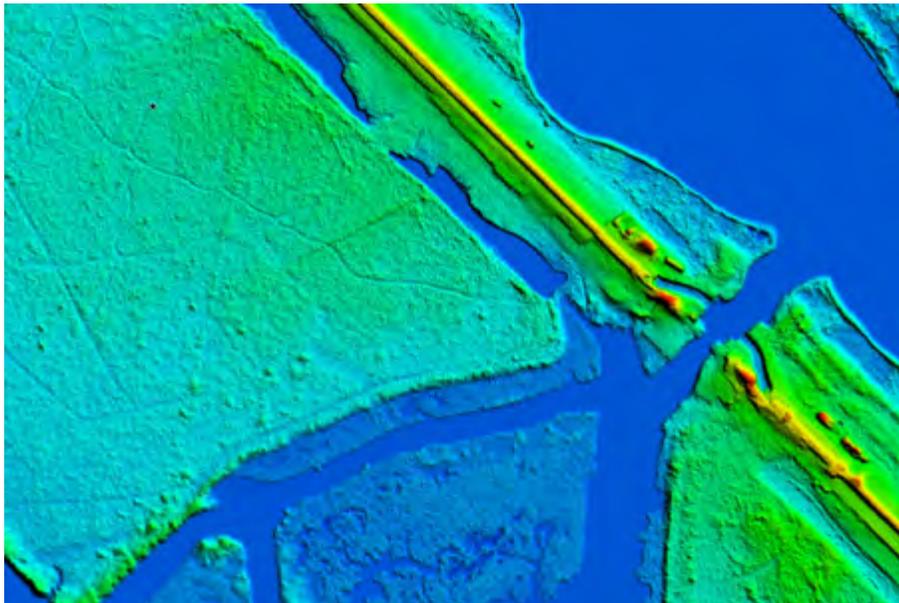
Figure 30 – 2<sup>nd</sup> delivery - Corrected. Ground elevation of DEM of tiles RBU250150 and RBU250135 showing that the ground has been correctly classified and added back to the ground model.

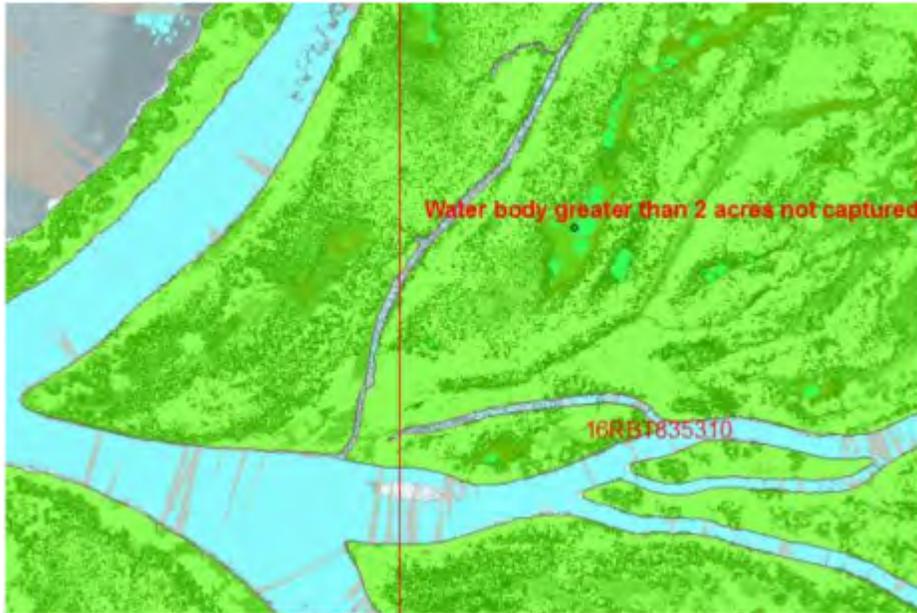
In the first review Dewberry identified 21 water bodies that are greater than 2 acres but not captured by the breaklines. During the second review all issues were addressed by Woolpert.

Figure 31 – 1<sup>st</sup> delivery. Full point cloud intensity image with tidal waters (blue) and islands (green) draped over showing a water body that was not captured.

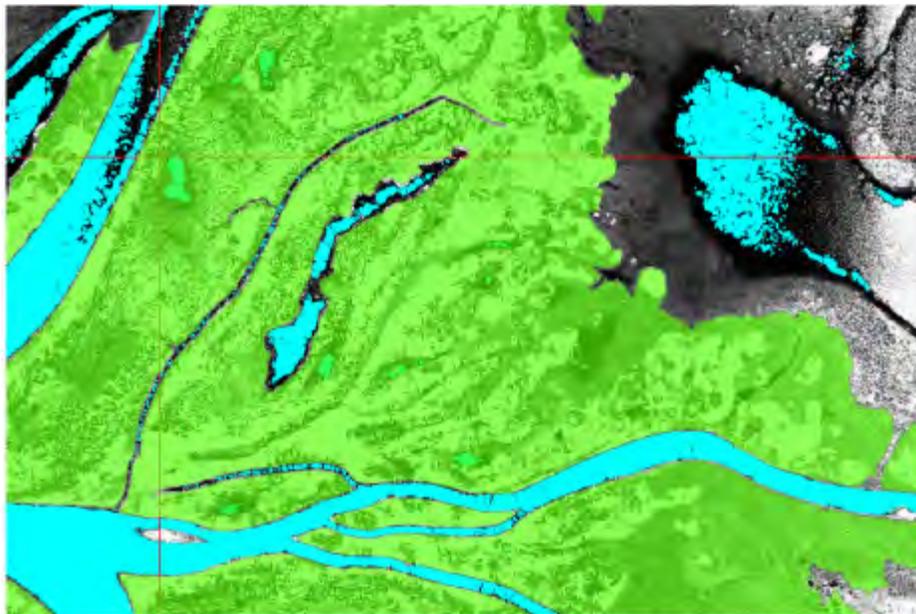
Figure 32 – 2<sup>nd</sup> delivery - Corrected. Full point cloud intensity image with tidal waters (blue) and islands (green) draped over showing a water body that not captured.

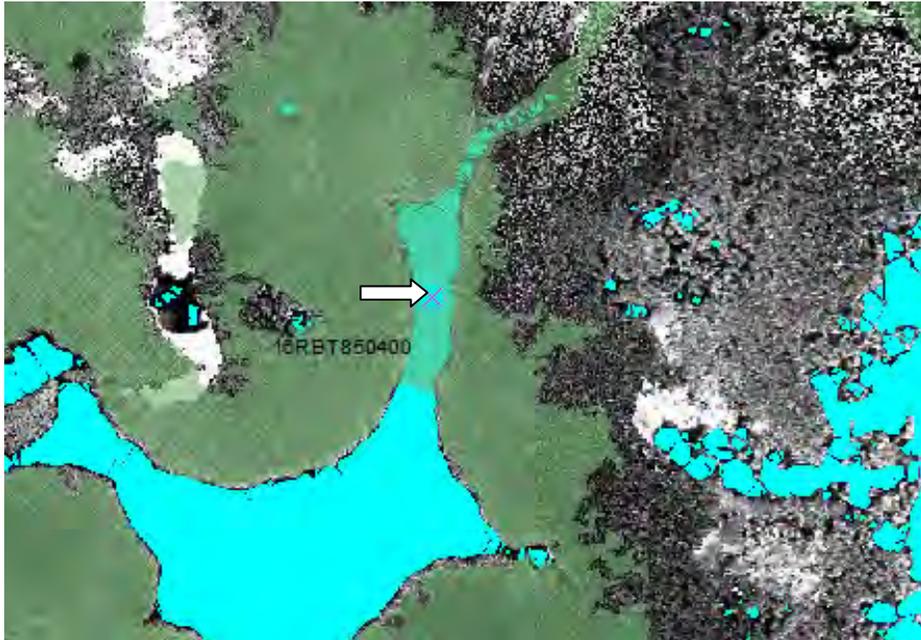
Figure 33 – 1<sup>st</sup> delivery. Full point cloud intensity image islands (green) draped over showing an area where water is classified as ground.

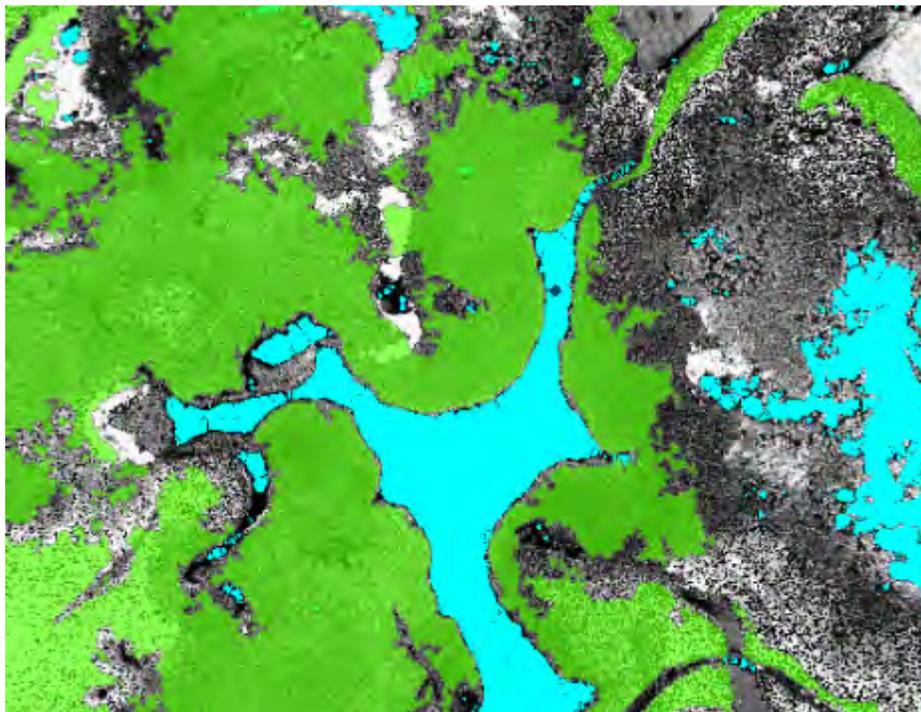
Figure 34- 2<sup>nd</sup> delivery - Corrected. Full point cloud intensity image shows that the islands (green) breakline has been adjusted to remove the water that was previous captured.

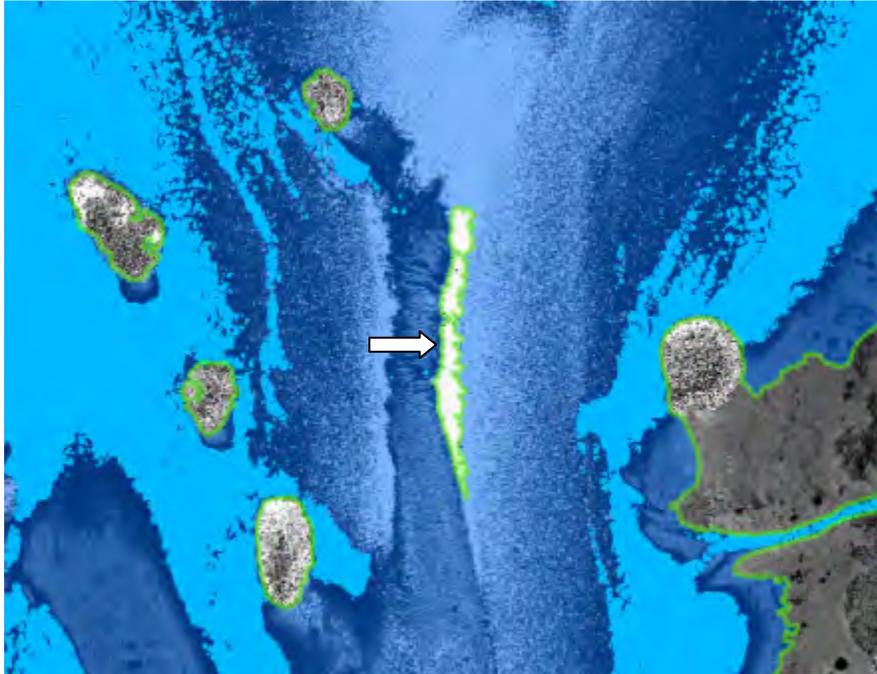
Figure 35 – Error Remains. Full point cloud for tile RBT790370, second delivery. A very bright return from in the LiDAR intensity has been incorrectly captured as an island. The island breakline indicated by the arrow should be removed and the area should be captured as water.

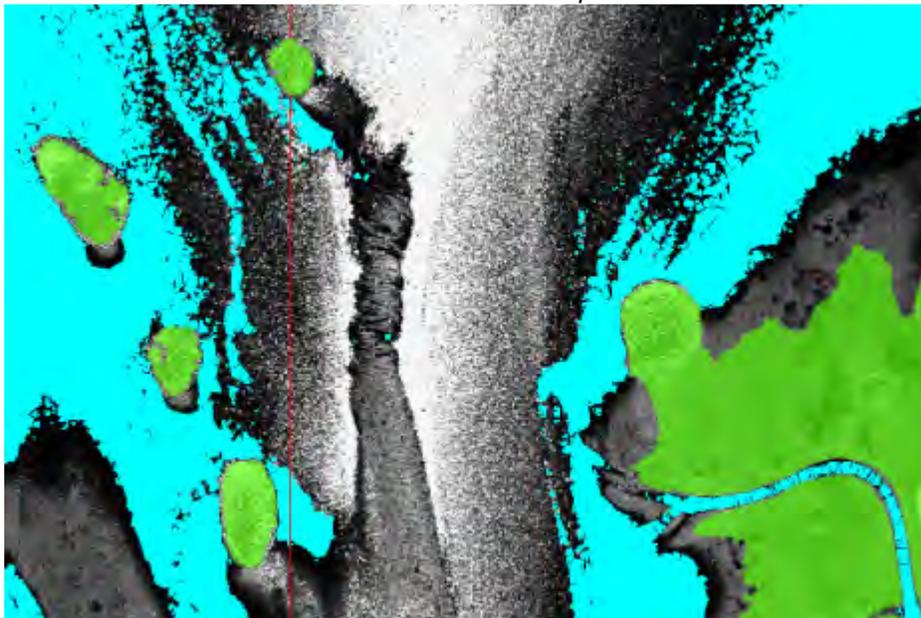
Figure 36 – Full point cloud for tile RBT790370, third delivery. The island breakline has been correctly removed and the area is now captured as water.

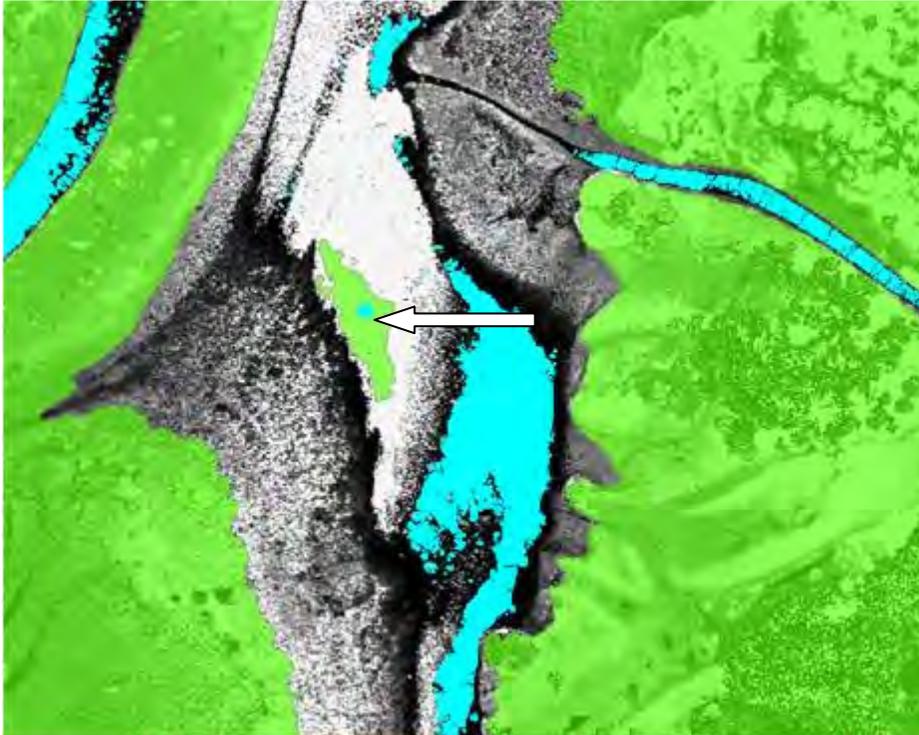
Figure 37 - Error Remains. Full point cloud for tile RBT820325, second delivery. Similar issue to image above. The island breaklines indicated by the arrow should be removed and the area should be captured as water.

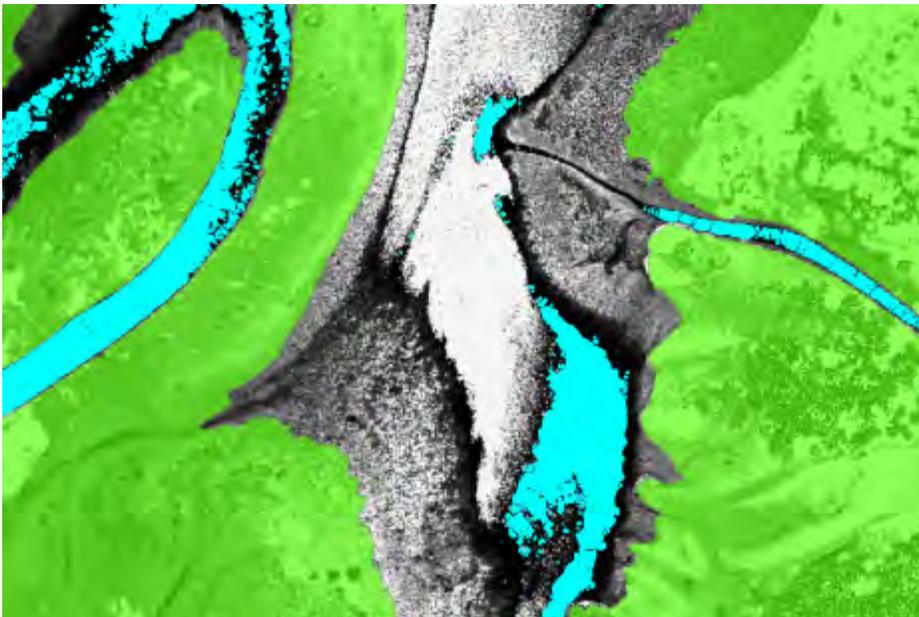
Figure 38 – Full point cloud for tile RBT820325, third delivery. Again the island breakline has been correctly removed and the area is now captured as water.
