LiDAR Quality Assurance (QA) Report  
Louisiana LiDAR ARRA Project - Region 2  
October 11, 2011

Submitted to:  
USGS

**Dewberry**

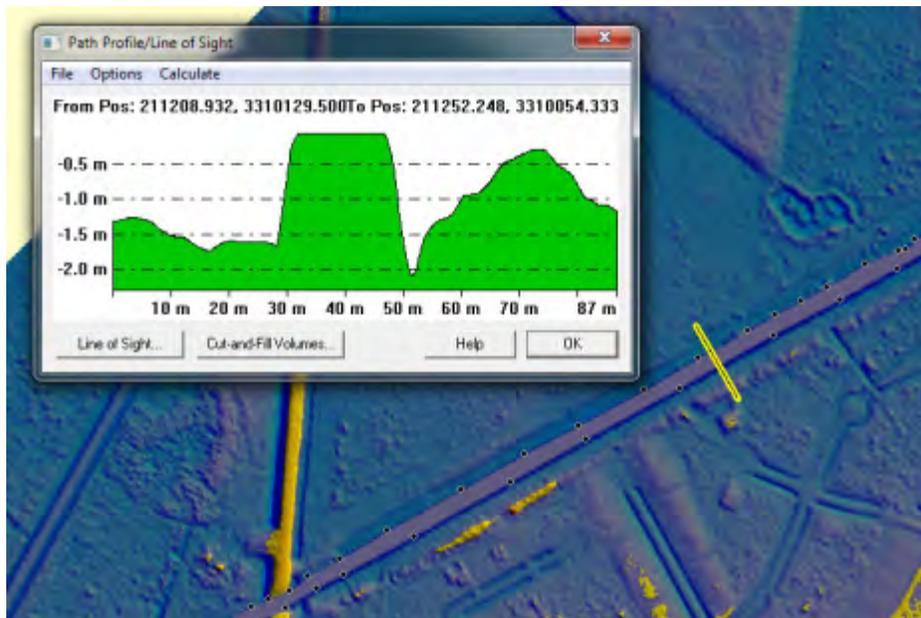
Several vertices were discovered that float above the terrain surface. In the first delivery Dewberry reviewed and identified 30 water features that significantly float above the water. Of these 30 floating water bodies Dewberry identified 10 that were not corrected in the second delivery of the breaklines. Additionally, four new areas of floating water were detected. These issues may be caused by the predetermined “0” elevation for water body features. The land around these breaklines is lower than 0 meters causing raised water bodies in the area. Examples can be seen in Figure 39 to Figure 41. A point feature class will be provided that details where the vertices are that float. The previous digging water body was corrected in the second delivery (Figure 42 and Figure 43).

*Figure 39 – Issue remains but no fix required. Ground elevation model of tile rbu100090 showing a floating water feature.*

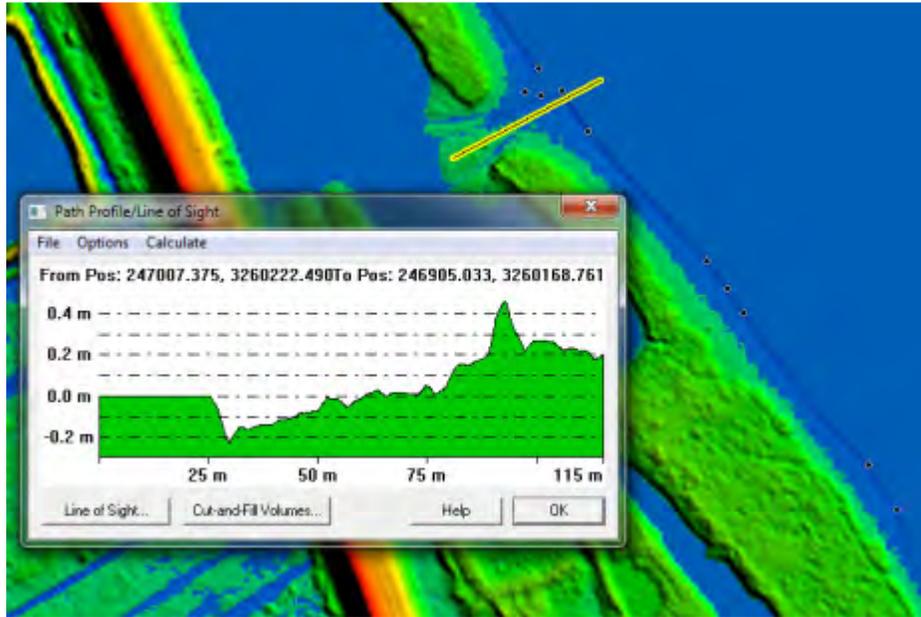
Figure 40 – Issue remains but no fix required. Ground elevation model of tile rbt475955 showing the tidal water breakline floats by ~22 cm.

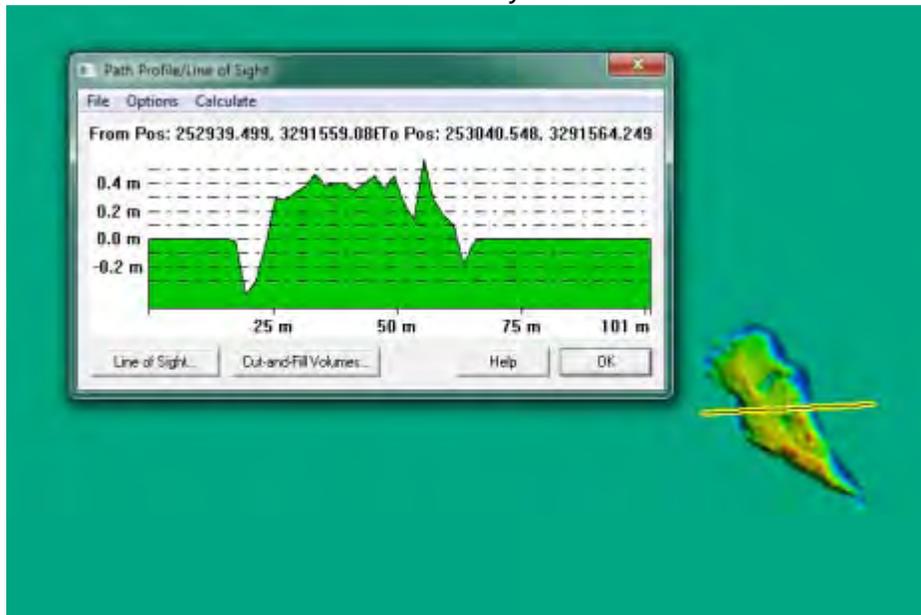
Figure 41 – Issue Remains but no fix required. Ground elevation model of tile rbt520910 showing that the tidal waters float by ~30cm around an island.

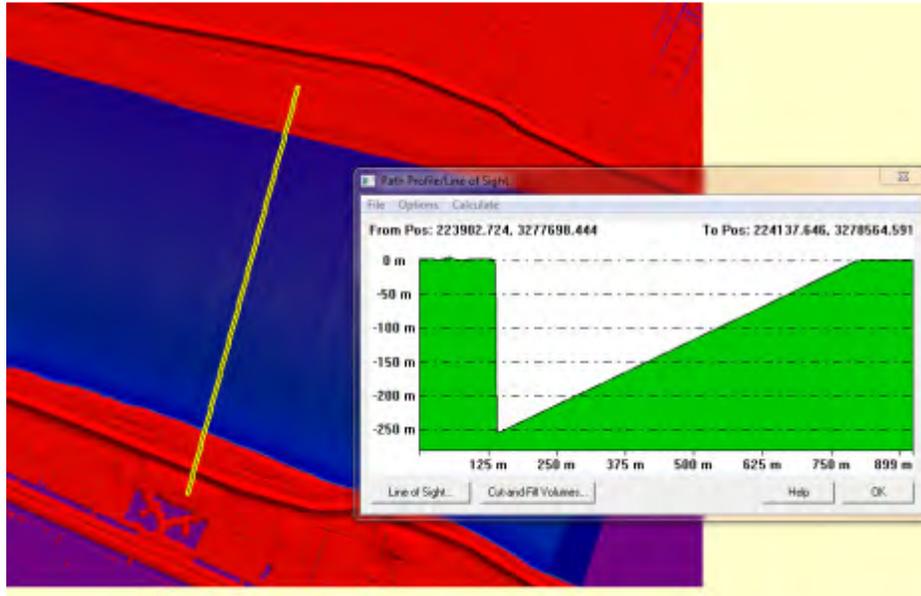
Figure 42 – 1<sup>st</sup> delivery. Ground elevation model of tile rbt235775, first delivery showing the water feature is digging by ~250m.

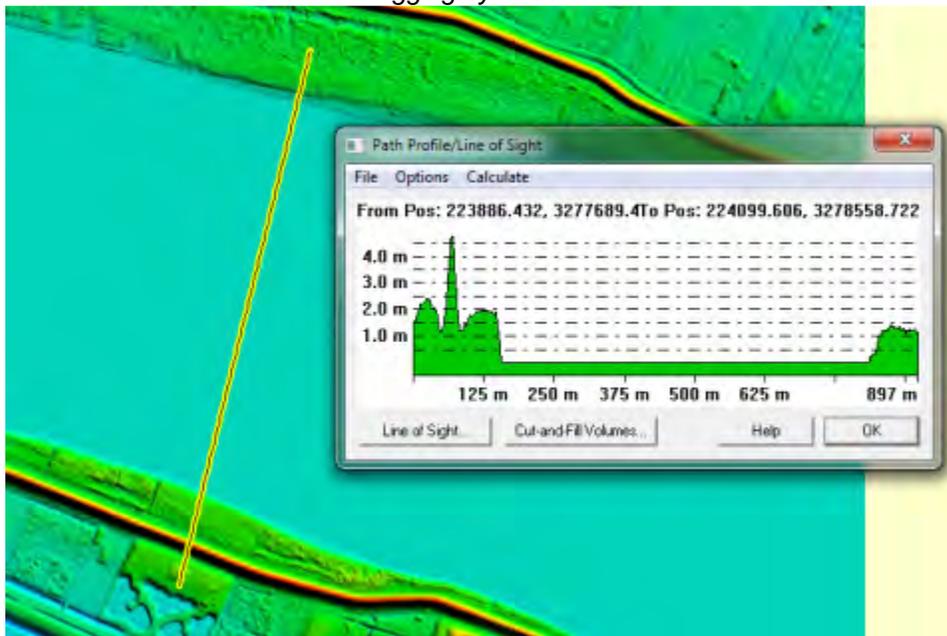
Figure 43 – 2<sup>nd</sup> delivery - Corrected. Ground elevation model of tile rbt235775, second delivery, showing that the digging water feature has been corrected in the second delivery.

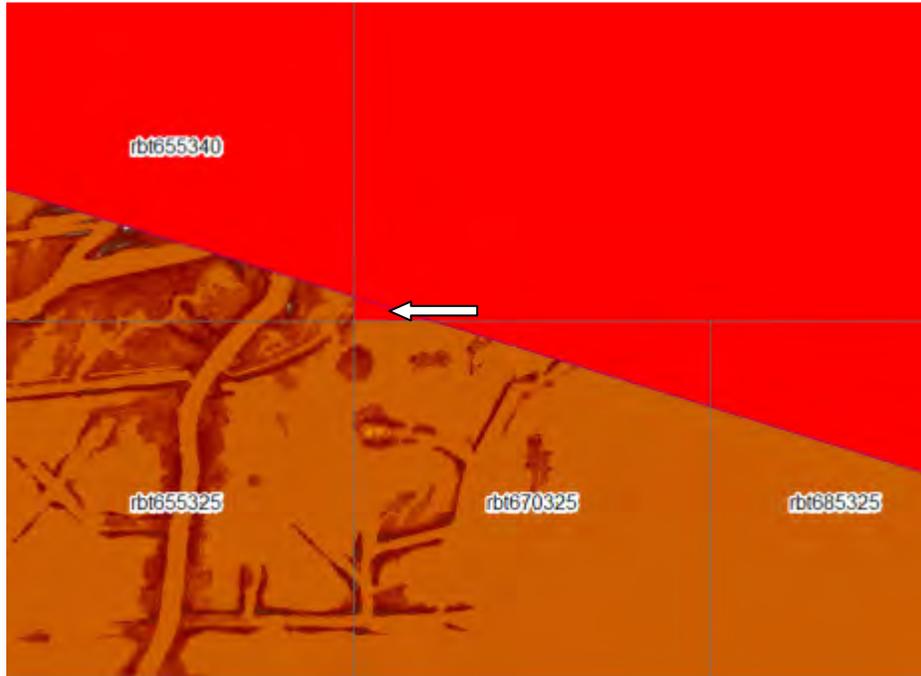
The first delivery of DEMs was missing 27 tiles that had LAS data (in addition to the 74 tiles Dewberry recommended be delivered to ensure no ground was overlooked). All missing DEMs were delivered in the second delivery. There are now 1290 DEMs which is consistent with the number of LAS tiles for the project.

Figure 44 – 1<sup>st</sup> delivery. Example of missing DEM tile (white arrow). Dewberry received LAS data for this area.

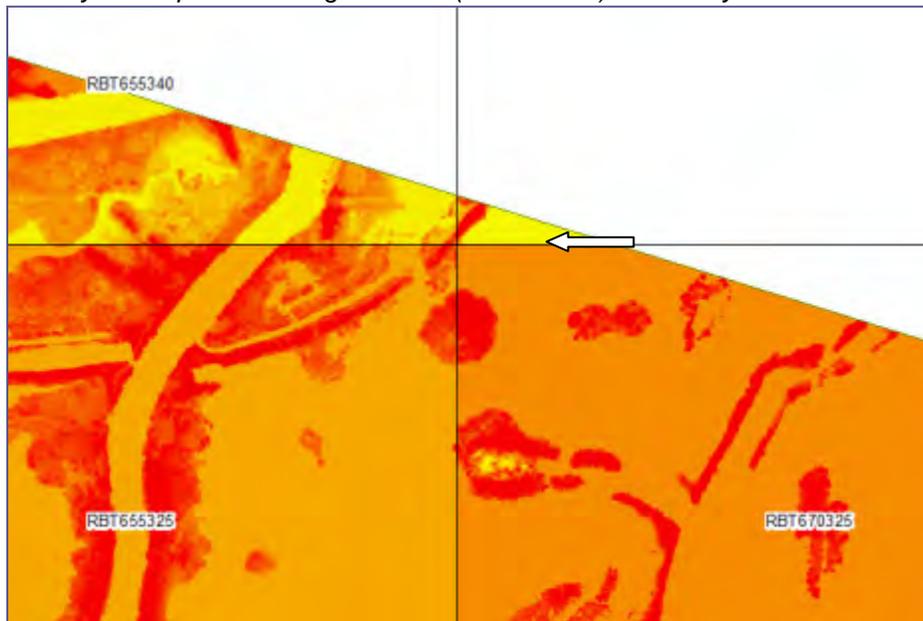
Figure 45- 2<sup>nd</sup> delivery - Corrected. The missing DEM was included in the second delivery.

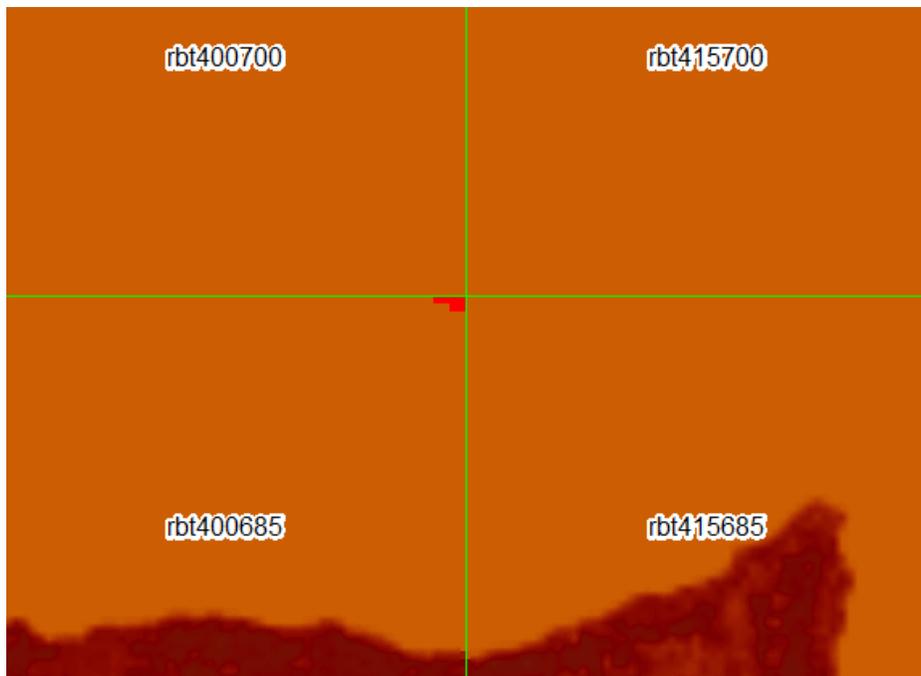
Dewberry also identified 11 tiles that have null pixels in the DEM that are not outside of the project boundary. Woolpert corrected all of these issues identified in the first delivery; however, Dewberry discovered 3 new DEMs with null pixels in the second delivery. Dewberry recommends these DEMs be reprocessed. Examples of the fixes and the new issues can be found below.

*Figure 46 – 1<sup>st</sup> delivery. Ground elevation model of several first delivery tiles. Tile rbt400685 has several null pixel values in the upper-right corner (In red).*

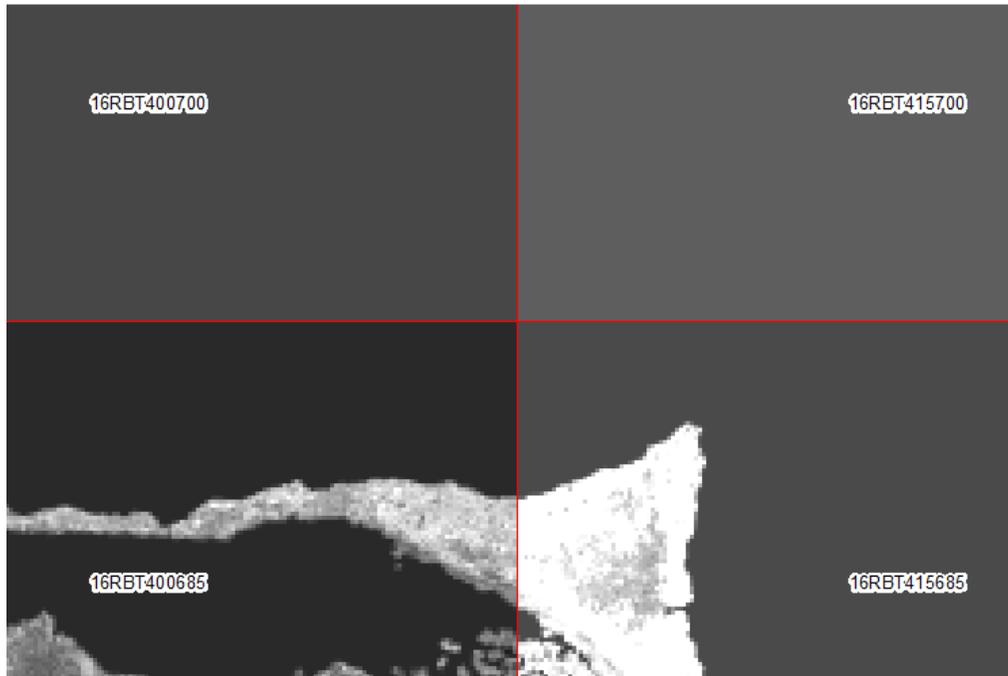
Figure 47 – 2<sup>nd</sup> delivery - Corrected. Ground elevation model of the second delivery of tile rbt400685. The null pixel values have been corrected.

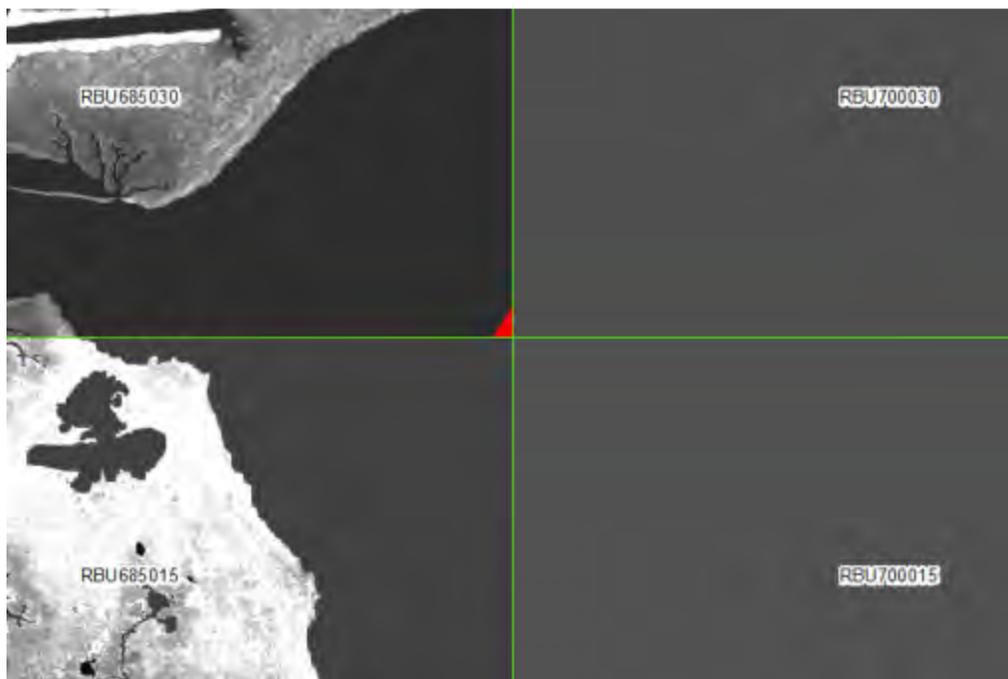
Figure 48 – Error Remains. Ground elevation model of several tiles in the second delivery. Tile rbu685030 shows several null pixels (red) in the bottom right corner of the tile.

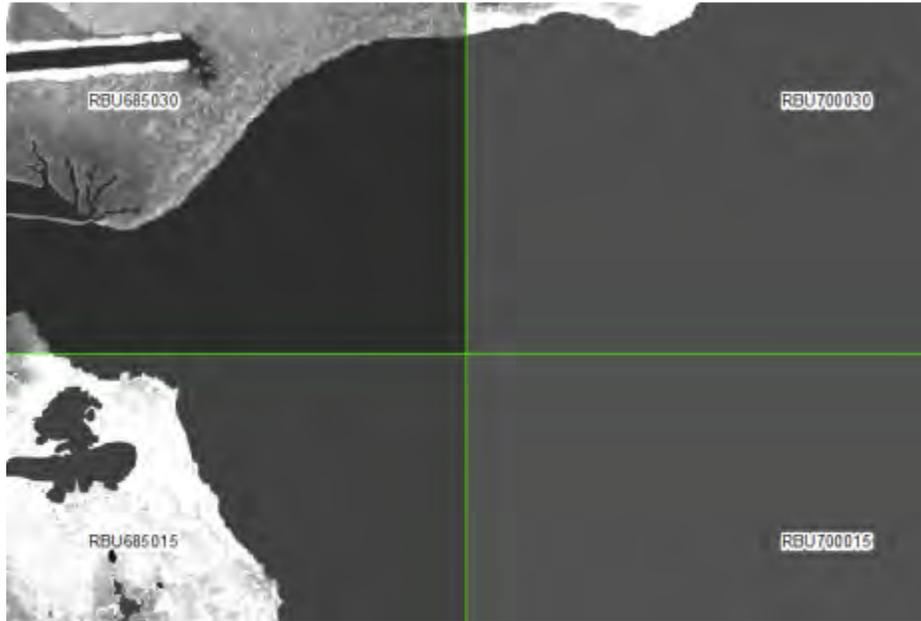
Figure 49 – The null pixels in the corner of tile rbu685030 have been corrected in the third delivery

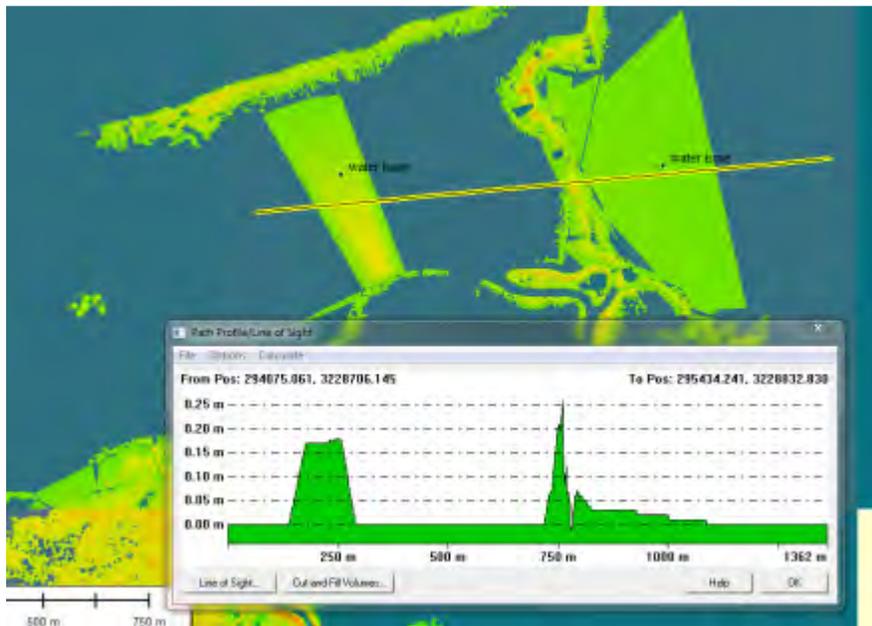
Figure 50 – 1<sup>st</sup> delivery. Ground elevation model of tile 16RBT940280, first delivery. The areas in between the islands are delineated in the breaklines as water, but this is not reflected in the DEM.

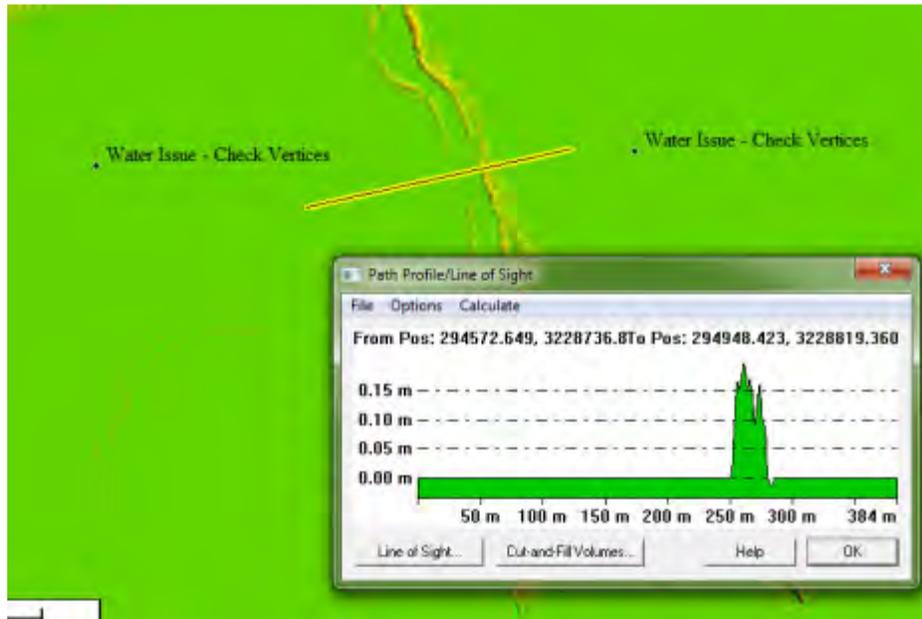
Figure 51- 2<sup>nd</sup> delivery – Corrected. Ground elevation model of tile 16RBT940280, second delivery. The water artifacts have been removed in the second delivery.
