Appendix A

Charles County Tiles

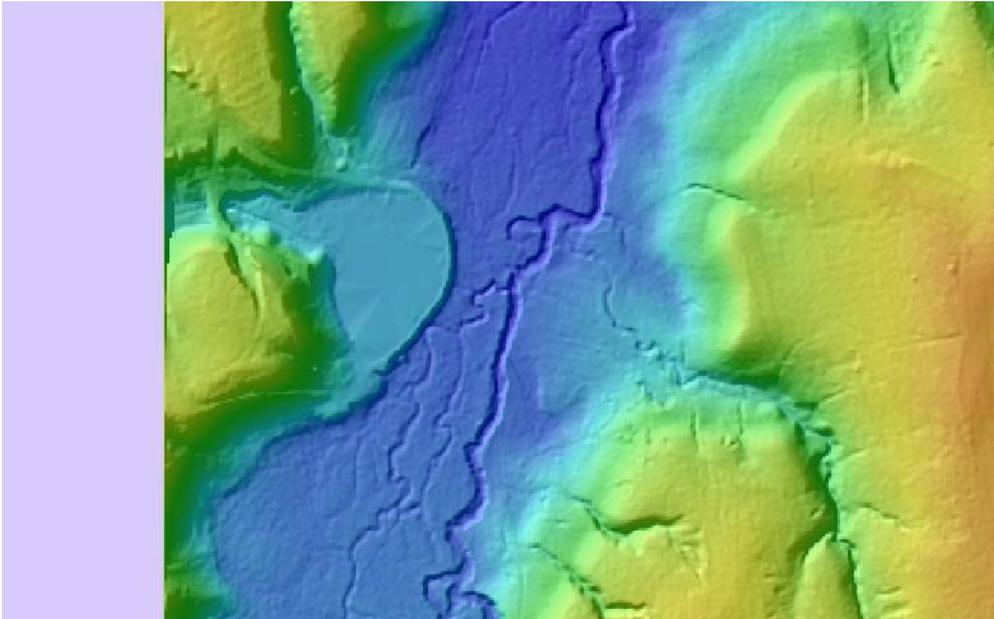
Figure 18 - AA1064 Excellent example of retaining the dam structure which typically gets removed because of it's similarity to a structure (building).

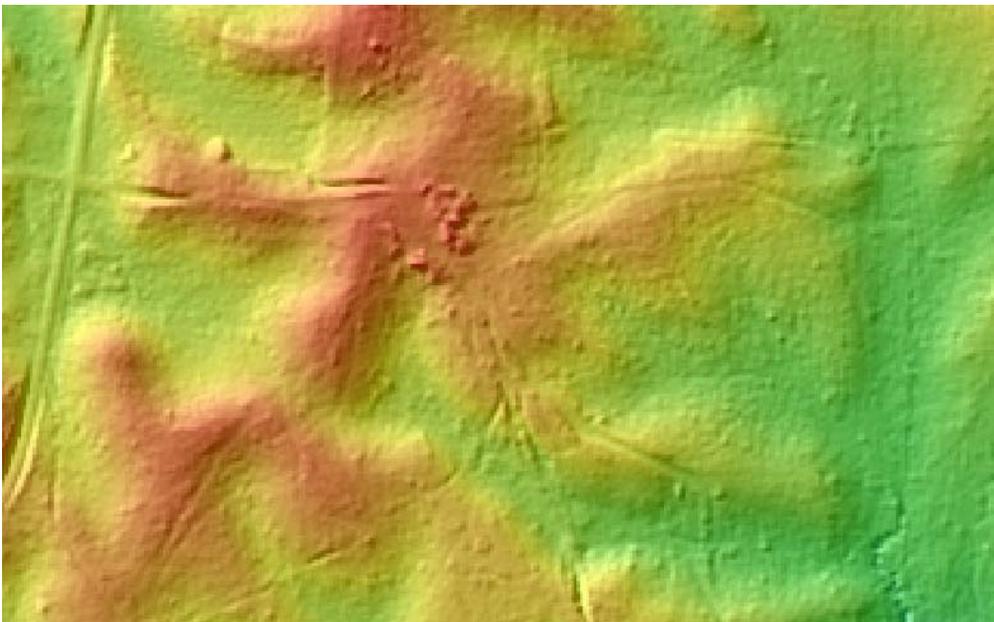
Figure 19 - AA1083 – potential artifacts (minor)

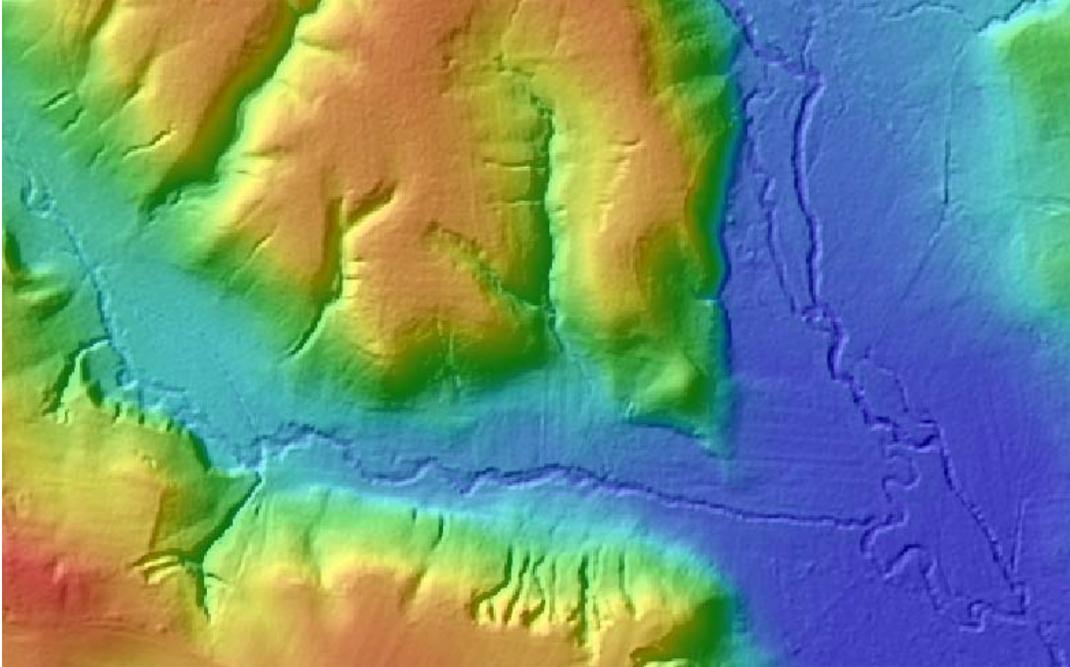
Figure 20 - AA1096 – excellent drainage patterns and cleanliness.

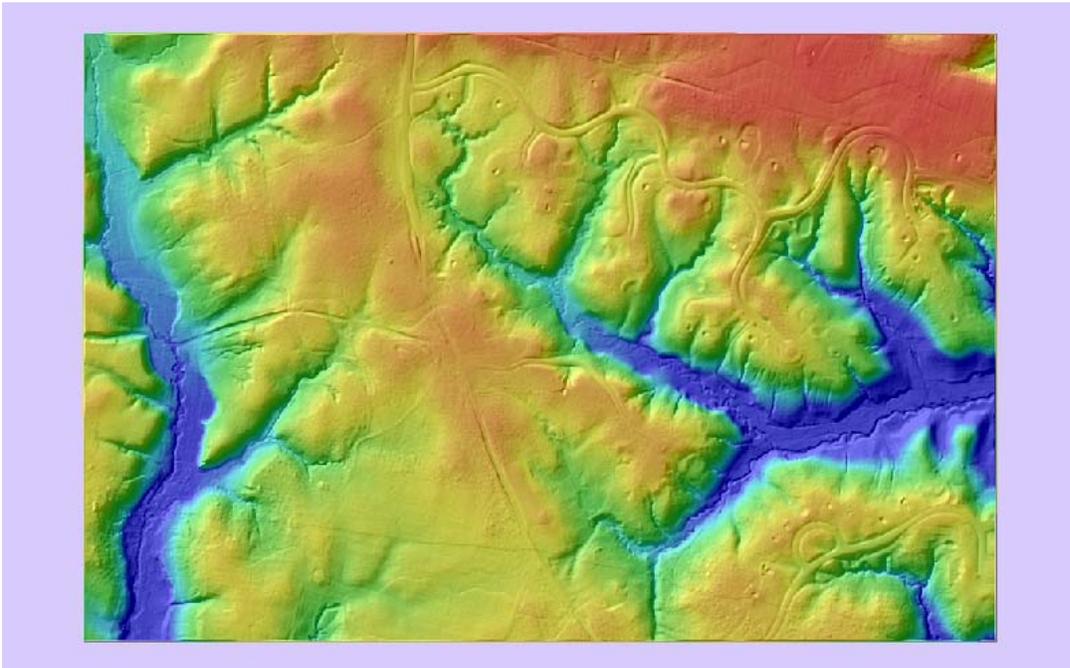
Figure 21 - A1111- example of small divots.

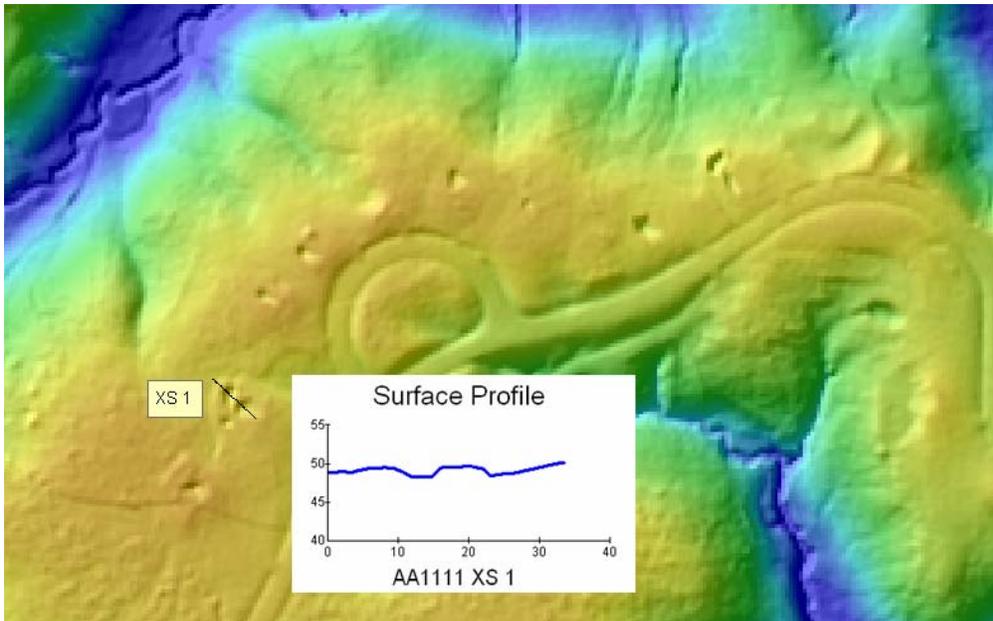
Figure 23 - AA1111 - zoomed in area and location of cross section with associated graph depicting divot.

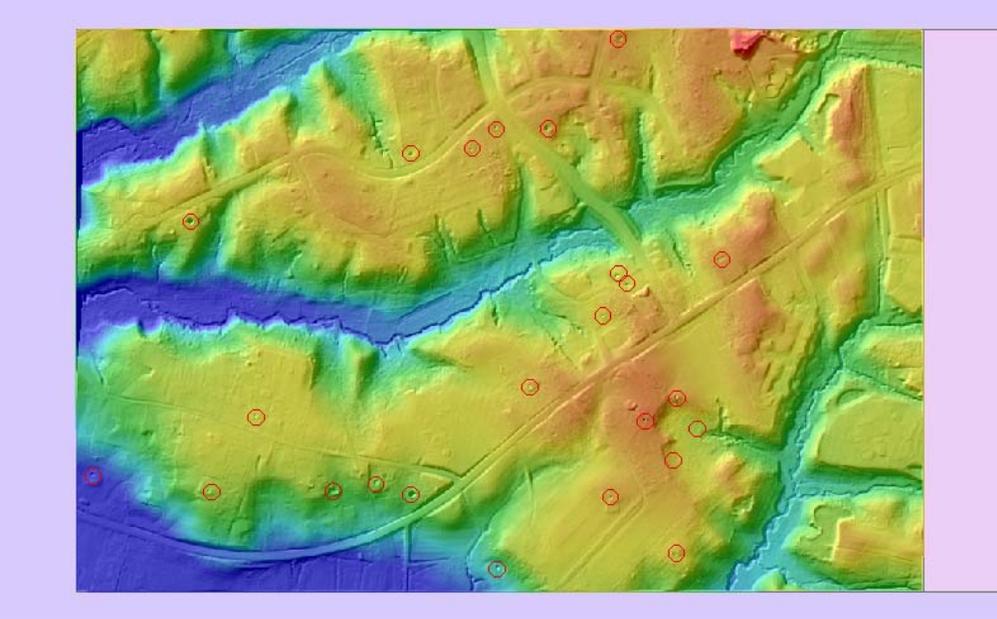
Figure 24 - AA1123 divots.

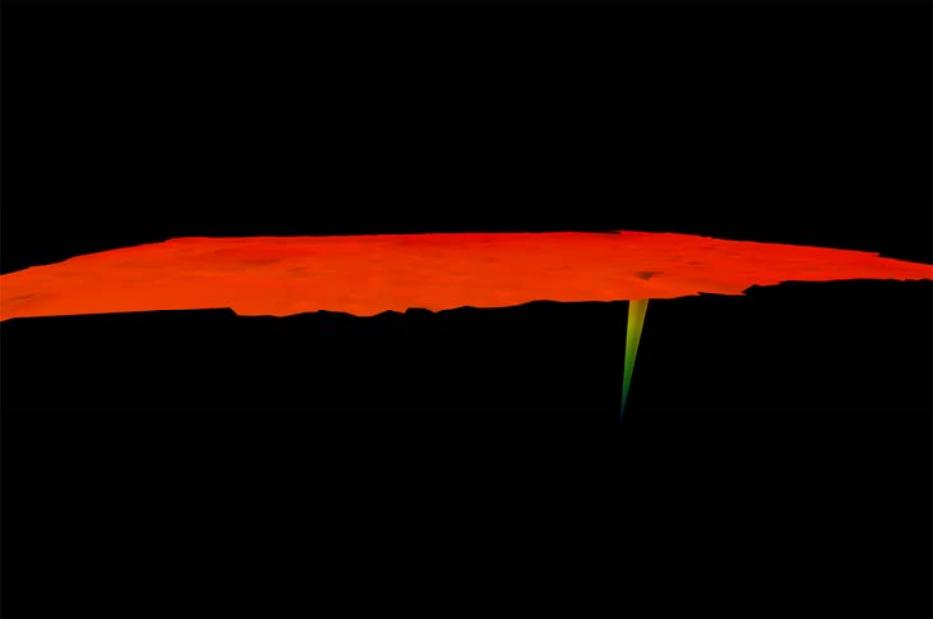
Figure 25 - AA1124 – 3D view of low point.

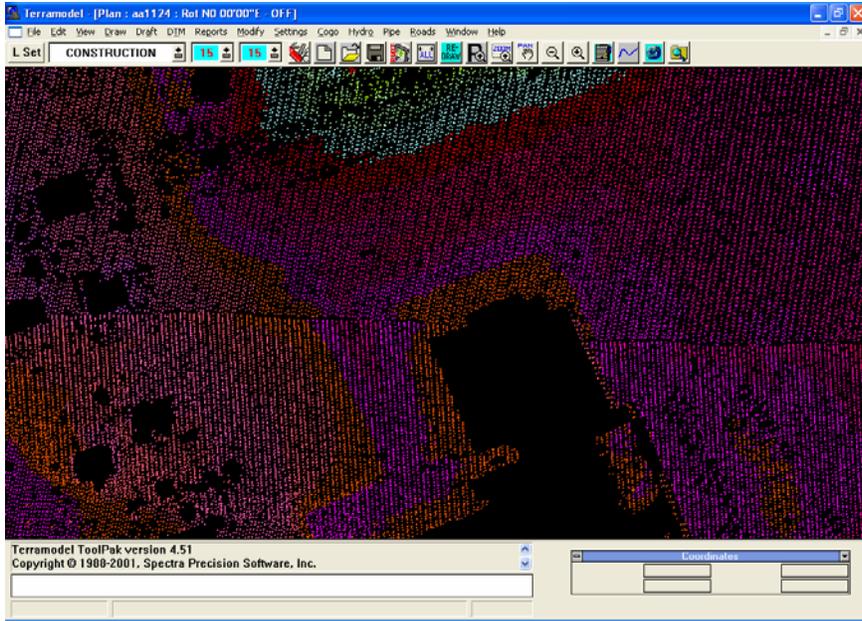
Figure 26 - AA1124: scan line issue (see figure 14)

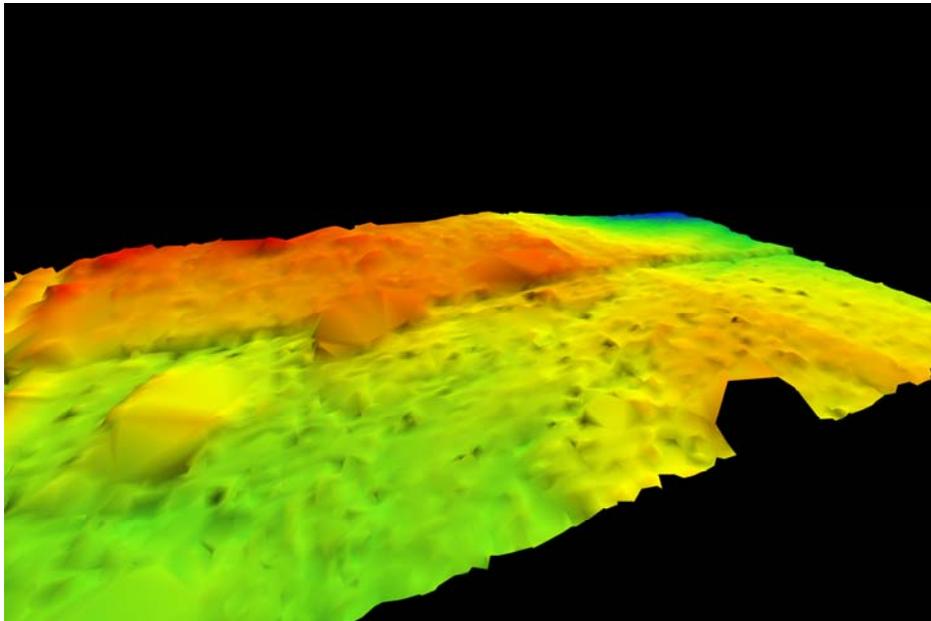
Figure 28 - AA124 scan line issue (See figure 16)

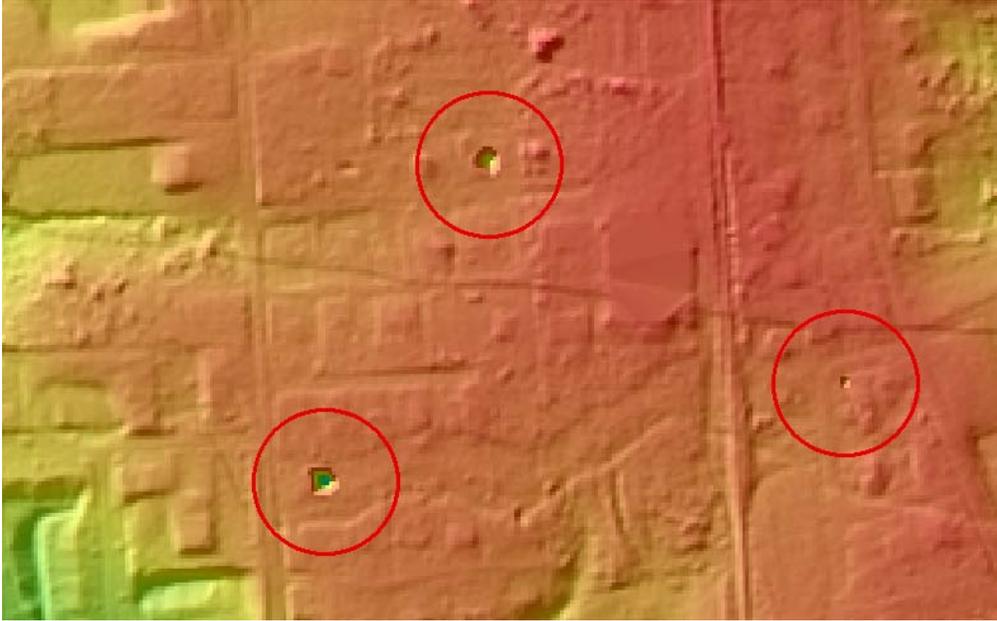
Figure 29- AA1124 divots.

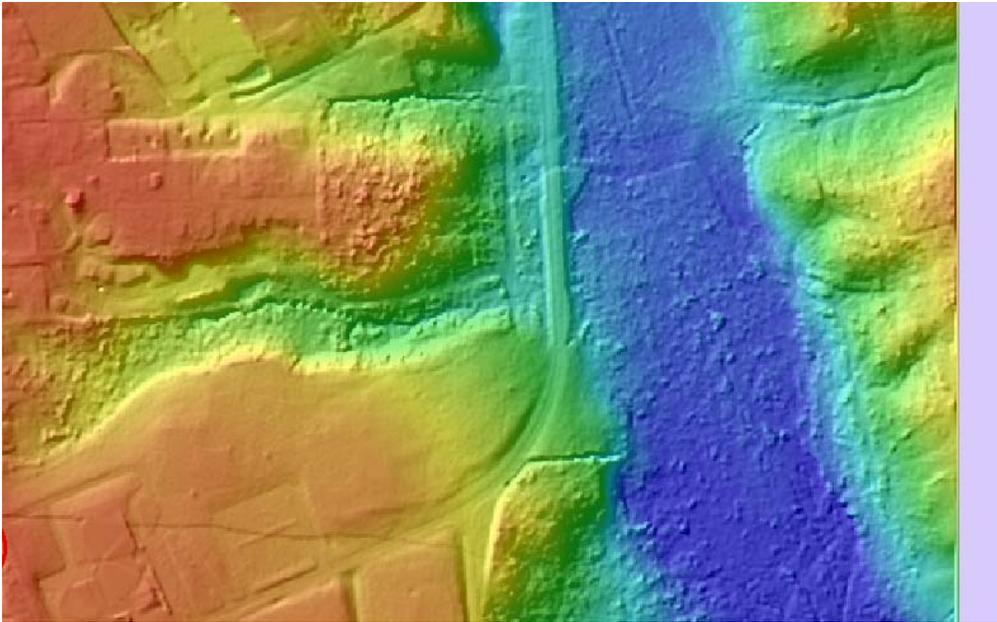
Figure 30 - AA1124 noisy data of potential artifacts.

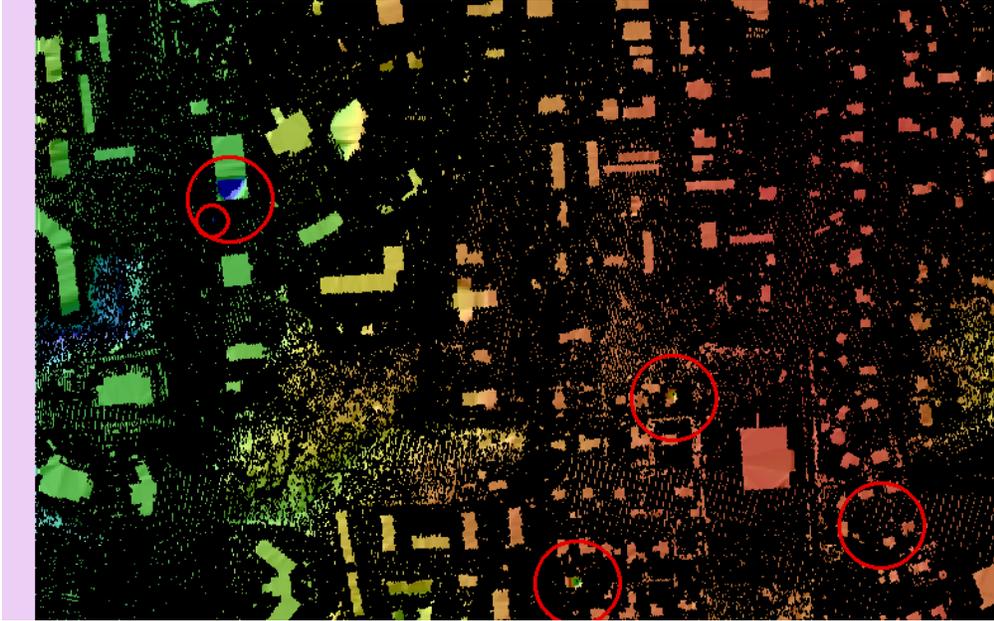
Figure 31 - AA1124 Terrain model with overlaid LIDAR. Note within the red circles that an errant LIDAR point exists within the confine of the building's perimeters.

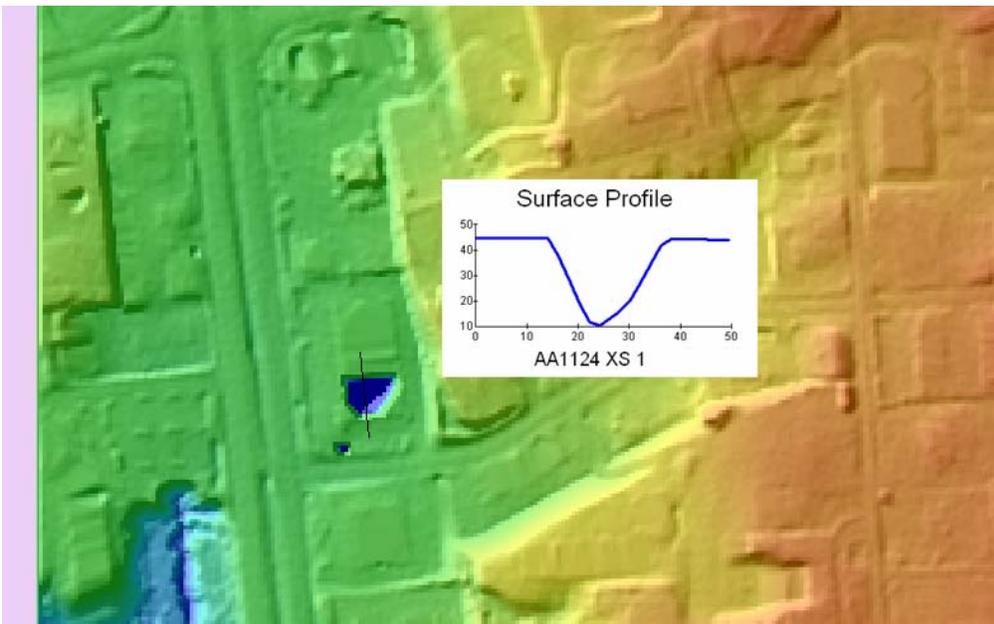
Figure 32 - AA1124 deep divot with cross section.

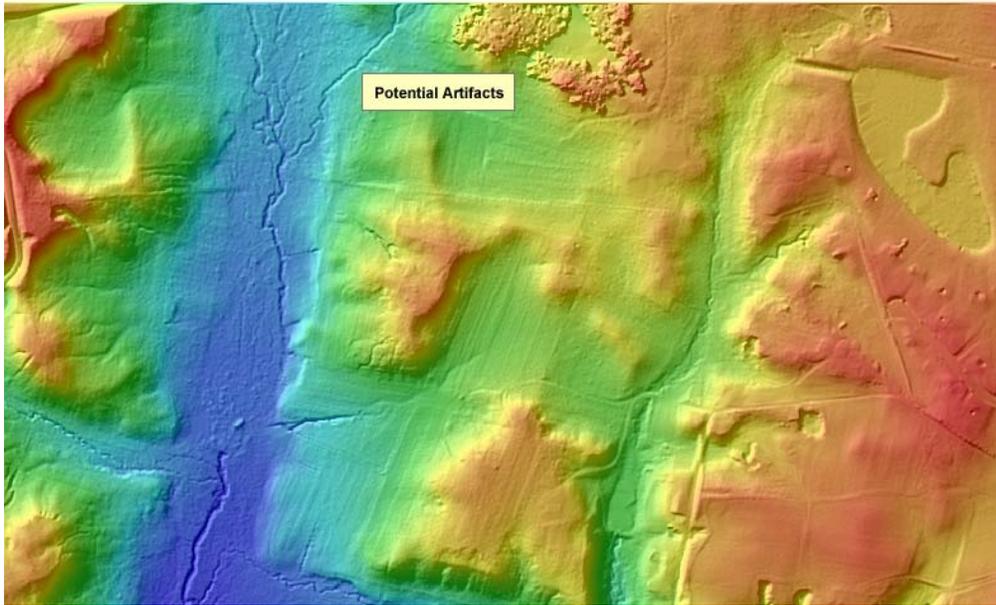
Figure 33 - AB1151 with potential artifacts.

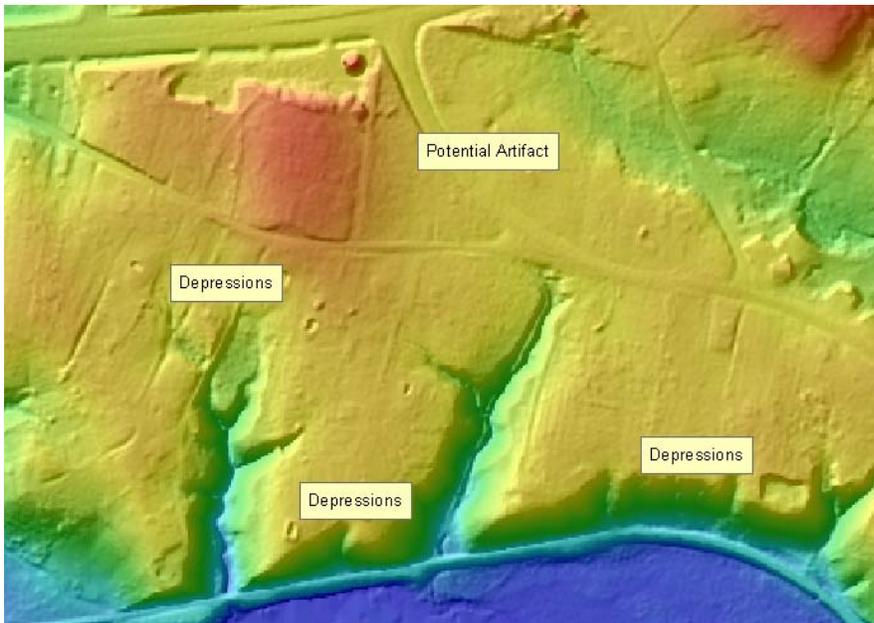
Figure 34 - AC1082 with potential artifacts and divots labeled depressions.

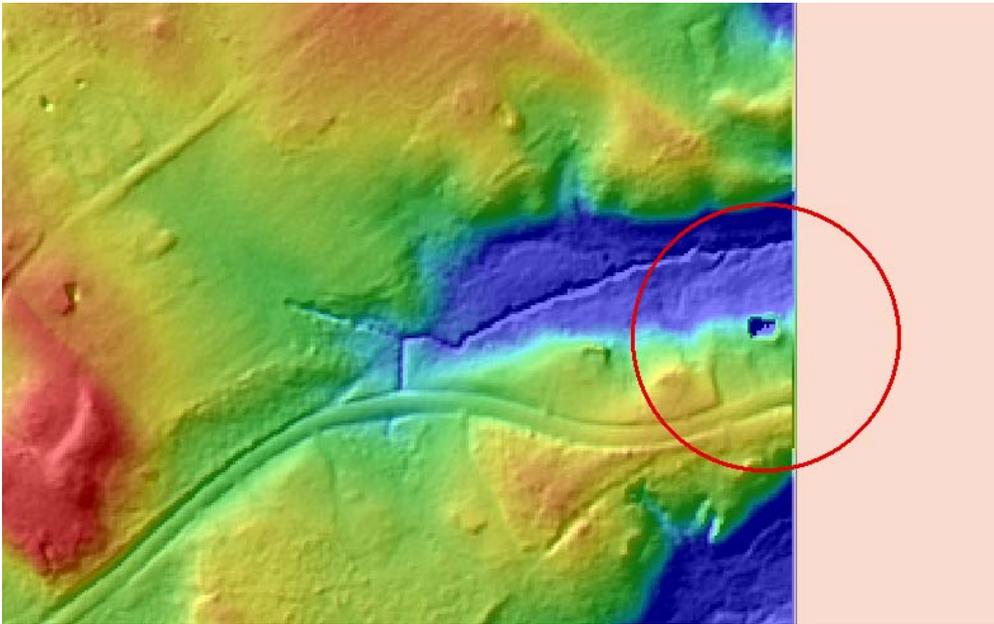
Figure 37- AC1153 with large divot.

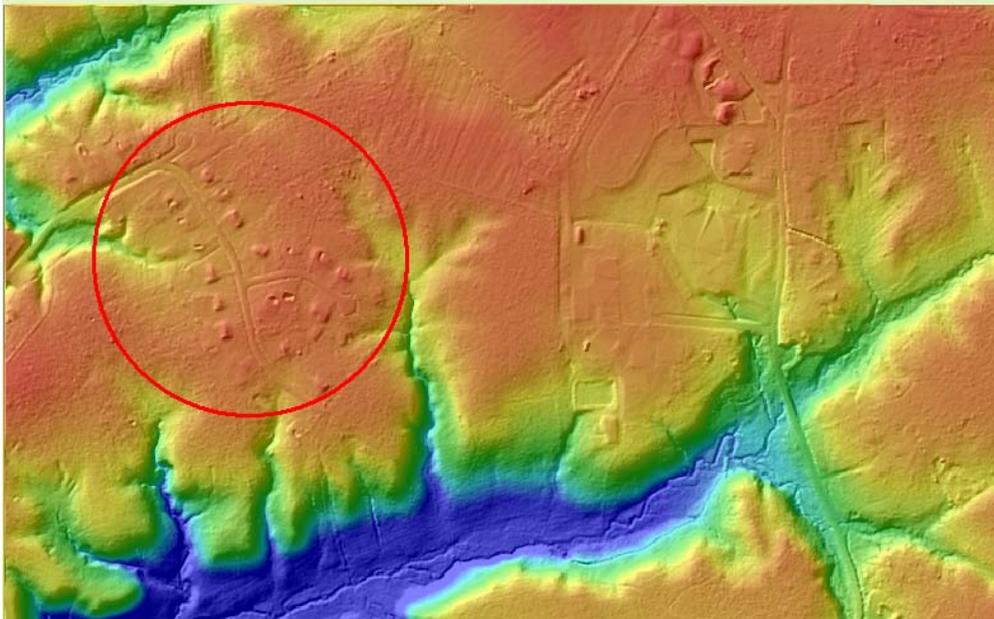
Figure 38 AD1105 with small divots.

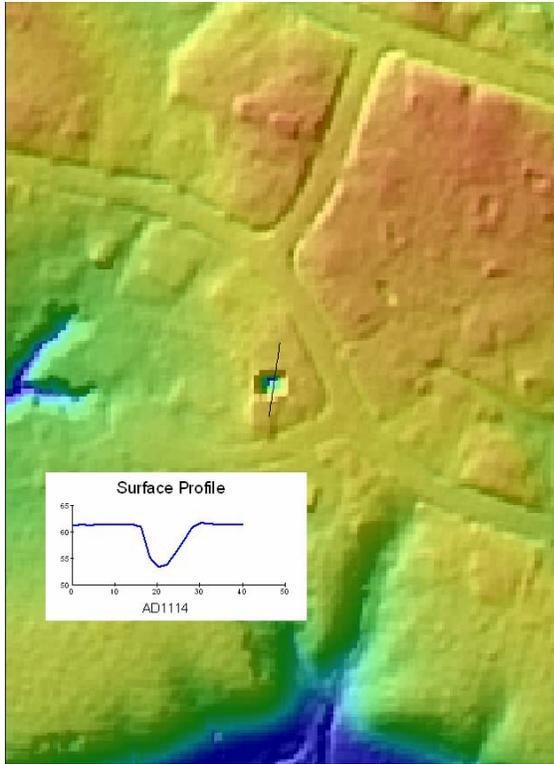
Figure 39 AD1114 with large divot.

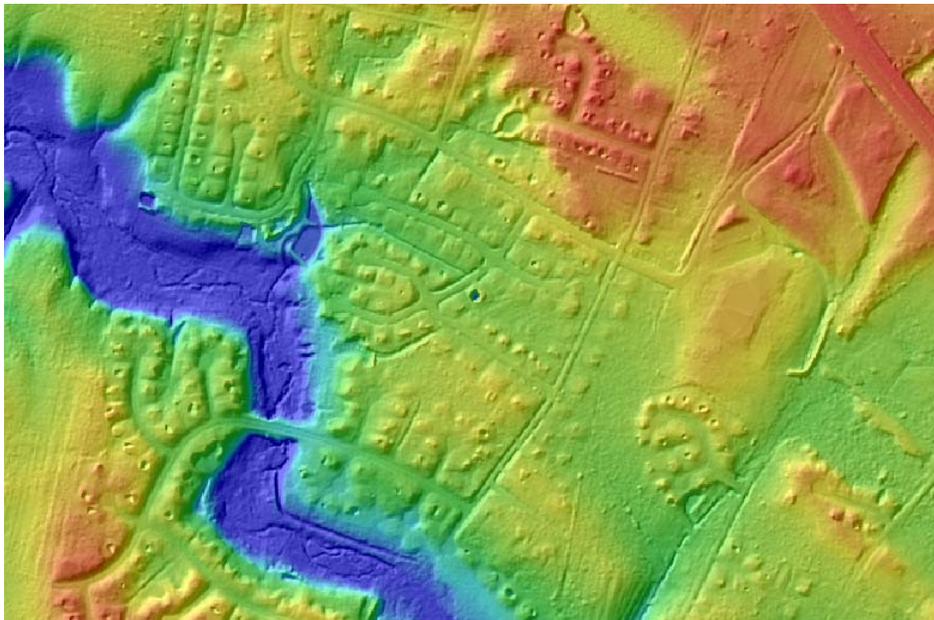
Figure 40 - Tile AD1132 with both large and small divots.

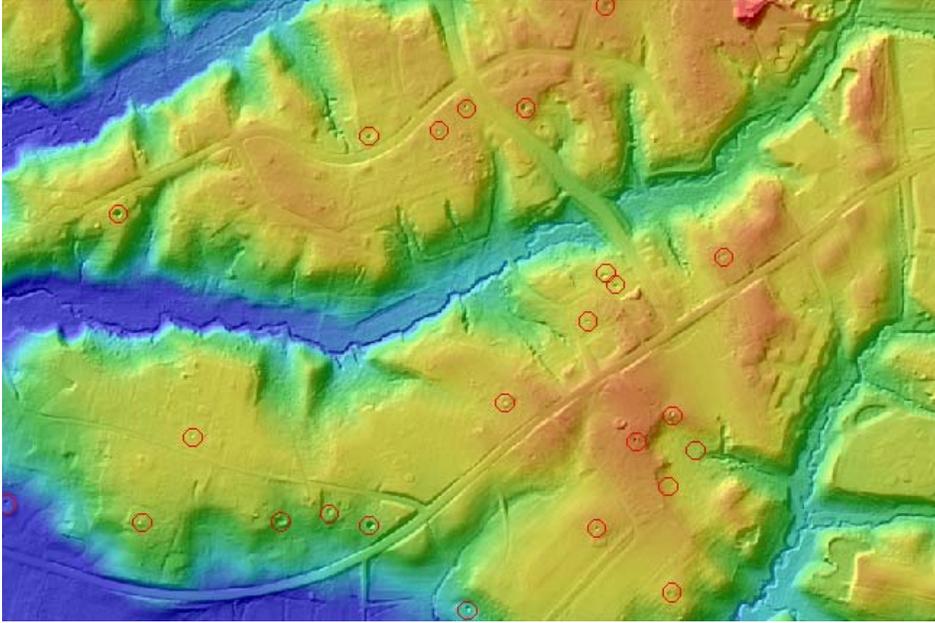
Figure 41 - AD1132 with small divots.

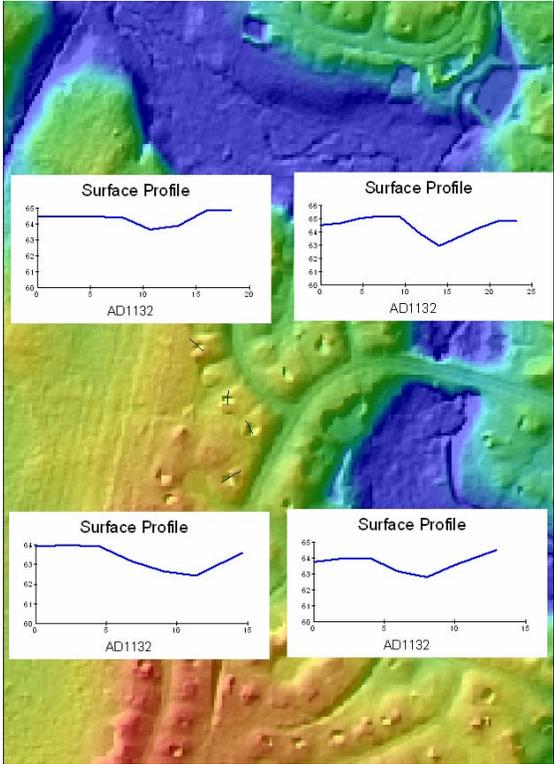
Figure 42- Tile AD1132 with small divots and associated cross sections.

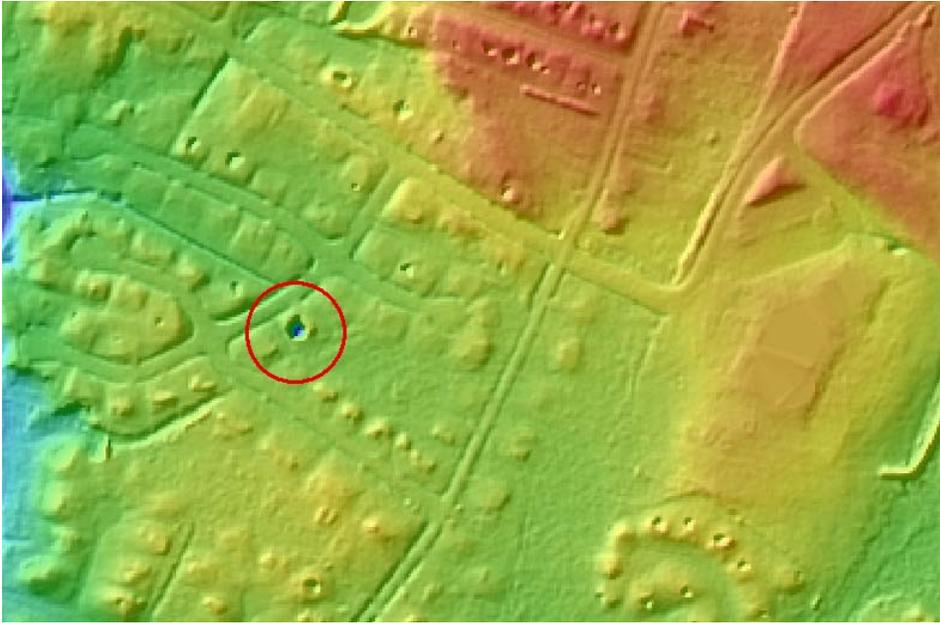
Figure 43 - Larger divot highlighted in red, smaller divots elsewhere.

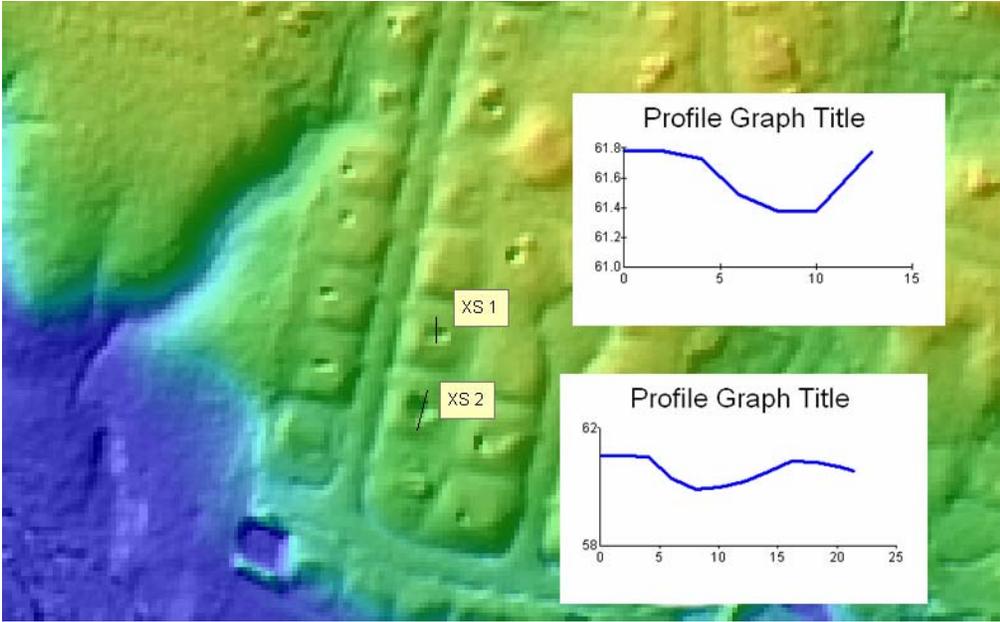
Figure 44 - AD1132 – smaller divots with associated cross sections.

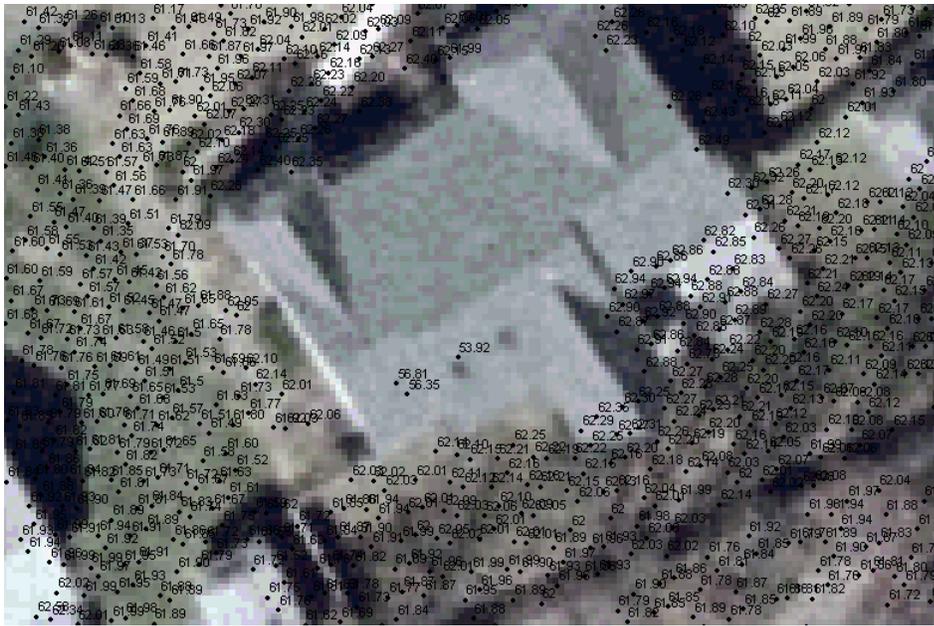
Figure 45 - AD1132 LIDAR points with their associated elevations. Three points exist that are approximately 5 meters less than the surrounding terrain.

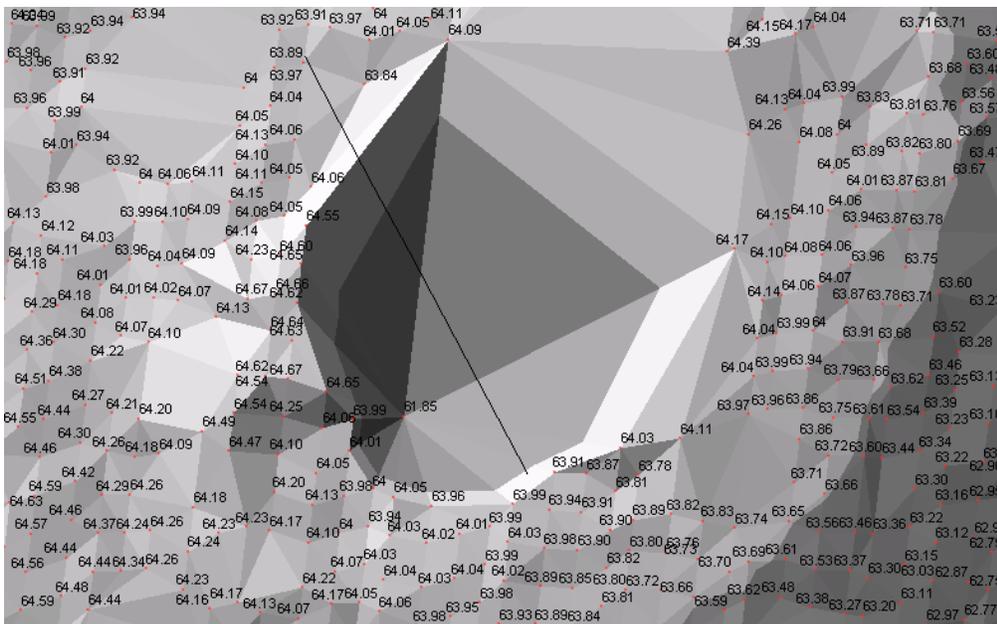
Figure 46 - AD1132 TIN with associated elevations. One point is three meters less than the surrounding area.

Upon working with Spatial Systems and Sanborn, an explanation was sought to find the cause of these divots. Sanborn was able to prove on the smaller divots at some locations that an external stairway leading to the basement was the culprit. However Dewberry is not convinced that this is the cause for all instances as there are too many. The divot issue also has to be broken down into to categories; small divots that are 1- 2 meters in depth and those 5 meters or greater.

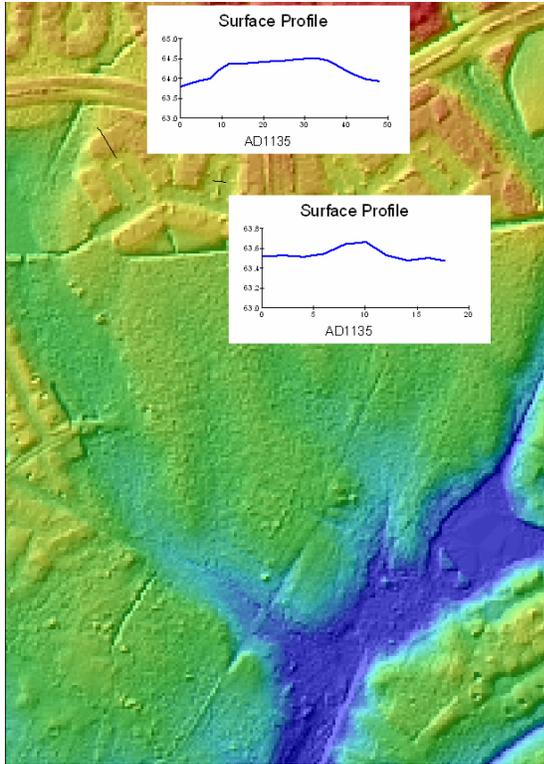
Figure 47 - AD1135 - Potential artifacts with associated cross sections.

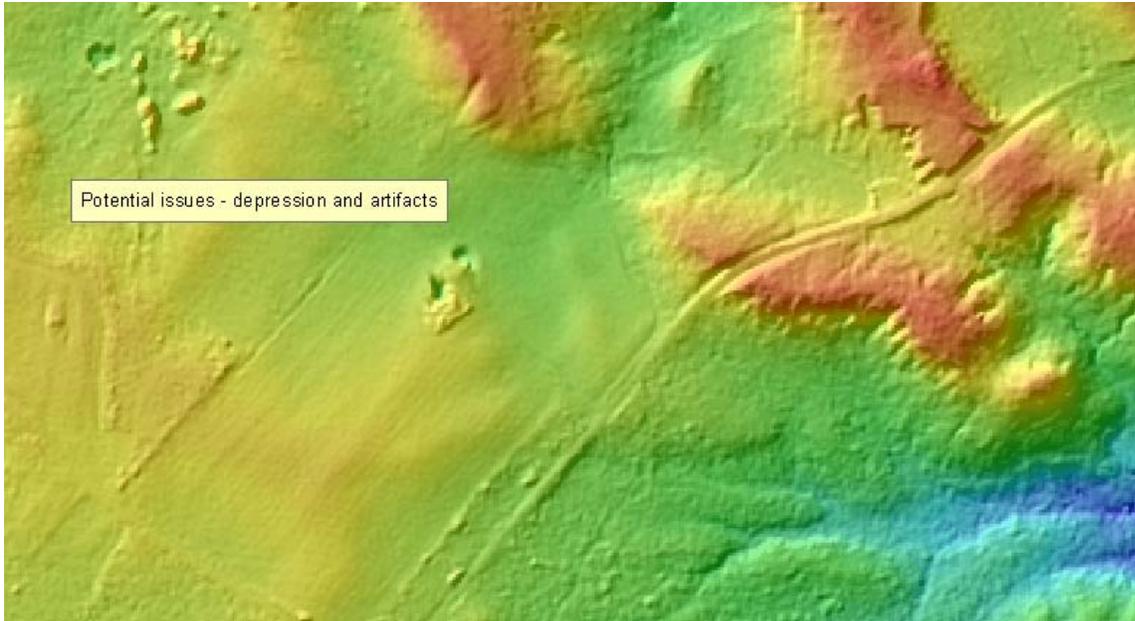
Figure 48- AD1176 – potential artifacts and depressions.

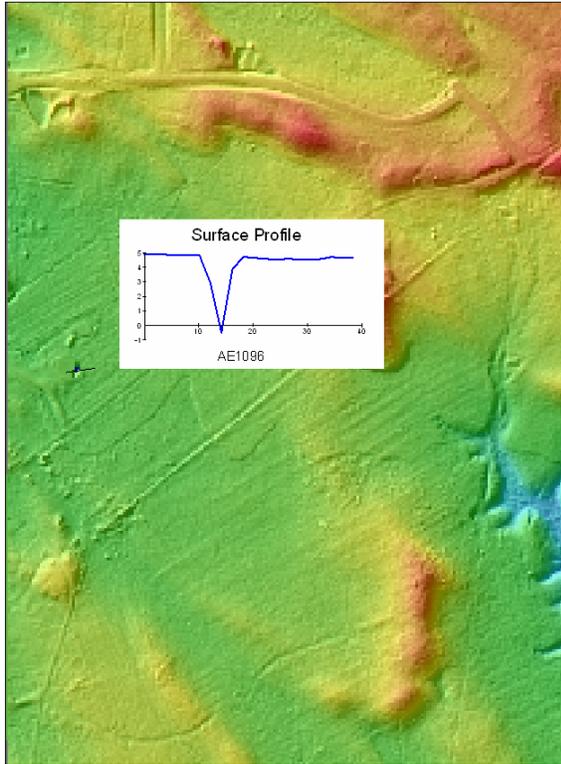
Figure 49 - AE1098 - Large divot.

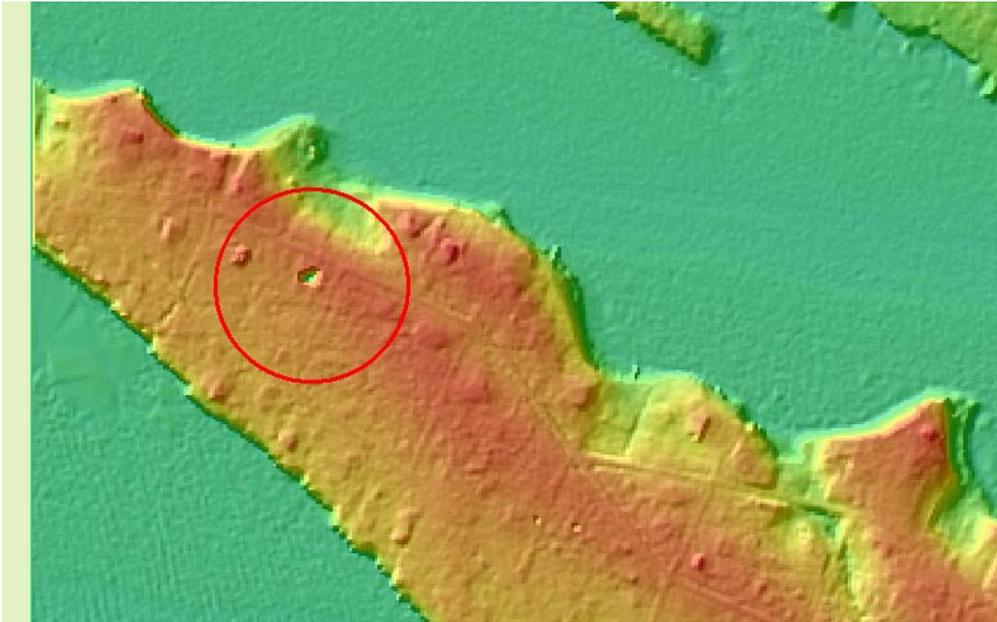
Figure 51 S1154 – Large divot

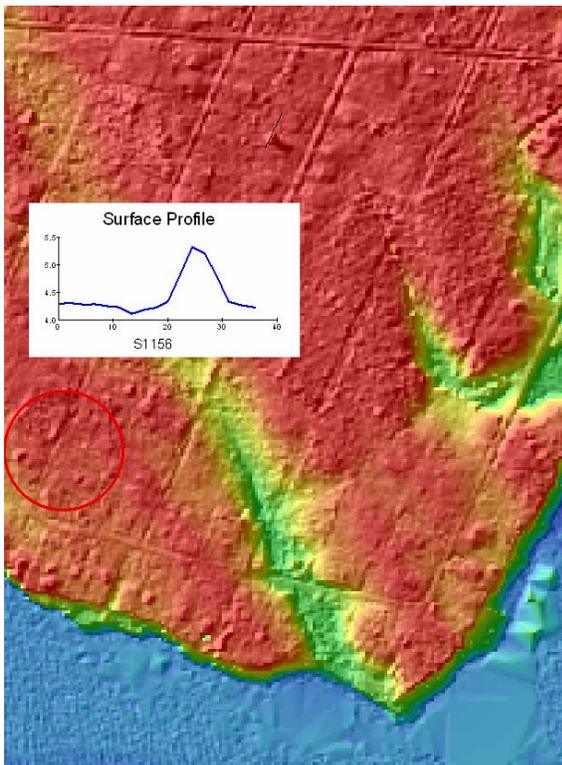
Figure 52 - S1156 – Potential artifact.

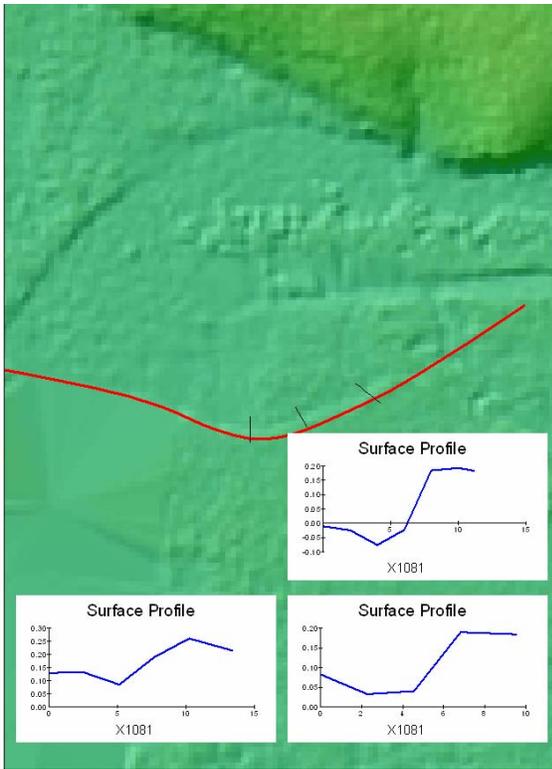
Figure 55 -X1081 Scan line issue with associated cross sections.

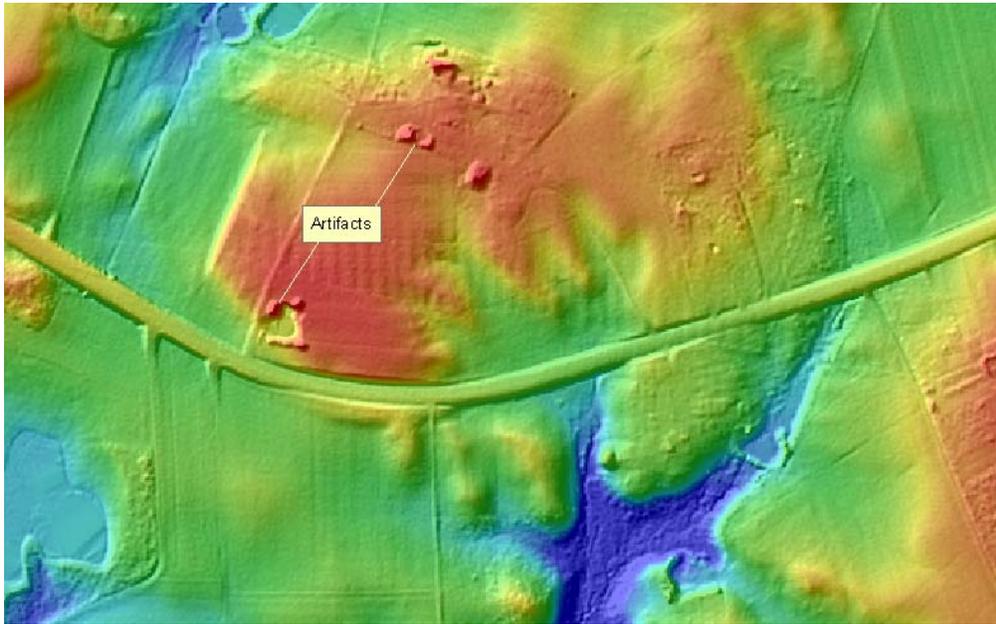
Figure 57 - Y1162 – Potential artifacts.

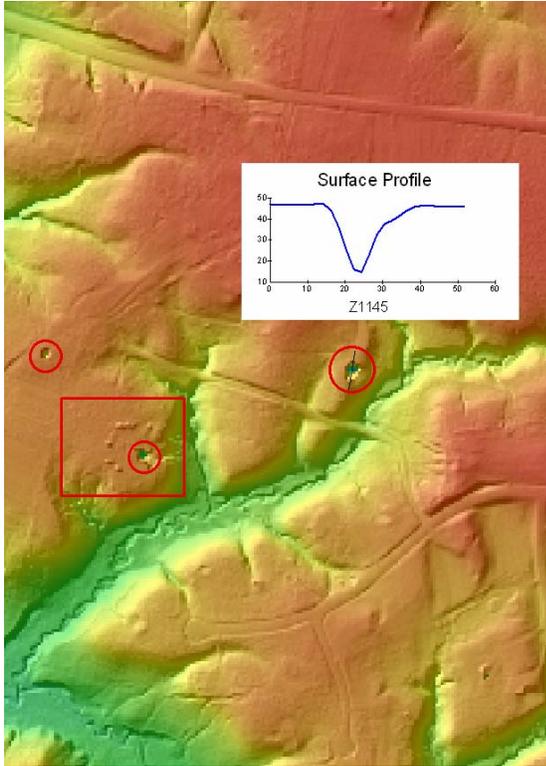
Figure 61- Z1145 – Large divot.

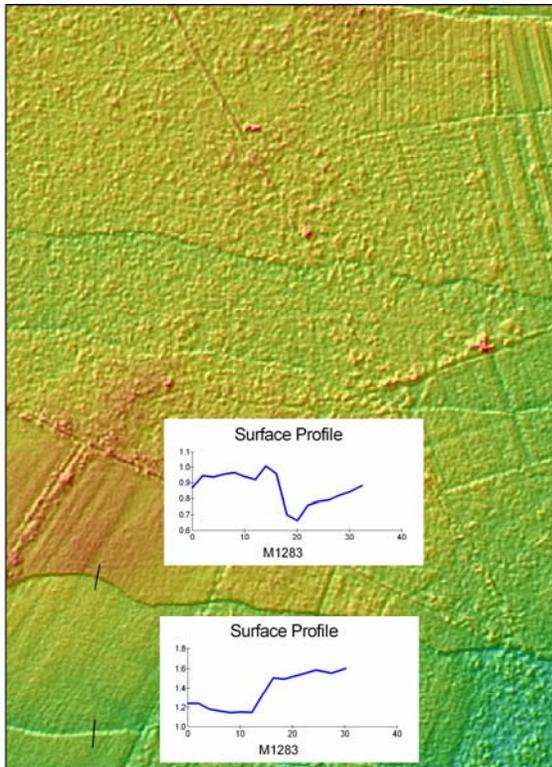
Figure 64 – M1283 – Scan line issue with associated cross section.

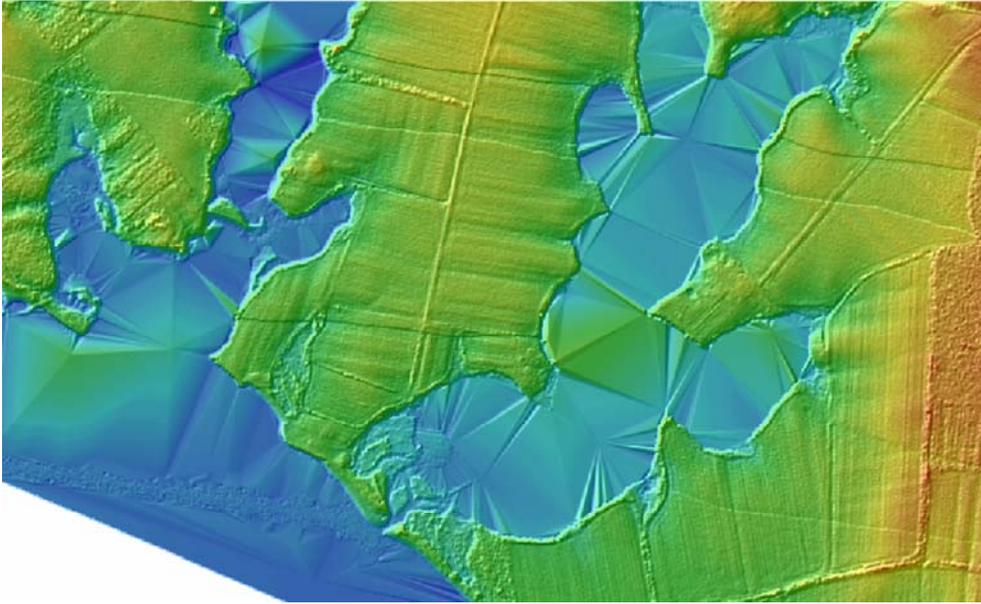
Figure 66 - N1275 – Scan line issues (multiple lines) but are less than 20 cm.

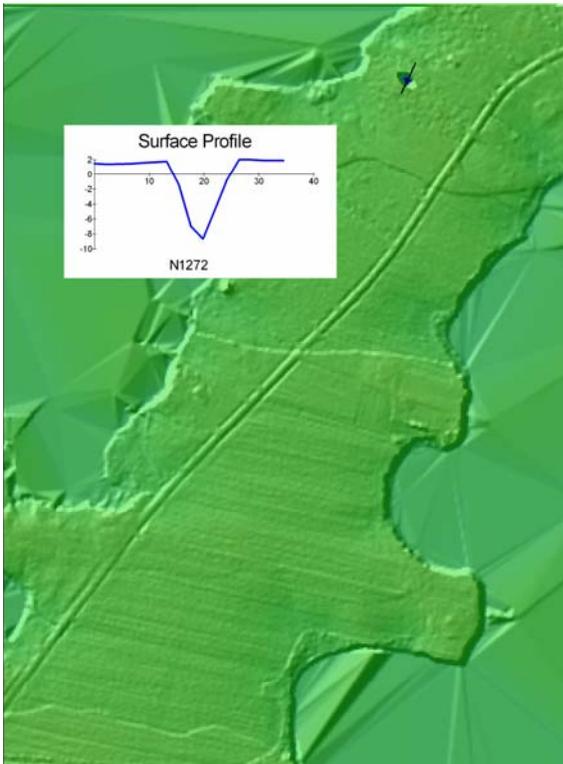
Figure 67 – N1272 – Large divot.

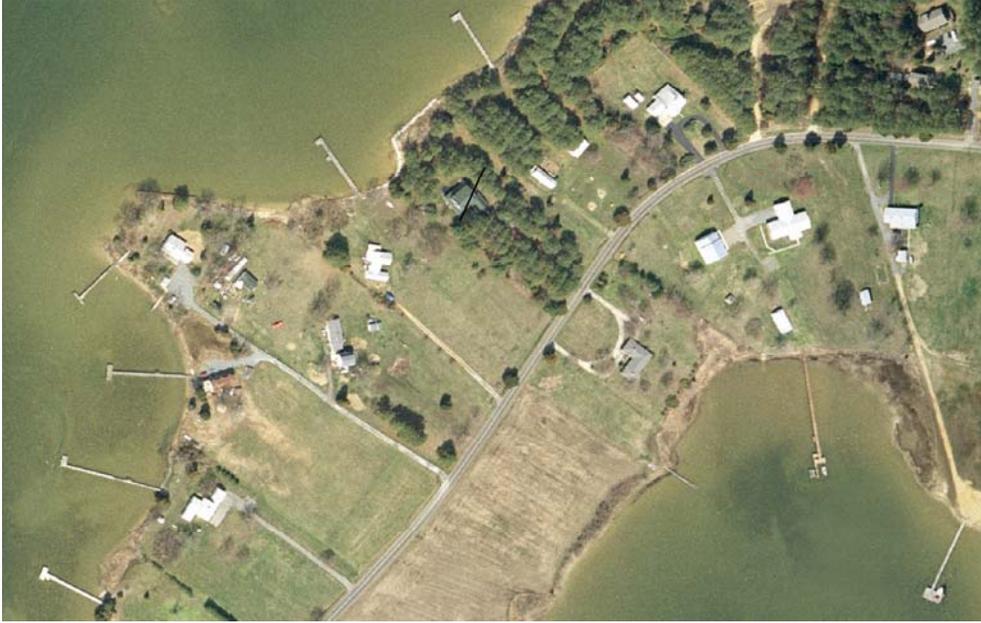
Figure 68 – N1272 – Ortho image with location of cross section of large divot (Figure 67)

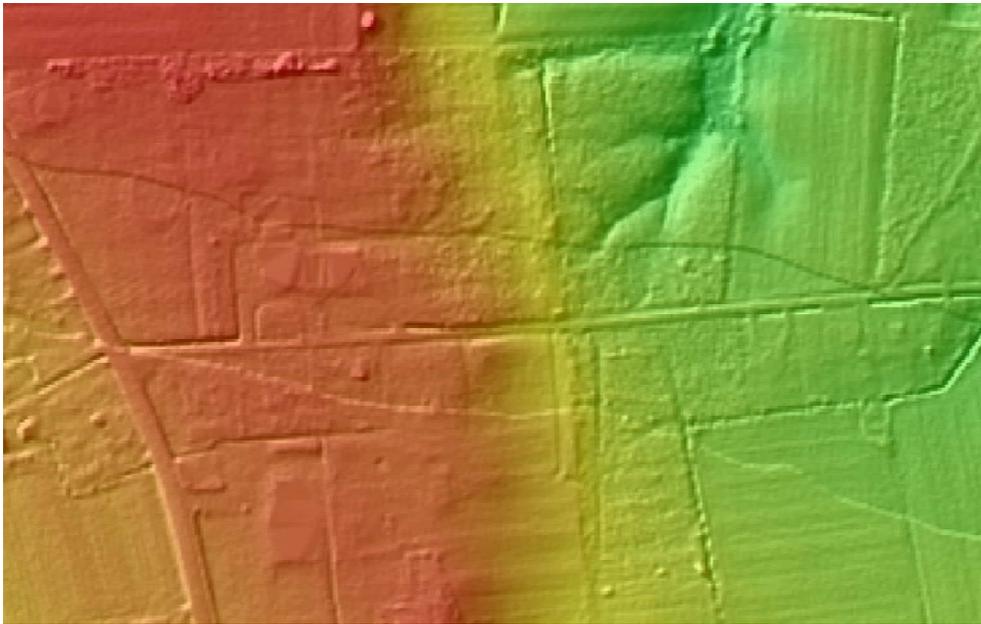
Figure 69 - N1272 - Scan line issues.

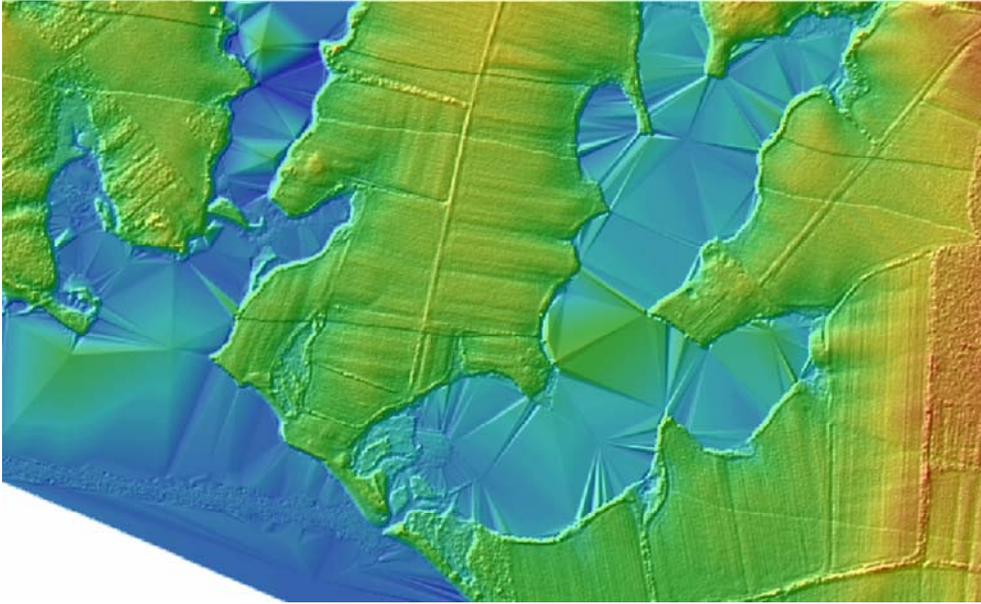
Figure 70 - N1275 - Scan line issues.
