Appendix A

Charles County Tiles

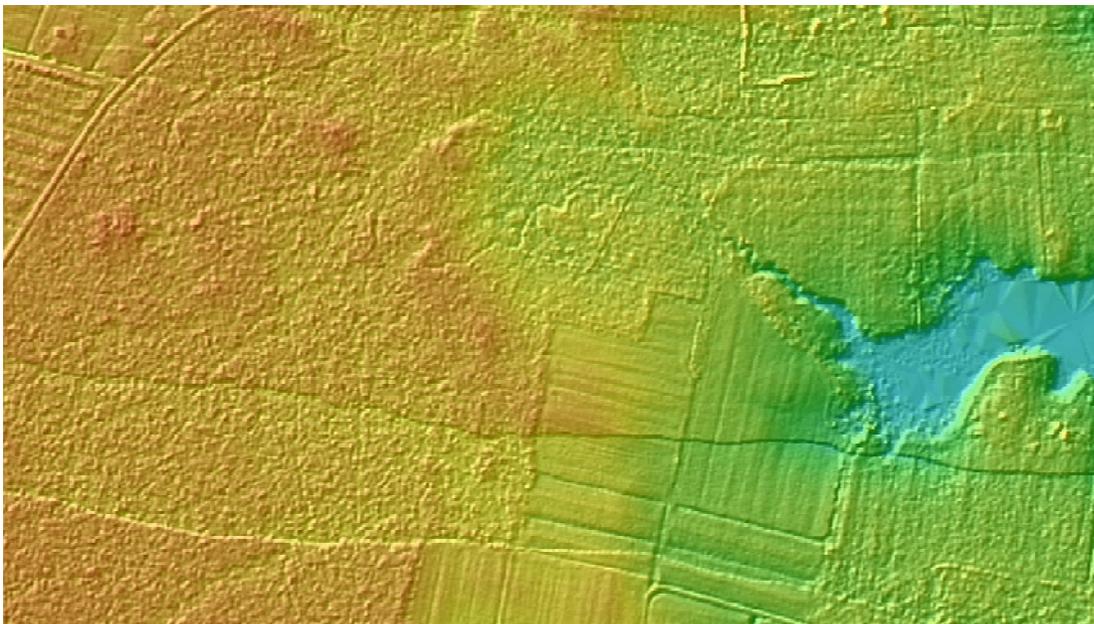
Figure 71 - N1283 - Scan line issues.

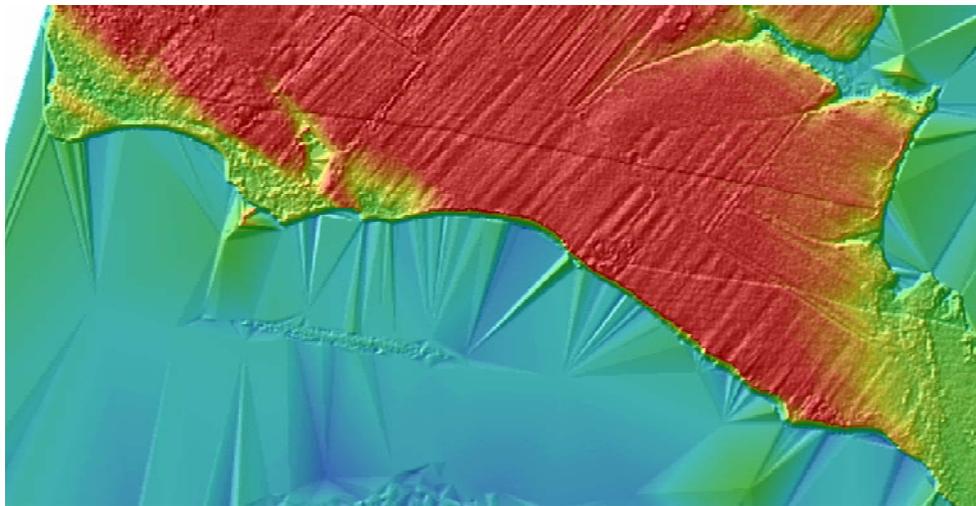
Figure 73 - O1244- Scan line issue (20 cm).

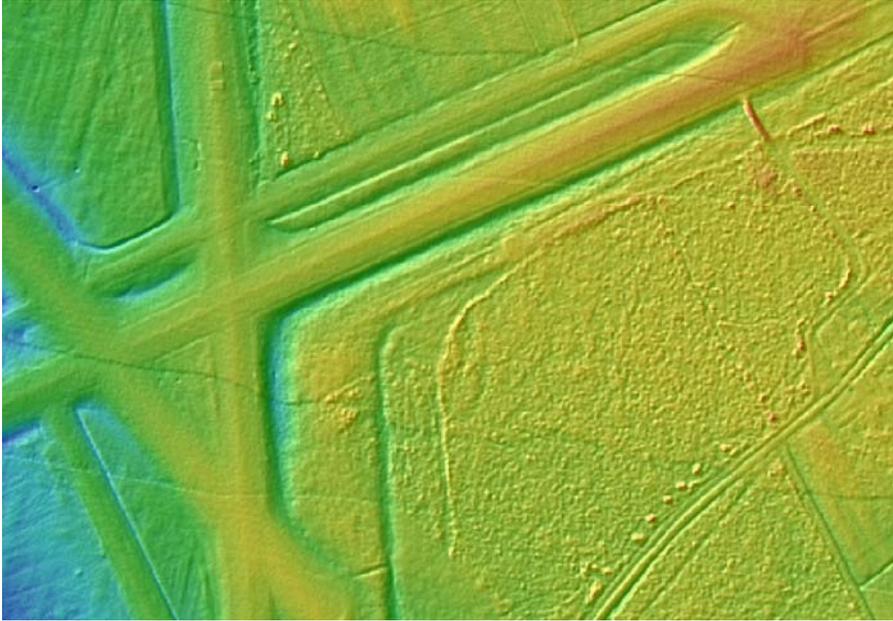
Figure 74 - O1261 - Scan line issues.

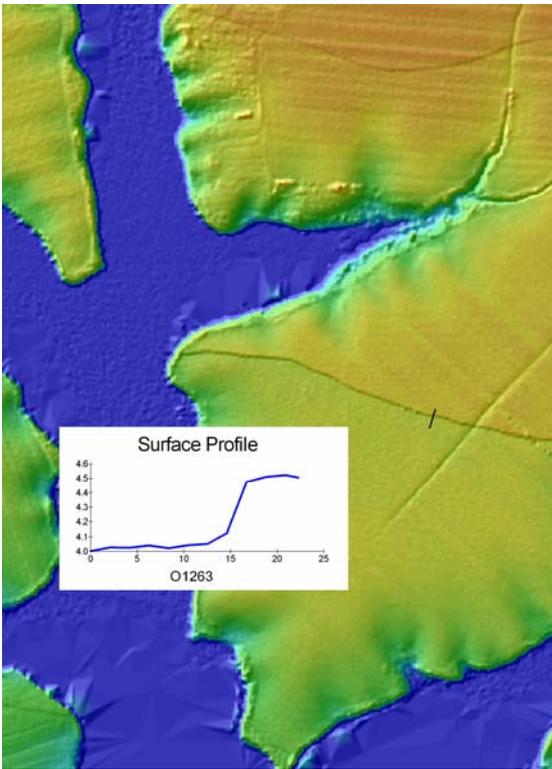
Figure 75 - O1263 - Scan line issue with associated scan line.

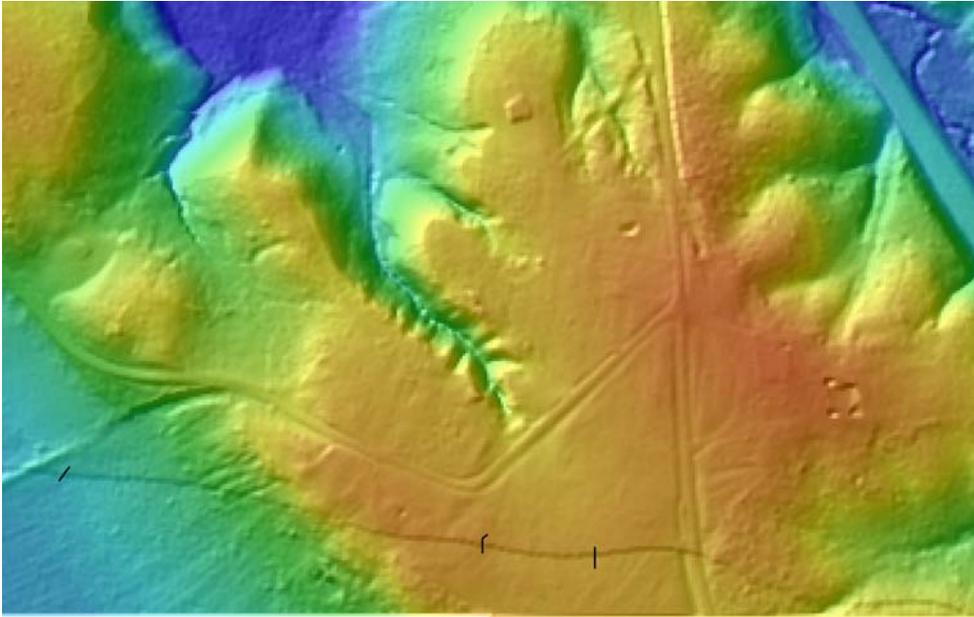
Figure 76 - O1273 - Scan line issue, lower portion.

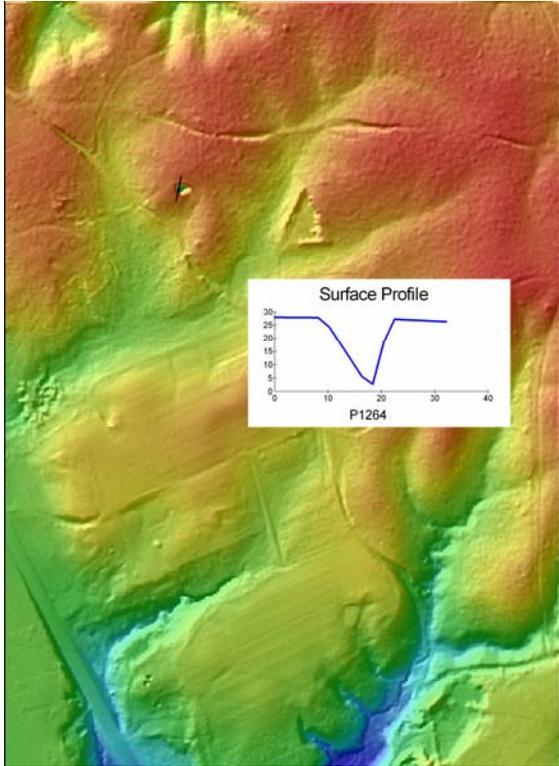
Figure 78 - P1264 - Large divot.

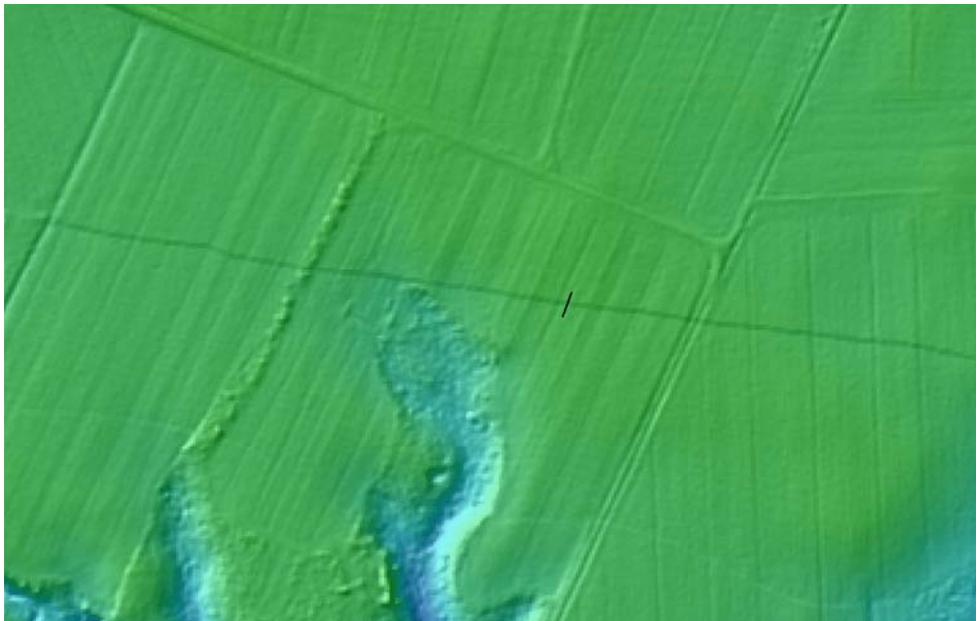
Figure 79 - P1276 - Scan line issue.

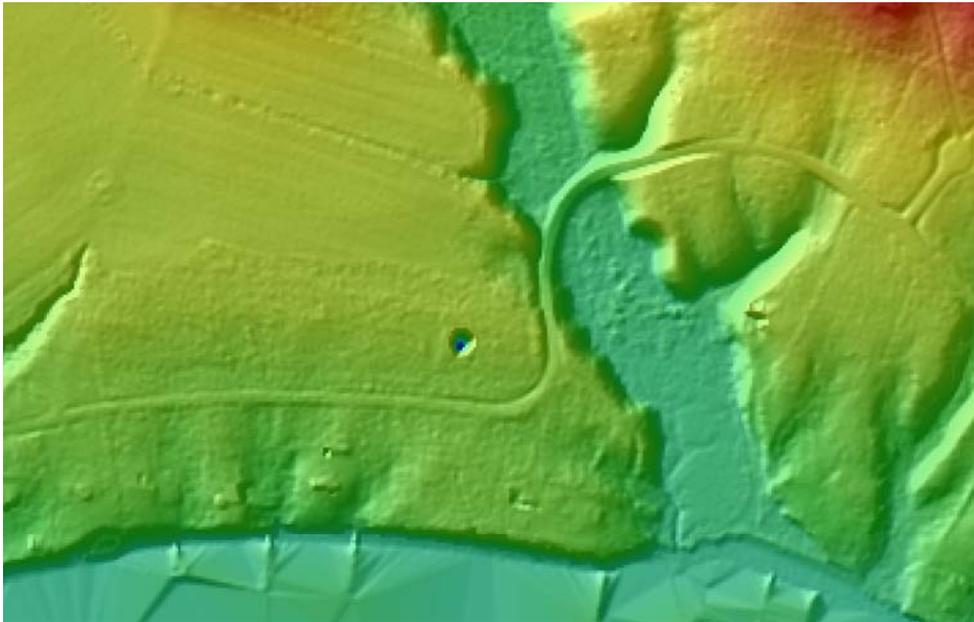
Figure 82 - Q1254 – Large divot but excellent retention of elevated road for transportation studies.

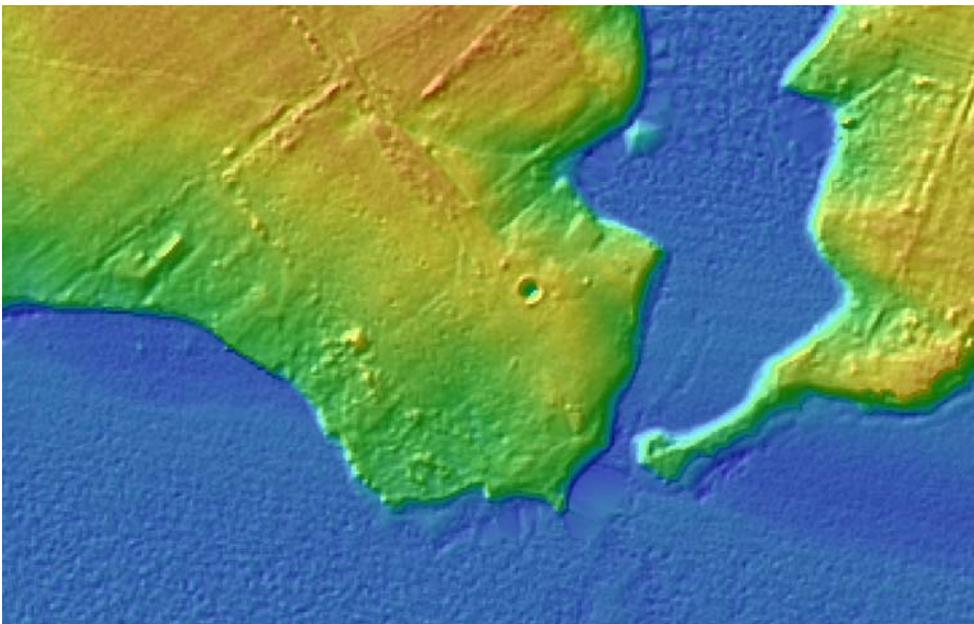
Figure 83 - R1183 - Large divot.

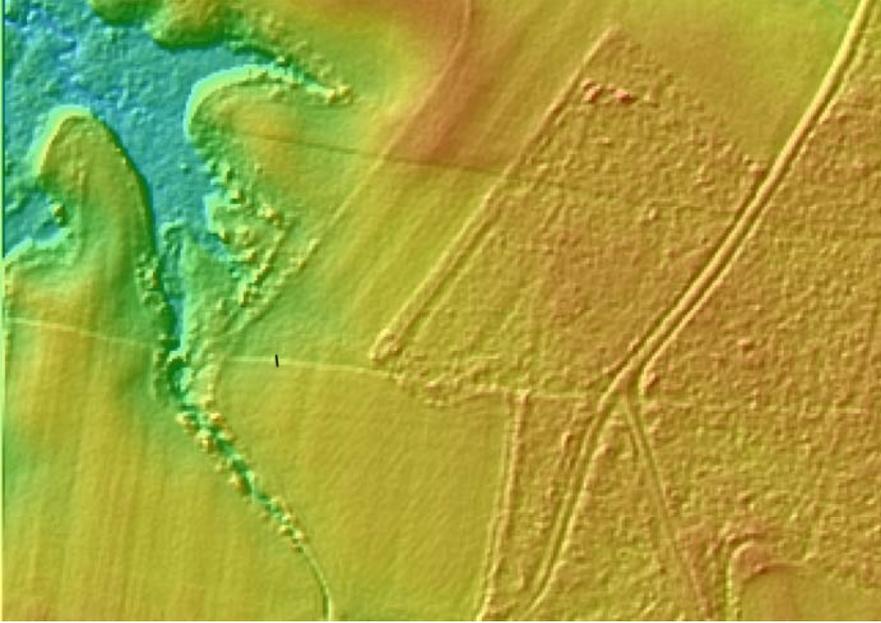
Figure 84 - R1191 - Scan line issue (center of image).

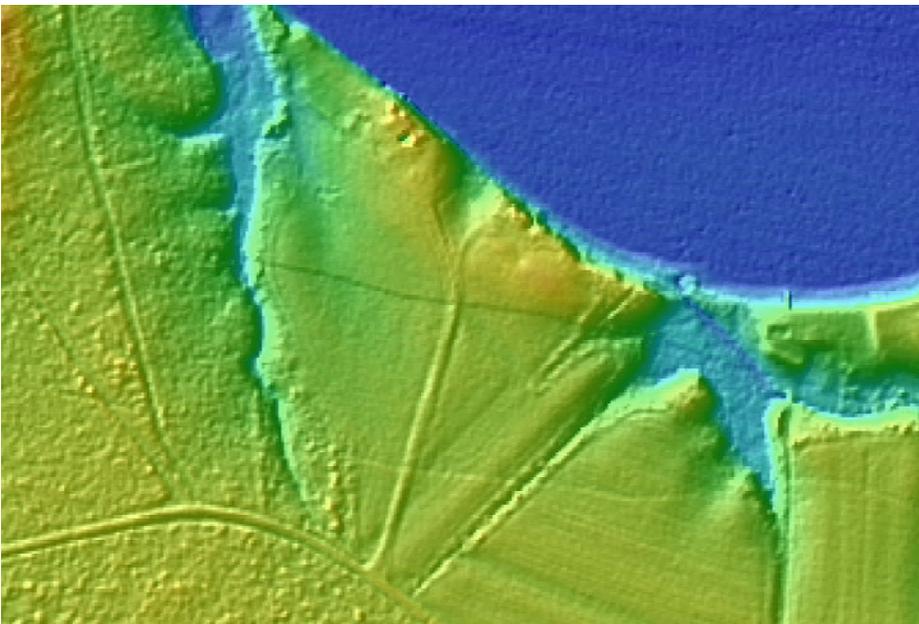
Figure 85 - R1201 - Scan line issue (center of image).

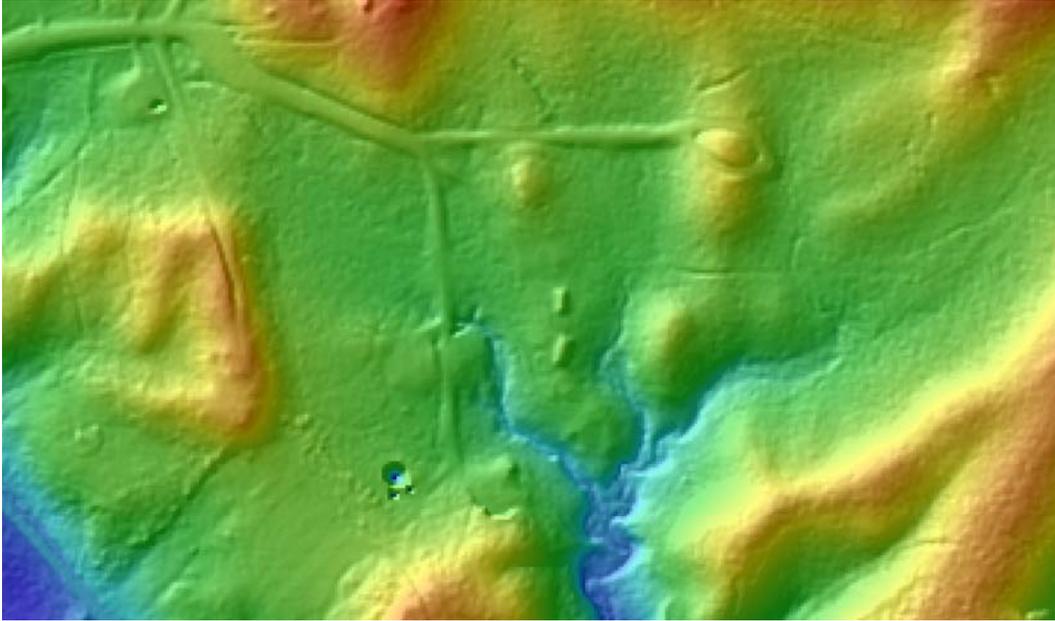
Figure 86 - R1212 - Large divot.

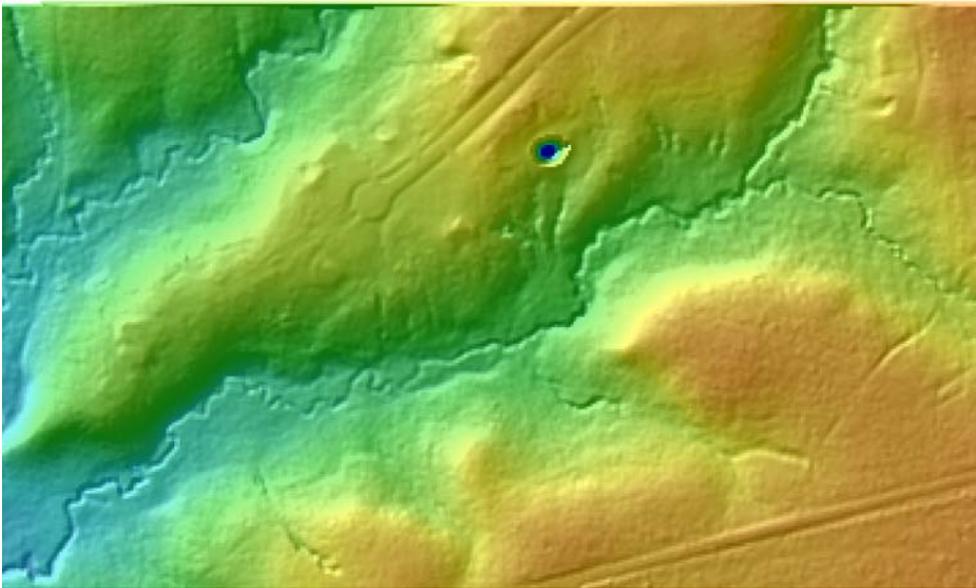
Figure 87 - R1226 - Large divot.

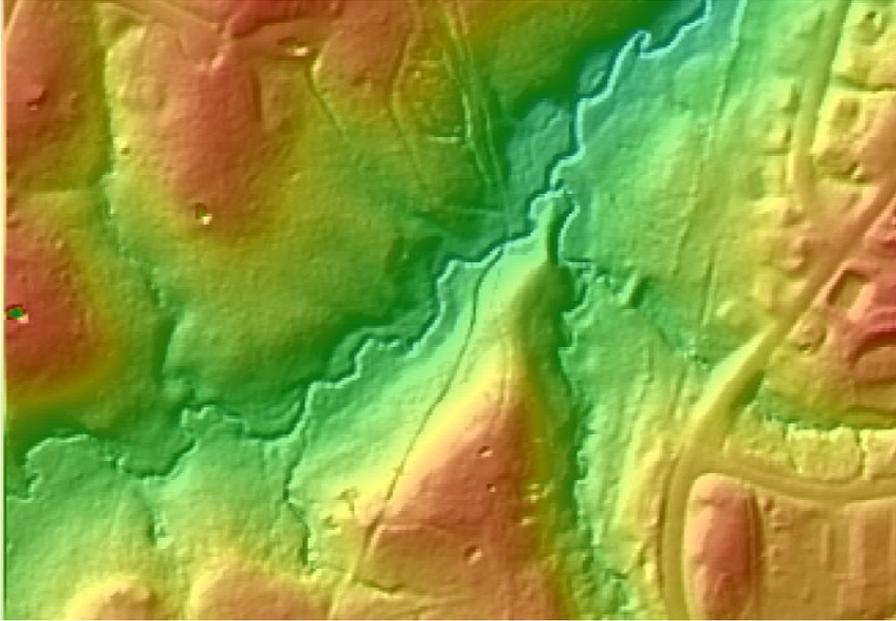
Figure 88 – R1232 – Divots.

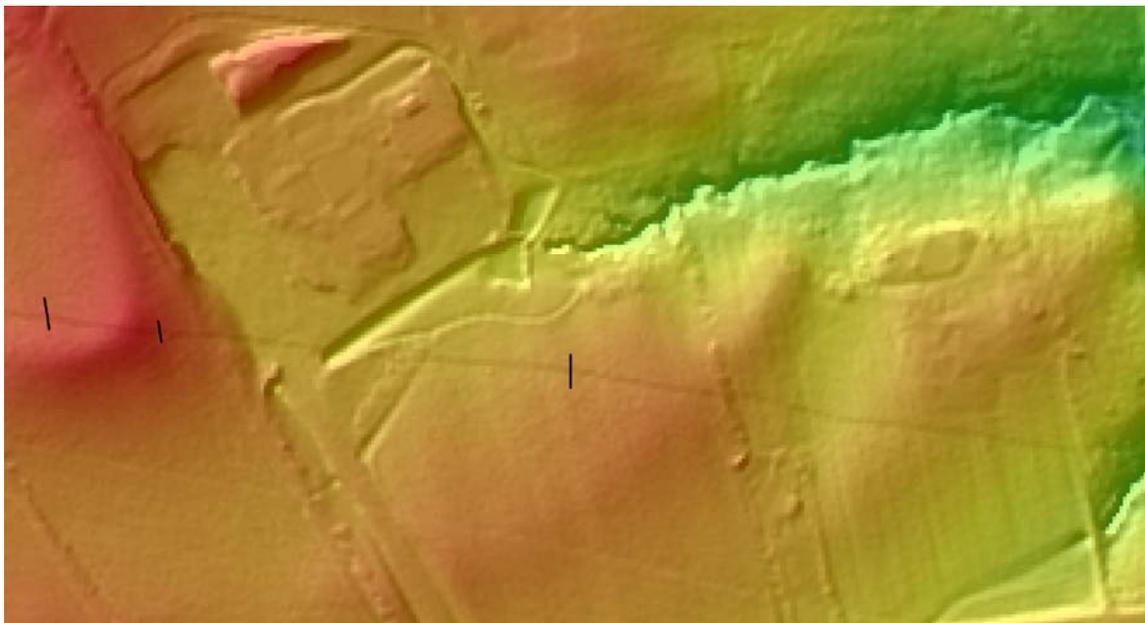
Figure 89 - R1232 - Scan line issue.

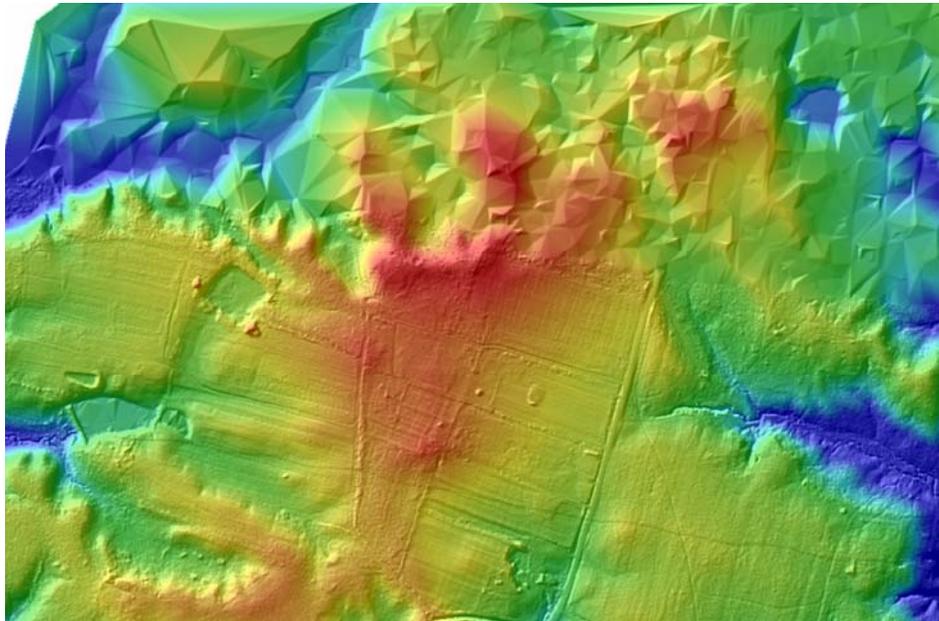
Figure 91 - R1251 - Sparse data in top portion. This is only for reference as this data was re-submitted.

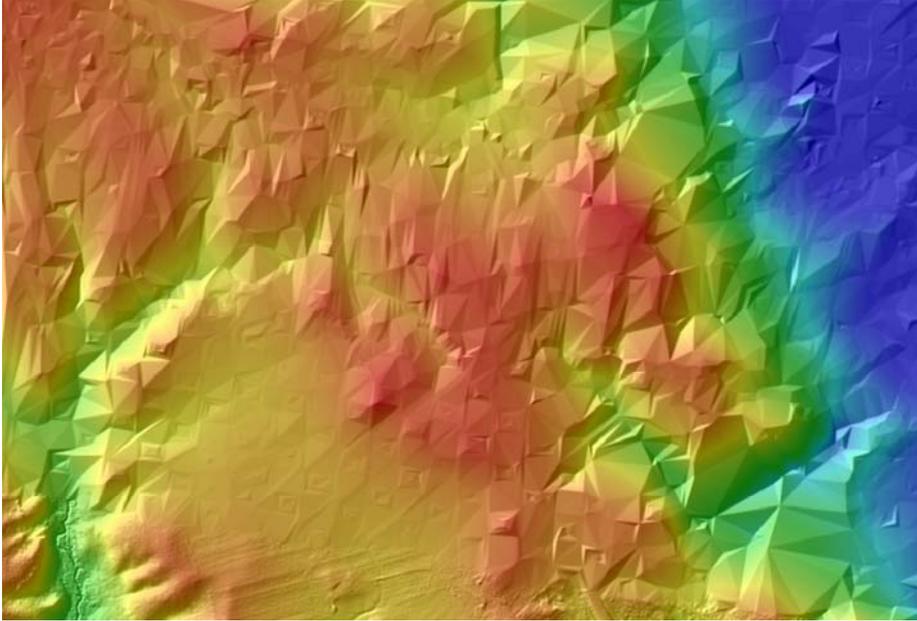
Figure 92 - R1261 - Sparse data in top portion. This is only for reference as this data was re-submitted.

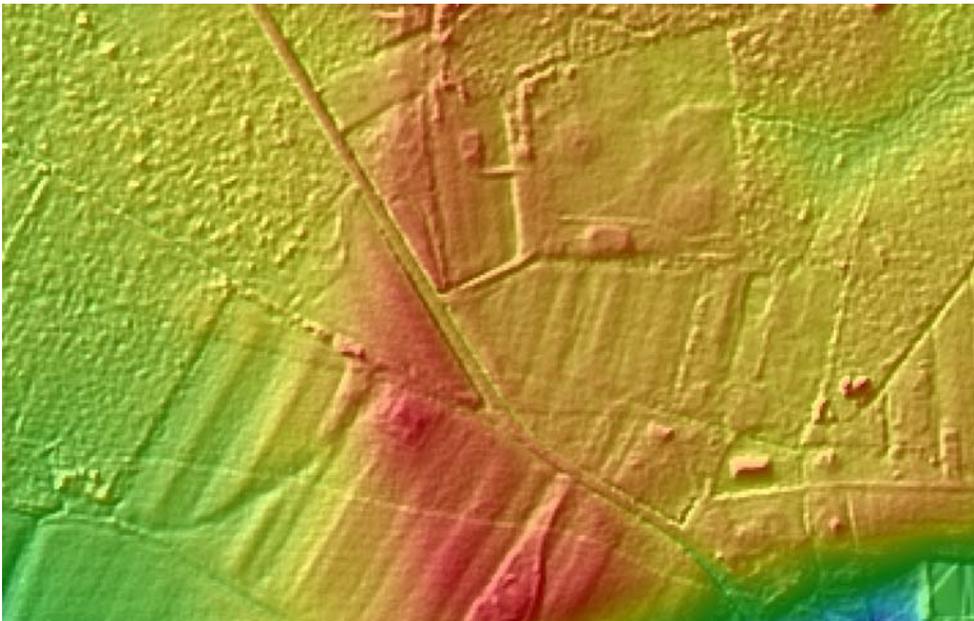
Figure 93 - S1174 - Scan line issue (20 cm.).

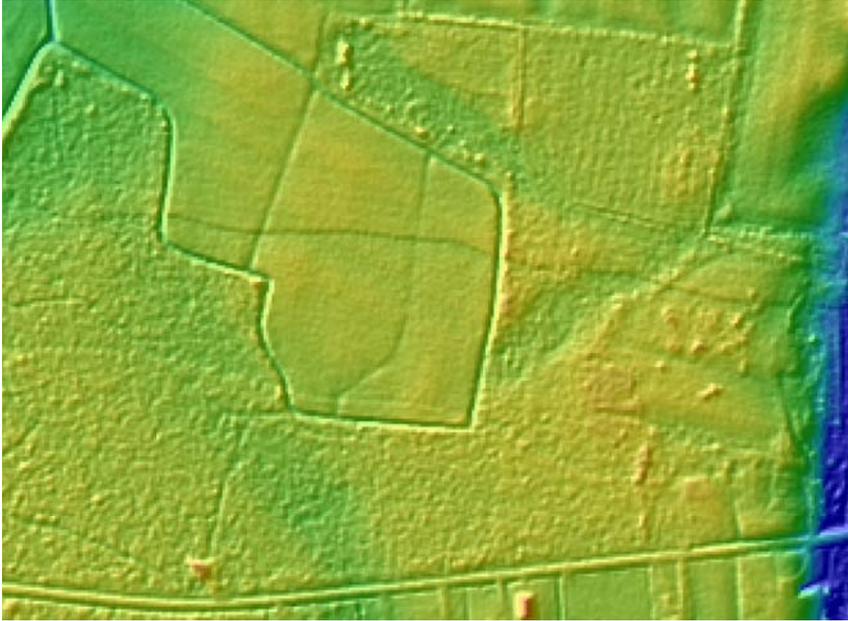
Figure 94 - S1176 - Scan line issue (center of image).

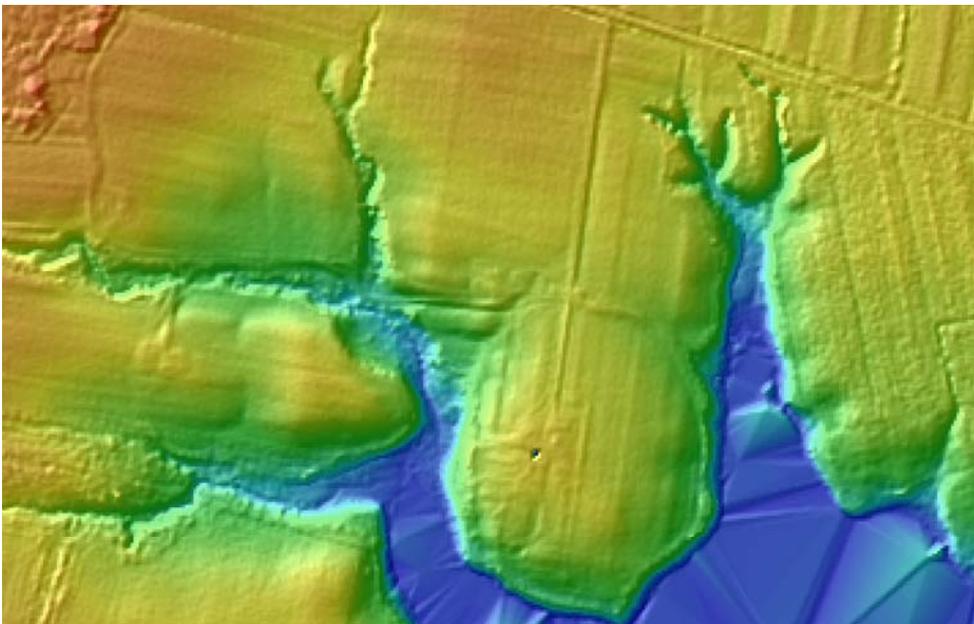
Figure 95 - S1182 - Large divot.

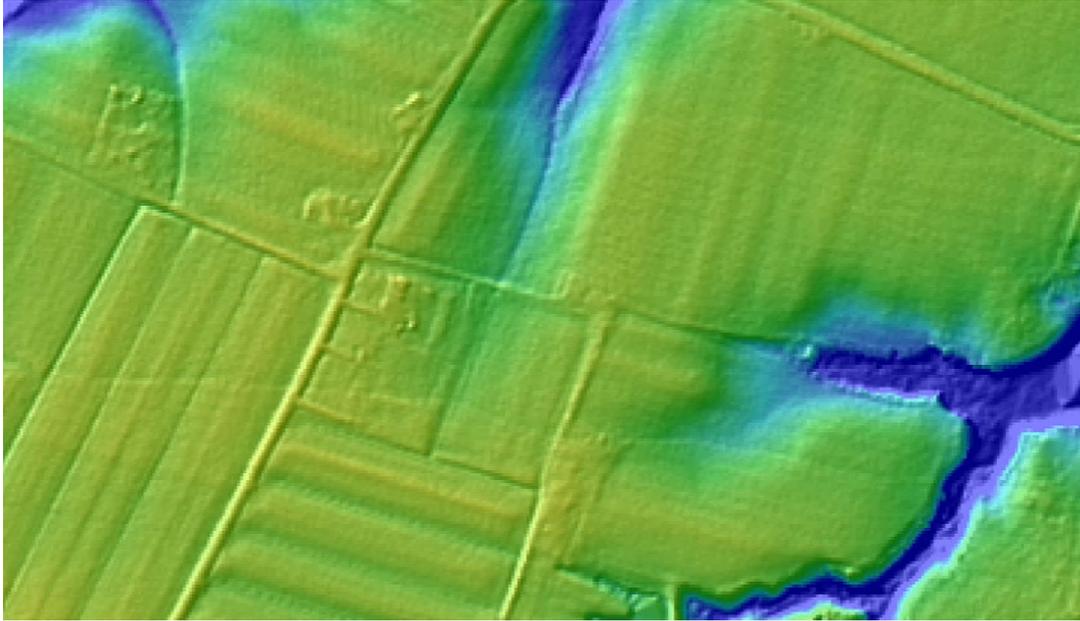
Figure 96 - S1185 - Scan line issue (20 cm).

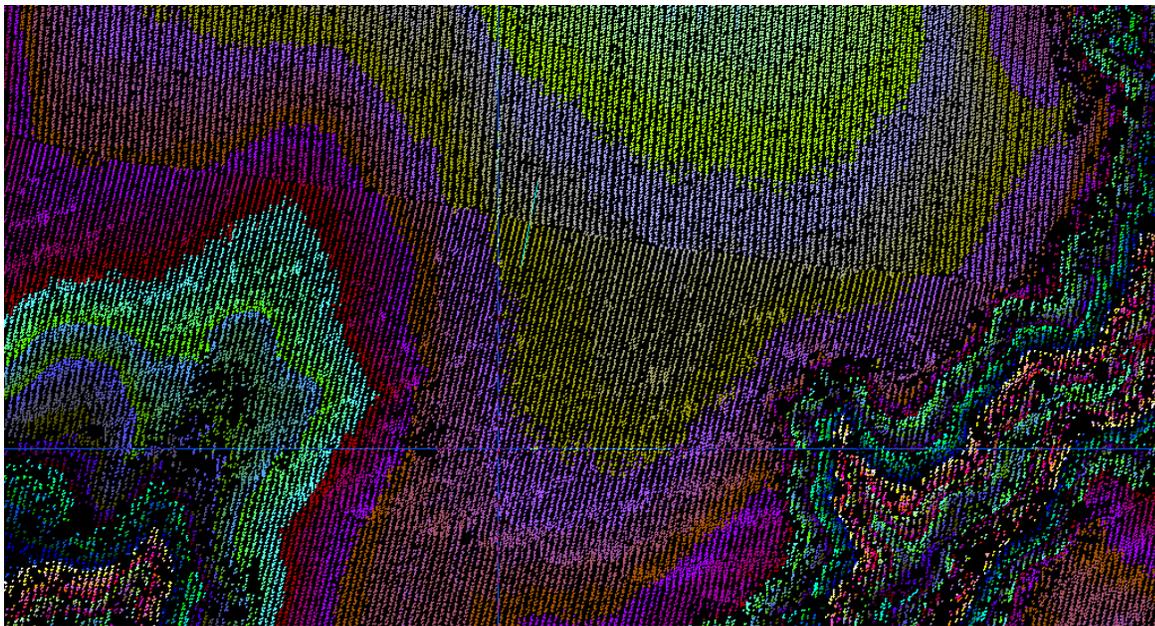
Figure 99 - S1203 - Scan line issue. LIDAR points colored by elevation. Note that the elevations appear to have a horizontal shift due to the differences in elevations.

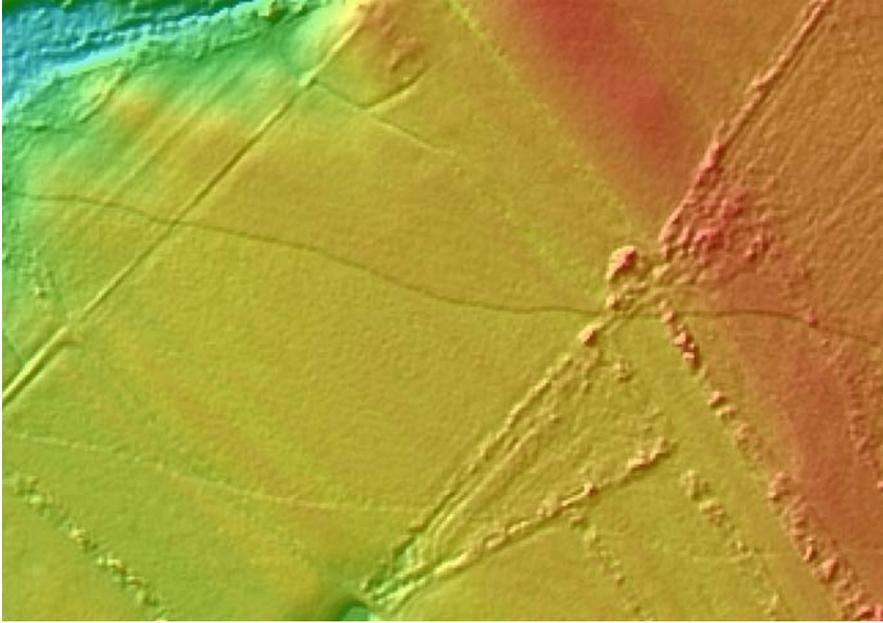
Figure 100 - T1166 - Scan line issue and potential artifacts.

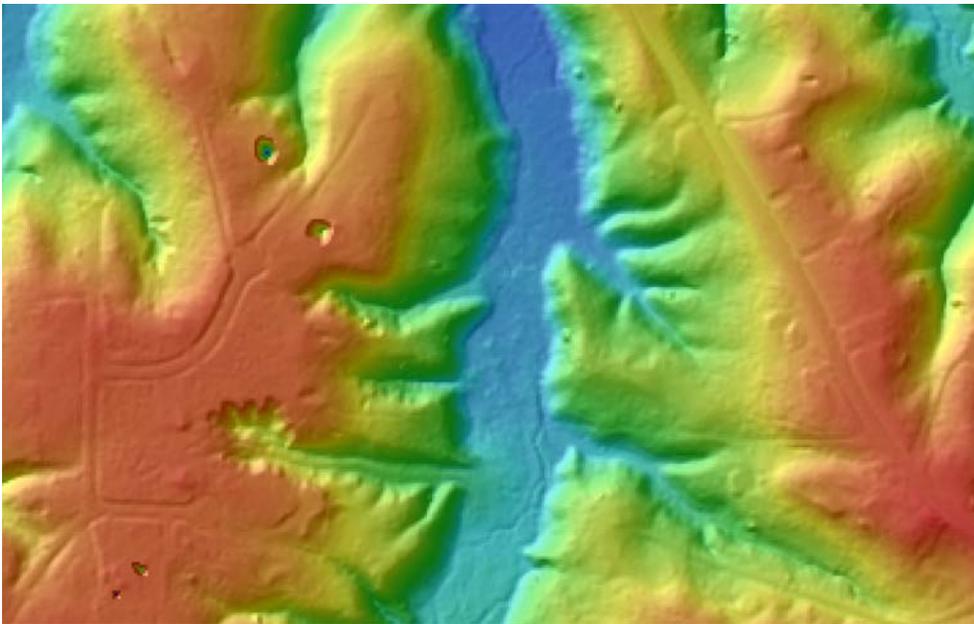
Figure 101 - T1244 - Large divot.

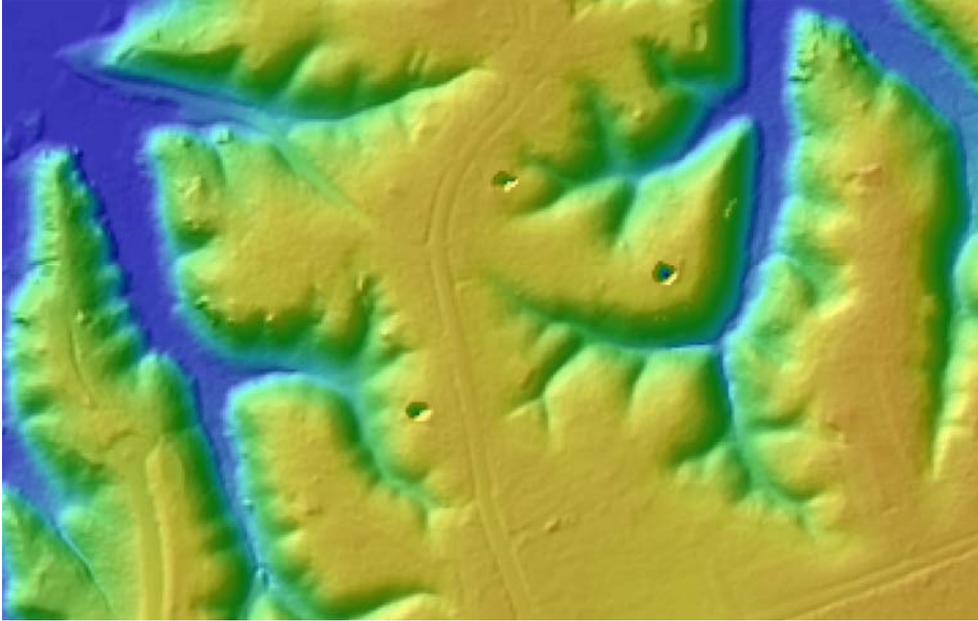
Figure 102 - V1222 - Large divot.

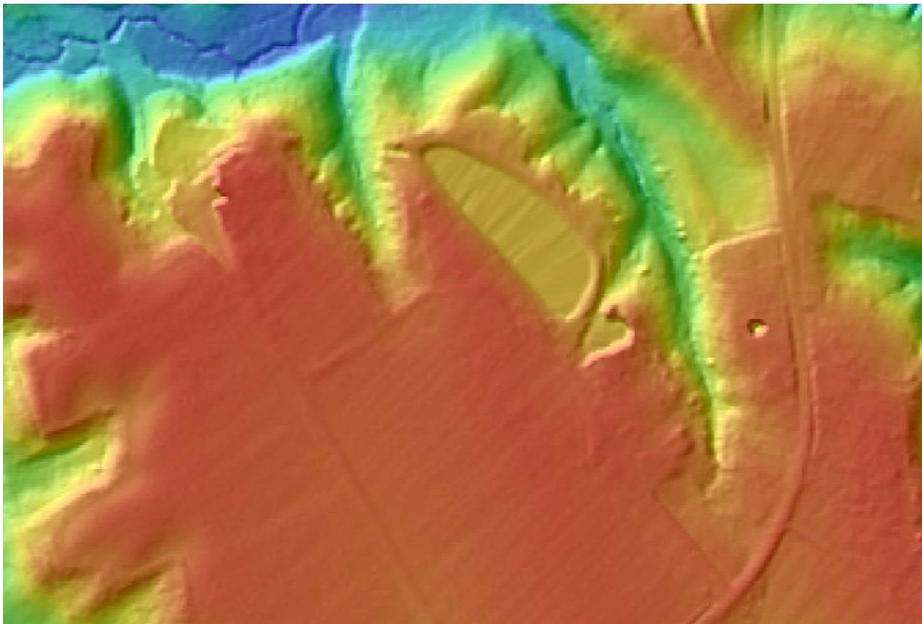
Figure 103 - V1233 - Divot

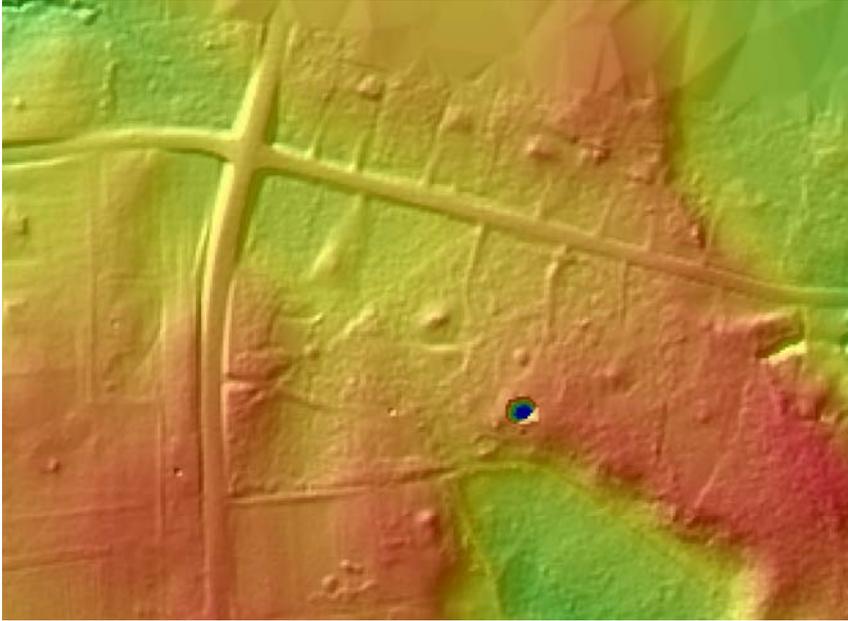
Figure 104 - W1186 - Large Divot.

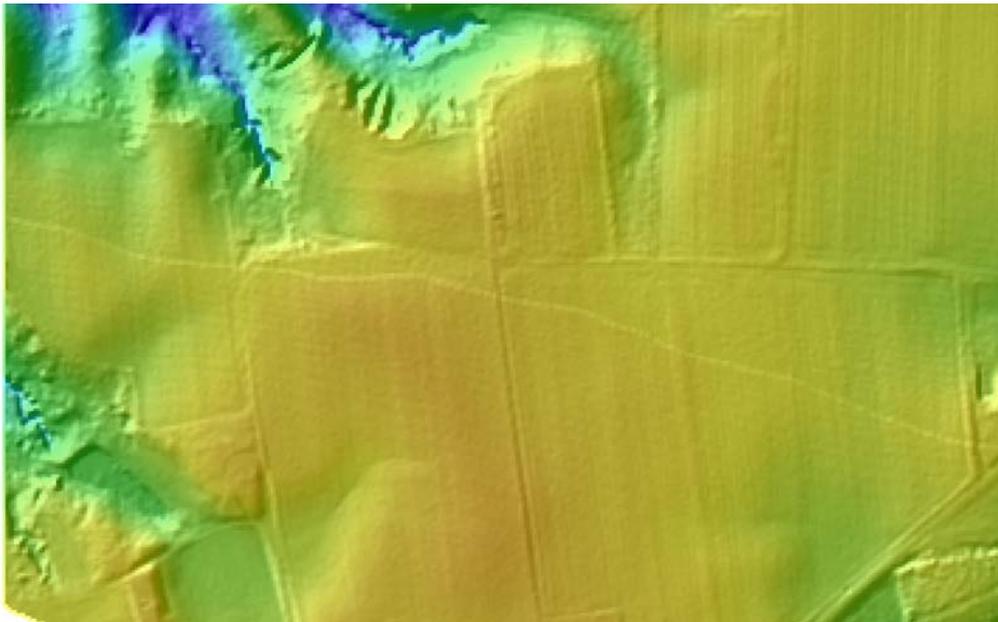
Figure 105 - W1186 - Scan line issue.

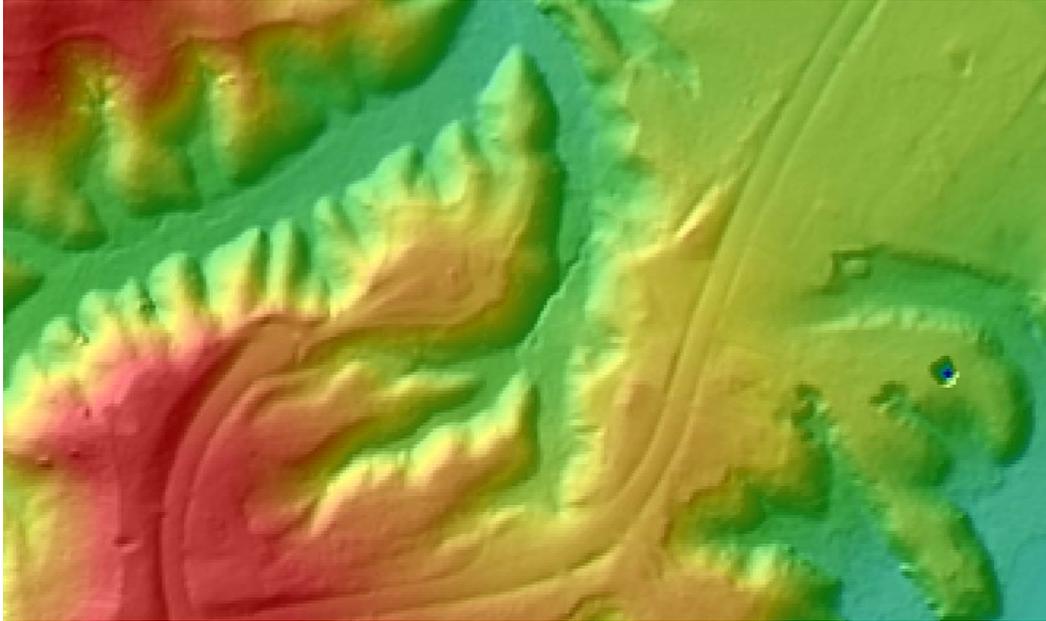
Figure 106 - X1215 - Large divot.

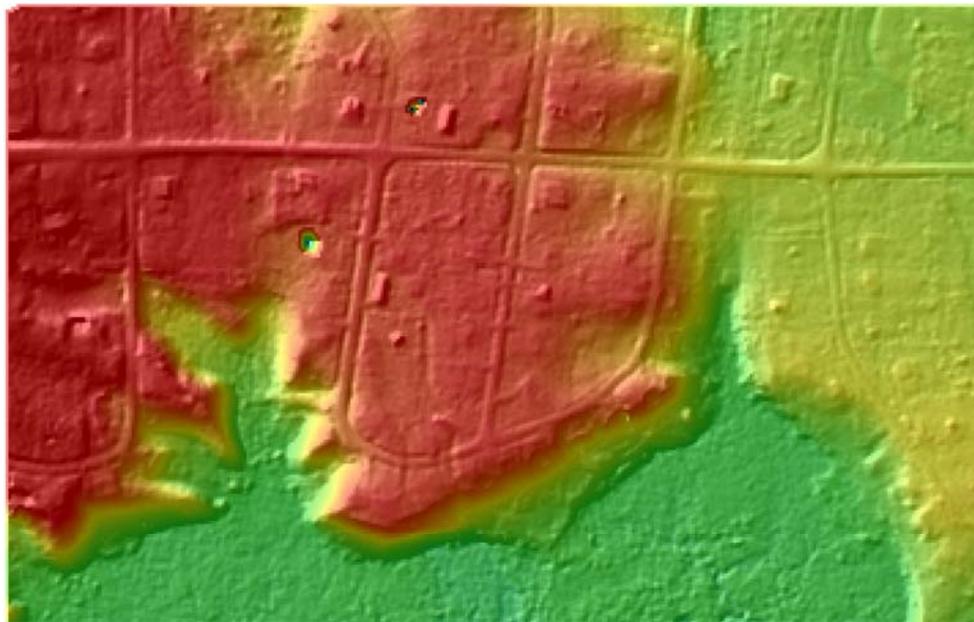
Figure 107 - Z1196 - Large divot.
