Lidar Fact Sheet: Victoria County, Texas

Review Results

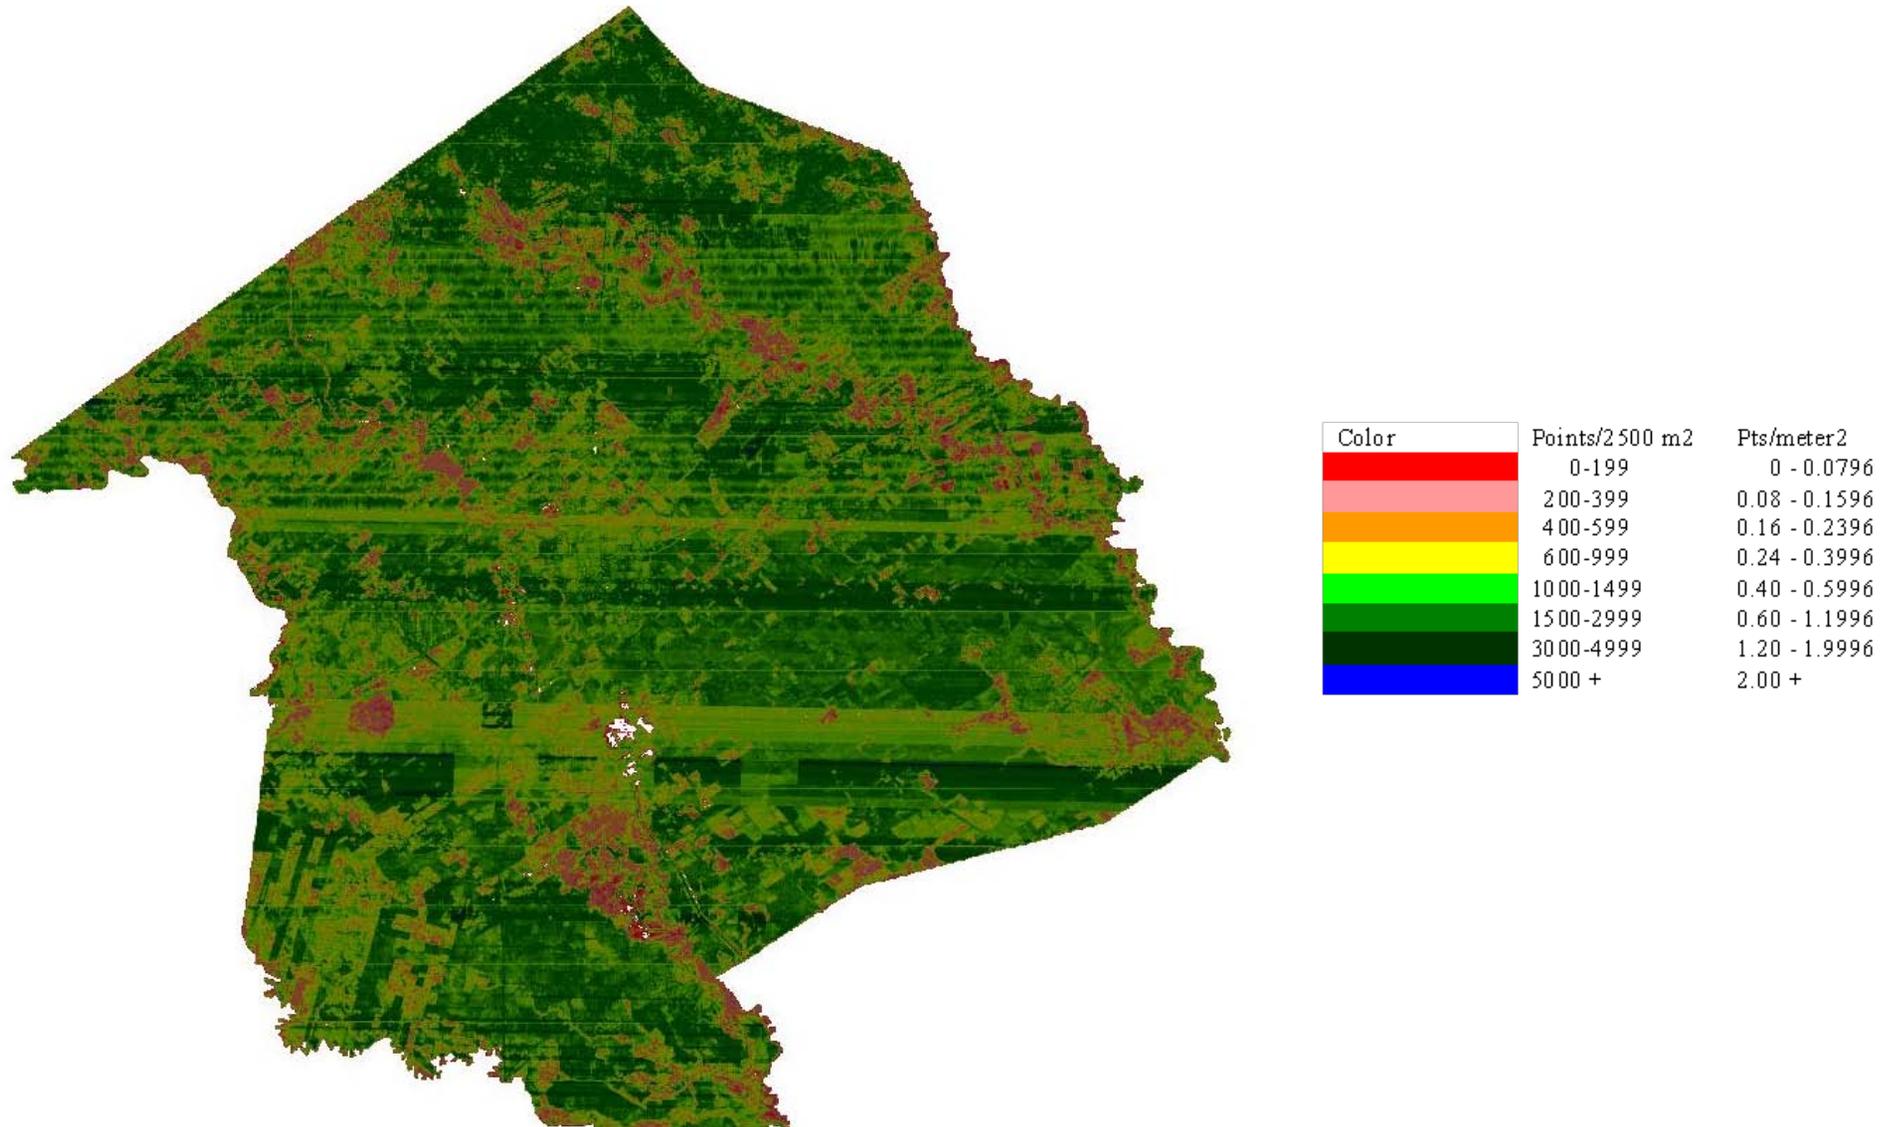
Figure 1 below depicts the bare-earth point density per 2,500 square meter cell and per square meter. The issues determined in this review are as follows:

1. There are noticeable point density deficiency “strips” in the middle of the county. This may be a sensor issue.
2. The northern portion of the county appears to have collected well.
3. The southern portion has some specific “flightline” point density (classification) variance.

Figure 1. Bare-earth point count density (pts/2500 square meters) in Victoria County.
