Lidar Fact Sheet: Chambers County, Texas

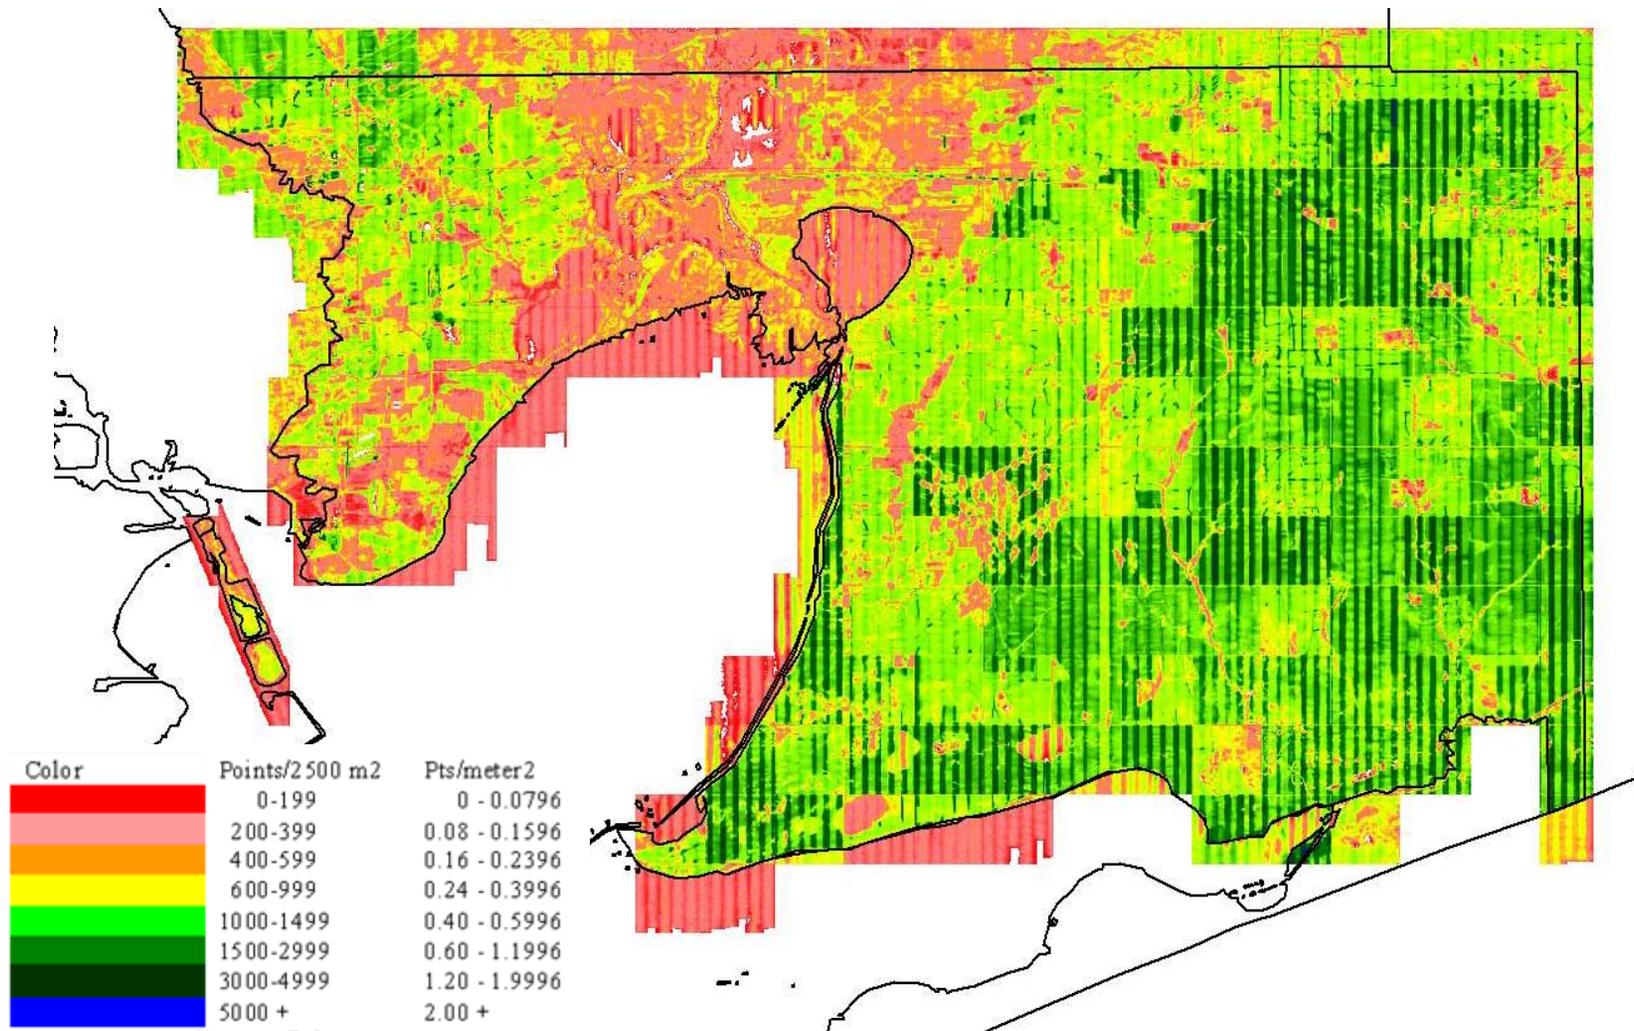
There appears to be a strong “tile”-specific level of classification as evidenced by the bare-earth point densities (color variations; Figure 1). Water points have been removed to some degree in many tiles; however, in adjacent tiles no apparent effort was made to remove water points. In either case, bare-earth points in water still largely remain.

The largest issue is the lack of proper return number information, which raises flags about the accuracy of the data. Additional data issues include the coastal portions of the county where water was randomly classified (Figure 1) and a tile-to-tile variation in classification “aggressiveness.” There are also some missing data on the southwestern edge of the county and a low density strip (yellow) running through the middle-eastern portion of the county.

Figure 1. Bare-earth point count density (pts/2500 square meters) in Chambers County.
