MEMORANDUM

SUBJECT: SOUTHEAST WISCONSIN 2015 LIDAR (SEWI_5)

Review Comments on September 23, 2015

Washington County LiDAR Review

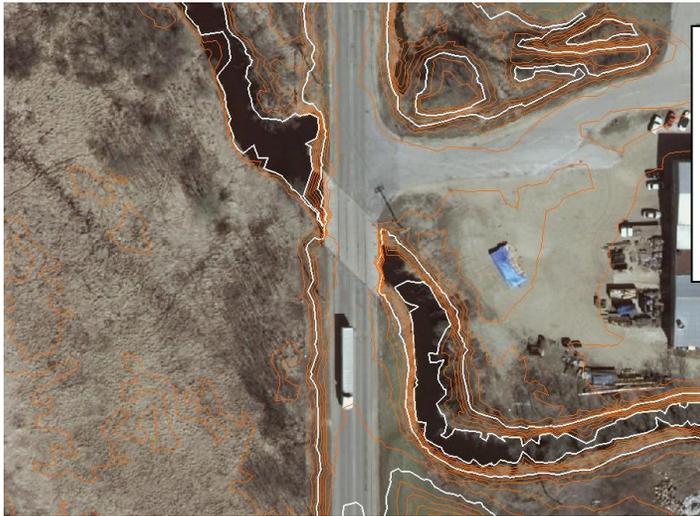
XY Location:
Northing: 488900
Easting: 2422800
Comment: Bridge classified using Classes 1 and 17 (Non-Ground and Overlap Non-Ground)...should be Class 14 (Bridge)

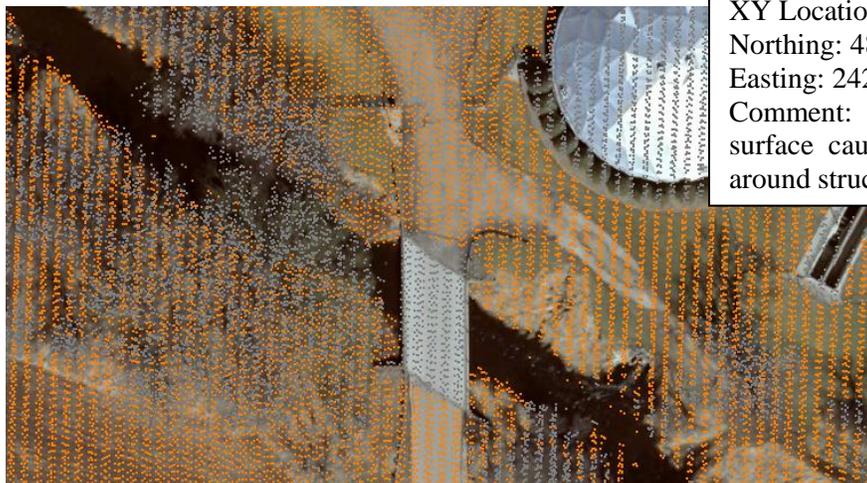
XY Location:
Northing: 485500
Easting: 2428440
Comment: Ground points left in surface causing improper contouring around structure.

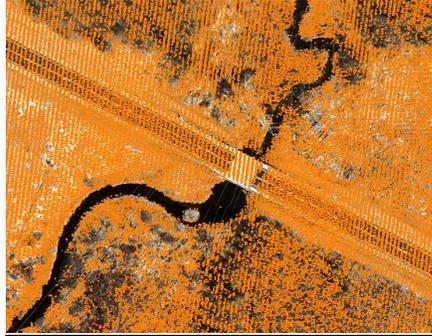
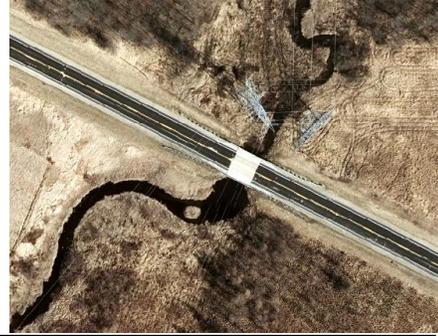
XY Location:
Northing: 502300
Easting: 2513200
Comment: Ground points left in surface causing improper contouring around structure.

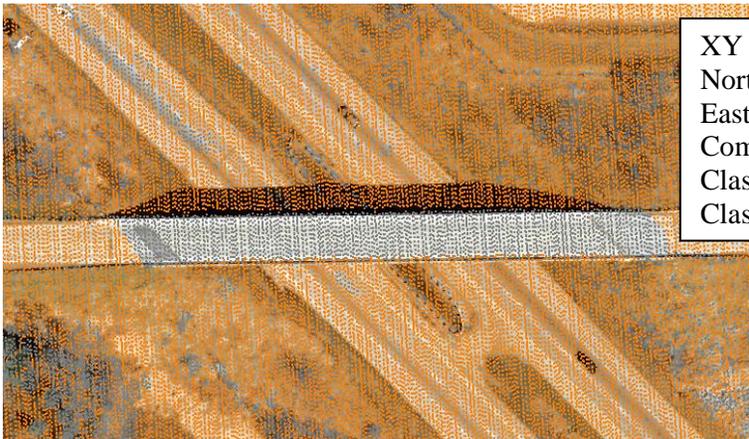
XY Location:
Northing: 477200
Easting: 2476400
Comment: Bridge classified using Class 1 (Non-Ground)...should be Class 14 (Bridge)

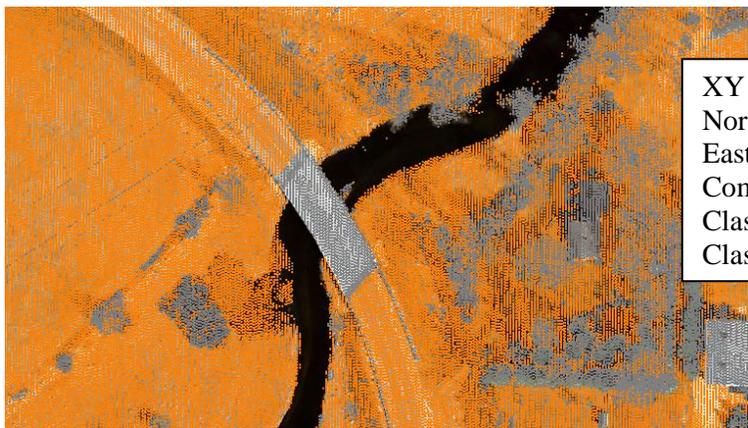
XY Location:
Northing: 495900
Easting: 2511300
Comment: Bridge classified using Class 1 (Non-Ground)...should be Class 14 (Bridge)

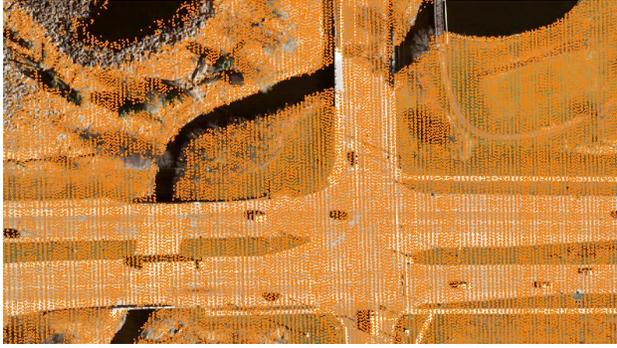
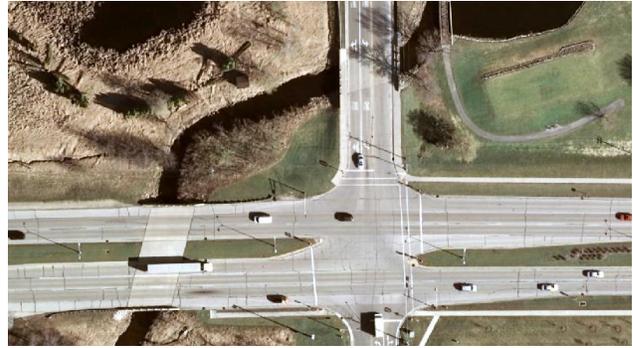
XY Location: Northing: 450600; Easting: 2497600
 Comment: Ground points left in surface causing improper contouring around structure.

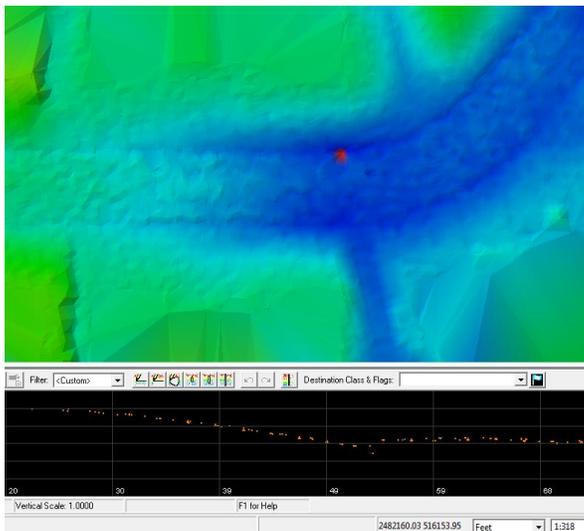
XY Location:
 Northing: 516154
 Easting: 2482167
 Comment: Ground points in storm sewer affecting the road elevation. Also model keypoint has a point in the storm sewer that would also affect the surface elevation

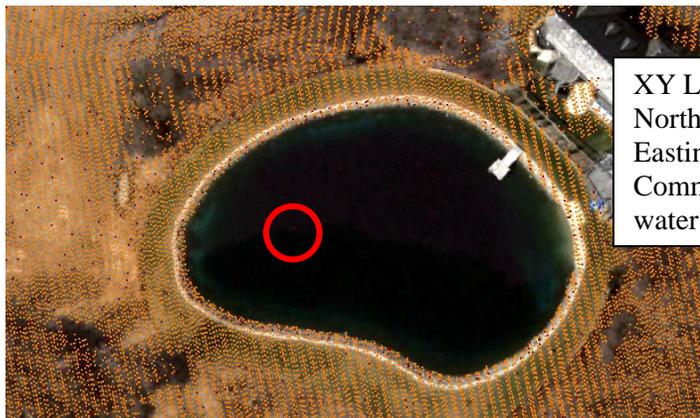
XY Location:
 Northing: 511425
 Easting: 2470591
 Comment: Single Model keypoint in water body.

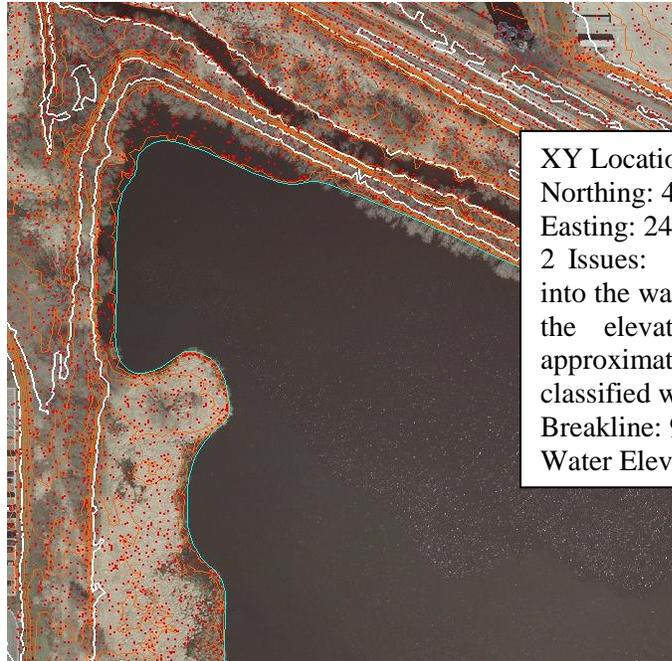
XY Location:
 Northing: 487400
 Easting: 2426200
 2 Issues: Hydro breakline encroaches into the water body significantly. Also, the elevation of the breakline is approximately 1.5 feet lower than the classified water points.
 Breakline: 956.000 feet
 Water Elev. approximately 957.5 feet

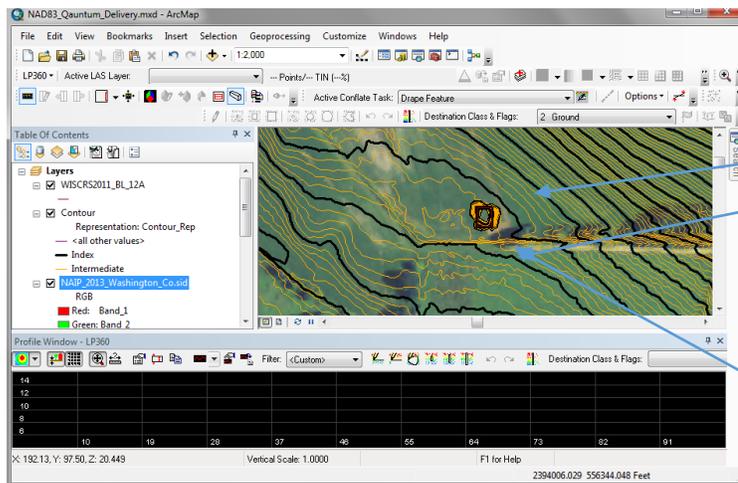
NAD83 Position:
X = 2394009ft; Y=556345ft

- A zero elevation breakline has been included affecting the contour generation which needs to be removed and new contours generated.

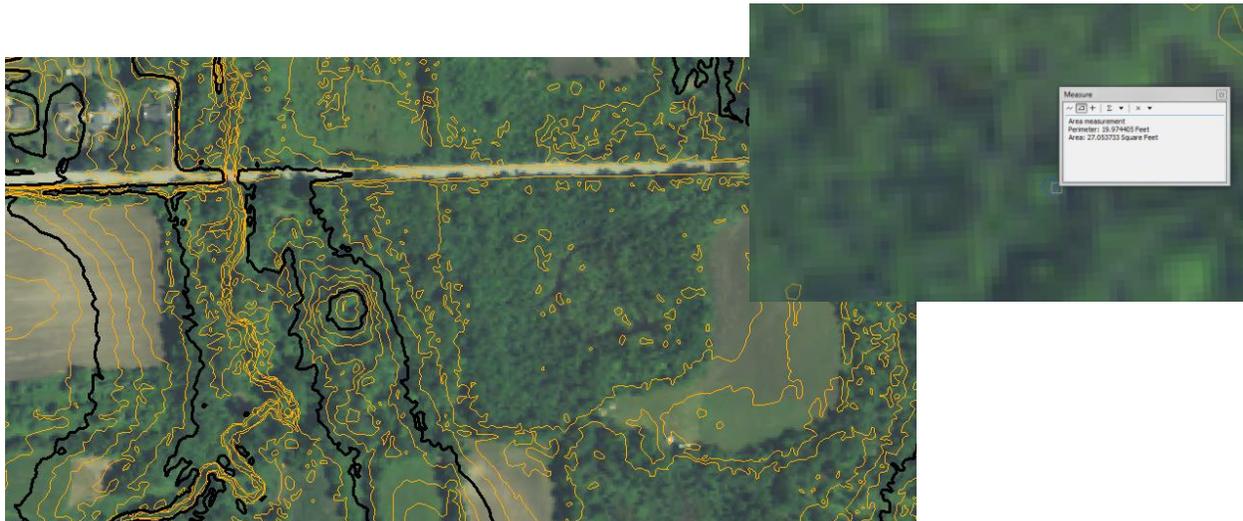
- Contouring filtering with removal of small contours are still evident throughout. Sample below show small contours of 27 ft² are evident. Agreed parameters of tops being 40ft² and depression that are 400ft² were to be filtered out. Regeneration of contours using provided parameters is necessary to remove analogous contours.

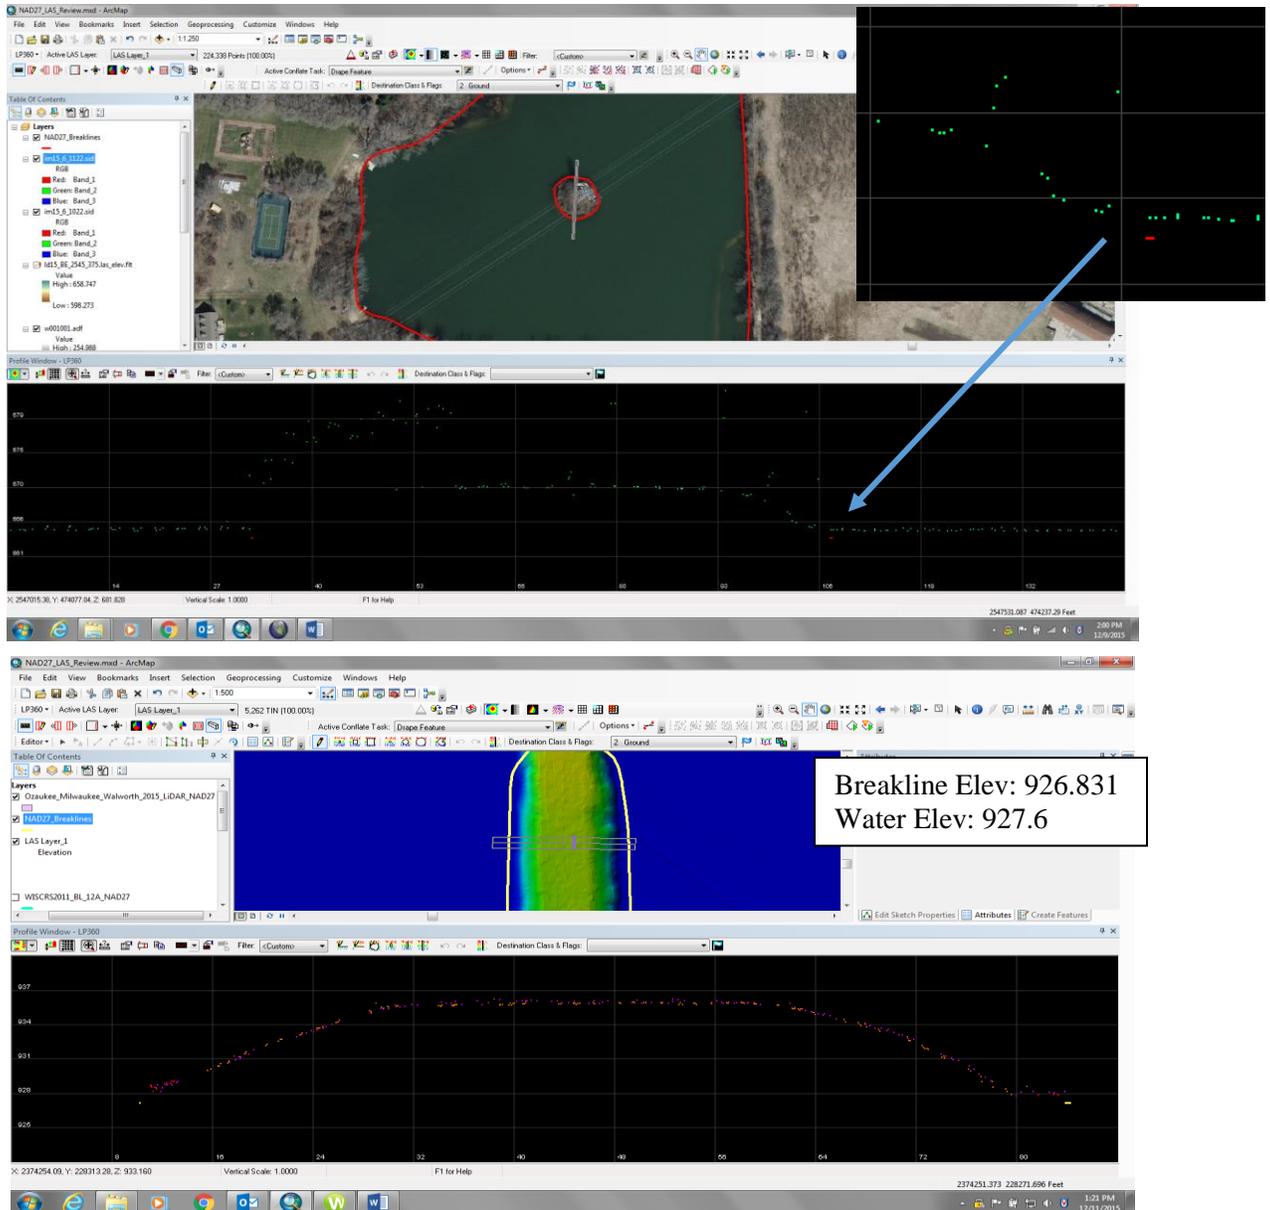
- Overall all hydro breaklines appear to be 0.5 – 1.5 feet lower than expect terrain. See below for screen capture examples demonstrating the inconsistencies. It should be noted that the bridge breaklines are consistent with topology. The hydro breaklines might be a possible indexing related to finalization of the classified LAS files due to Geoid procedures.

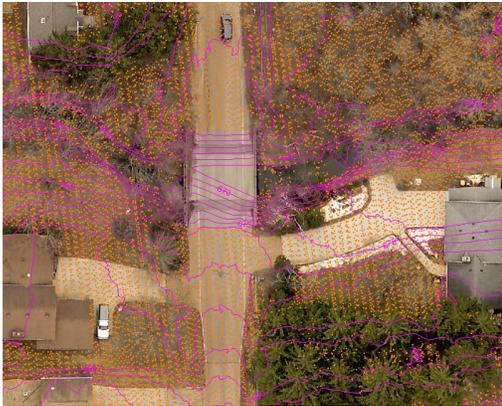
- A few bridge breakline were missed. Below is a screen capture demonstrating the issue when no breakline are used on shorter spans

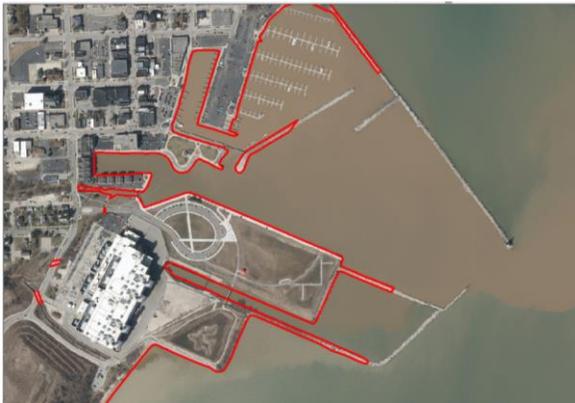
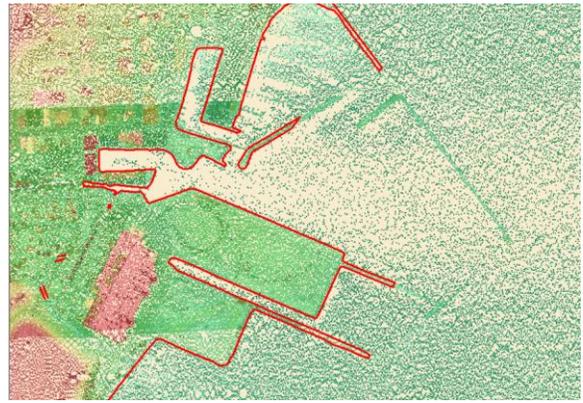
- Breaklines in the city of Port Washington have been terminated leaving the breakwater wall classified as water and/or non-ground. Continue breaklines along these features and re-class to ground. Below is area of concern with 2015 Ortho with breaklines in red and also LiDAR point data by elevation with breaklines in red of the same area.

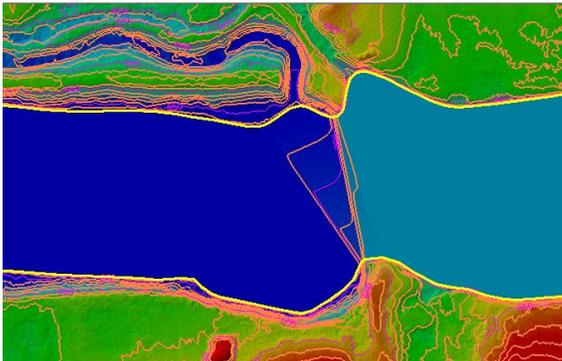
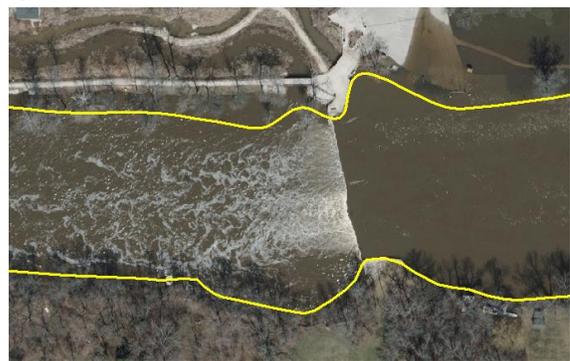
- Breaklines along dams need a line across the top and bottom and/or have closed polygons beginning and ending at the dam to properly enforce triangulation and minimize poor contouring around this hydro feature. See below demonstrating the issue.

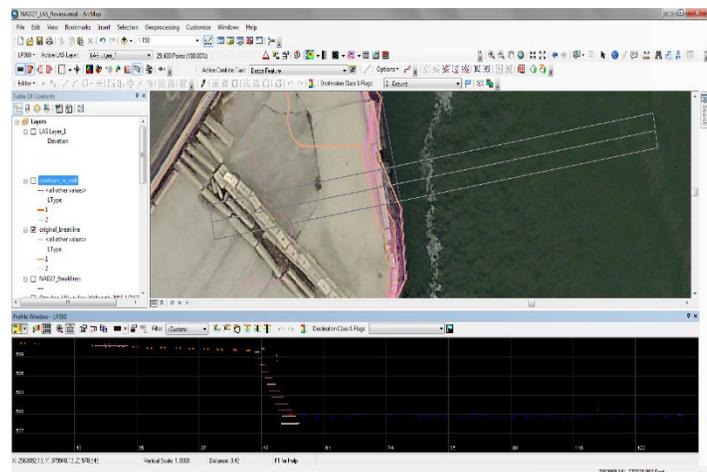
- Breaklines especially near walls have significant issues. The first issue is horizontal alignment accuracy. Most wall breaklines were collected well inside of the wall surface itself (i.e. breakline is placed in the water). The horizontal placement ranges anywhere from 3 – 10 feet off of apparent location which is cause numerous issues on the contour generation. Shown below is a location with both horizontal error and how the contouring looks when the breakline is enforced. The measured horizontal error on this sample below is 4.6 feet. The second major issue is the need to create a second breakline due to the significant vertical change and assurance of proper contouring around these features in meeting National Map Accuracy Standards. This second breakline allows proper enforcement and characterization of the topology around these specific wall features. The screen capture below shows what the contours look around this area. The Commission edited the existing line to locate it at the base of the wall itself and placing the breakline at the water surface of 580.0. The second breakline was created using LP360-retaining wall conflation tool.

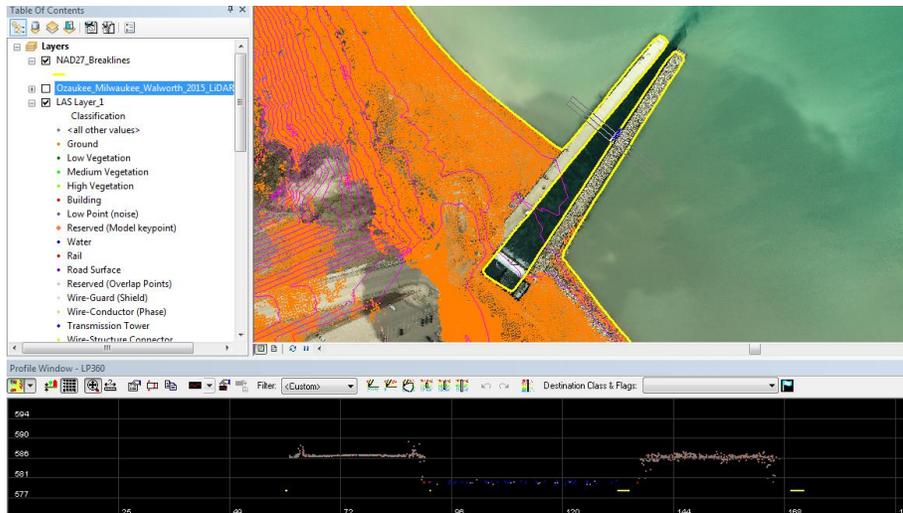
- Missing ground points and model keypoints. Need to put ground points back in surface supporting walls around collected breakline below.

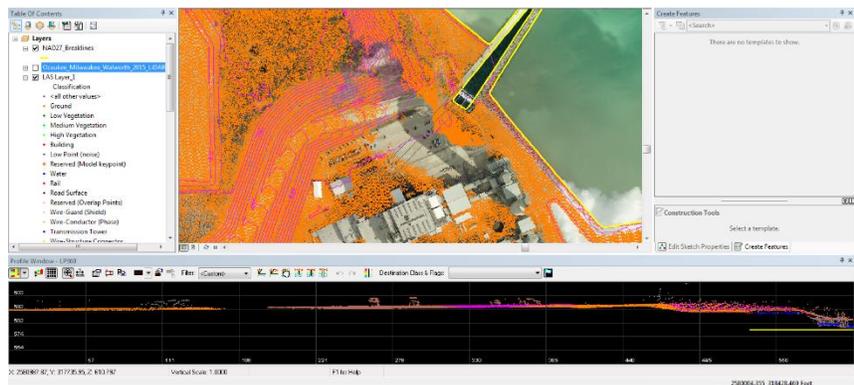
- Missing ground points around power plant. Smoke was causing a major ground obstruction on the primary flight line but the neighboring flight line(s) covered the ground well. Need to re-run ground around plant area to properly classify terrain. This mis-classification edit call was not in the shapefile but location was near the edit call location for ground points along the shoreline wall discussed above.

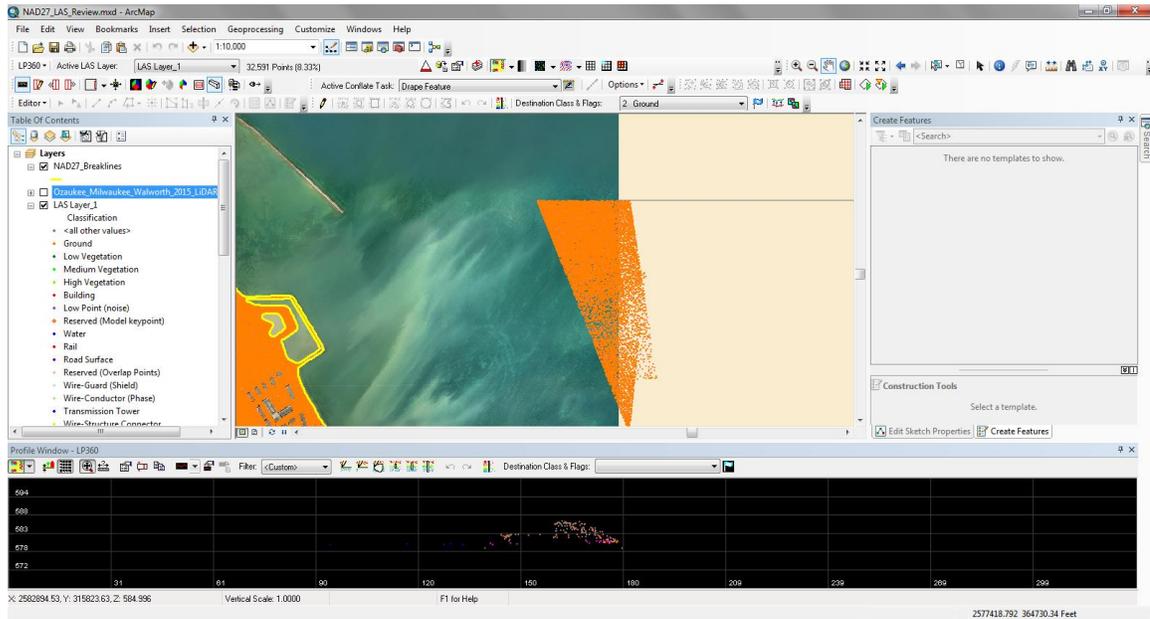
- Water points that were classed as ground. Need to re-classed points to water. These points are the tiles along Lake Michigan shoreline and are well out in the lake

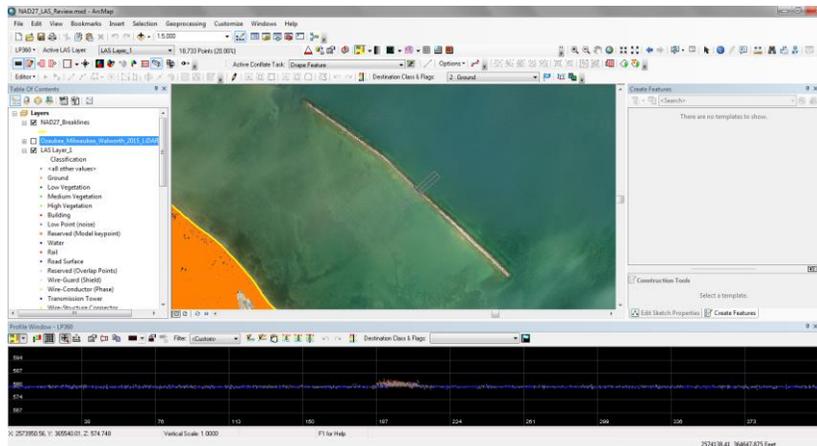
- All break water walls located along the near shoreline of Lake Michigan have been omitted. These wall need to be collected and a breakline captured around it consistent with the elevation of the shoreline for proper triangulation and contour generation for these missed features.

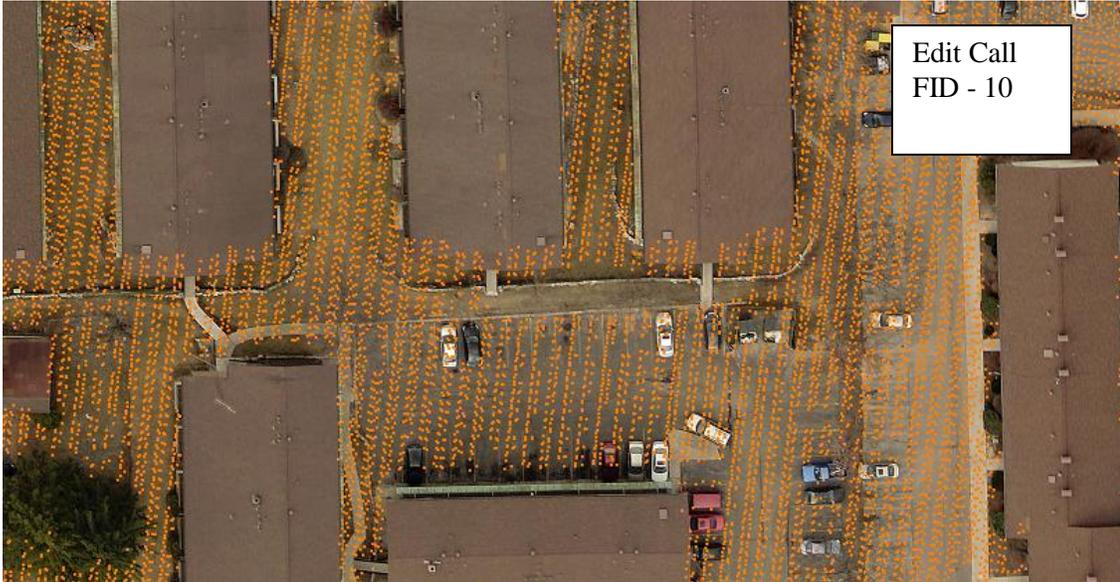
- Ground points missing causing the contouring to be affected.

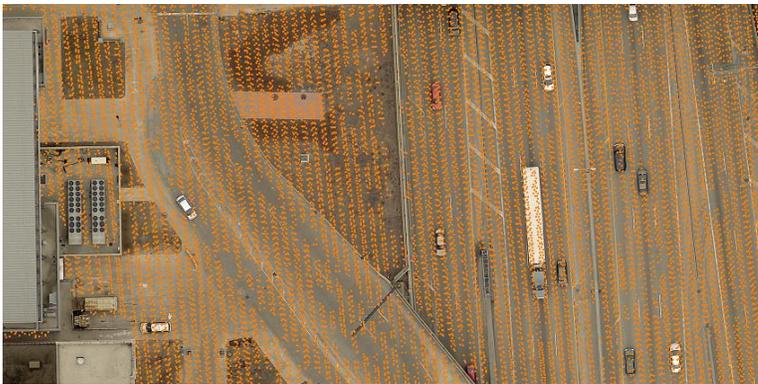
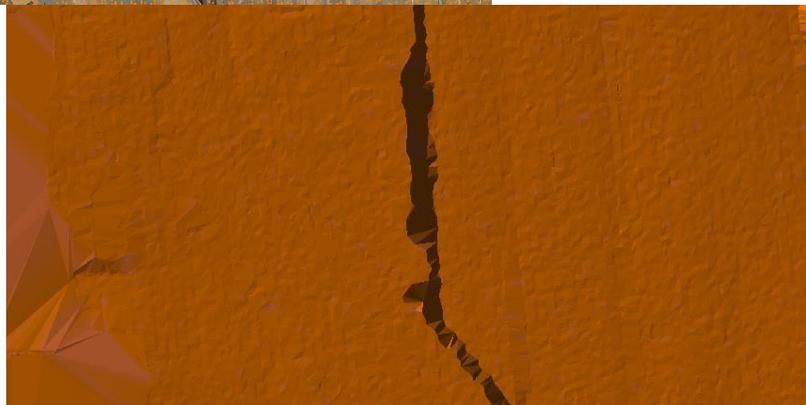
- Missing ground points along a transportation wall that affects contouring and DTM surface modeling. See below regarding a sample effect of the ground macro peeling back the ground points along a vertical feature.

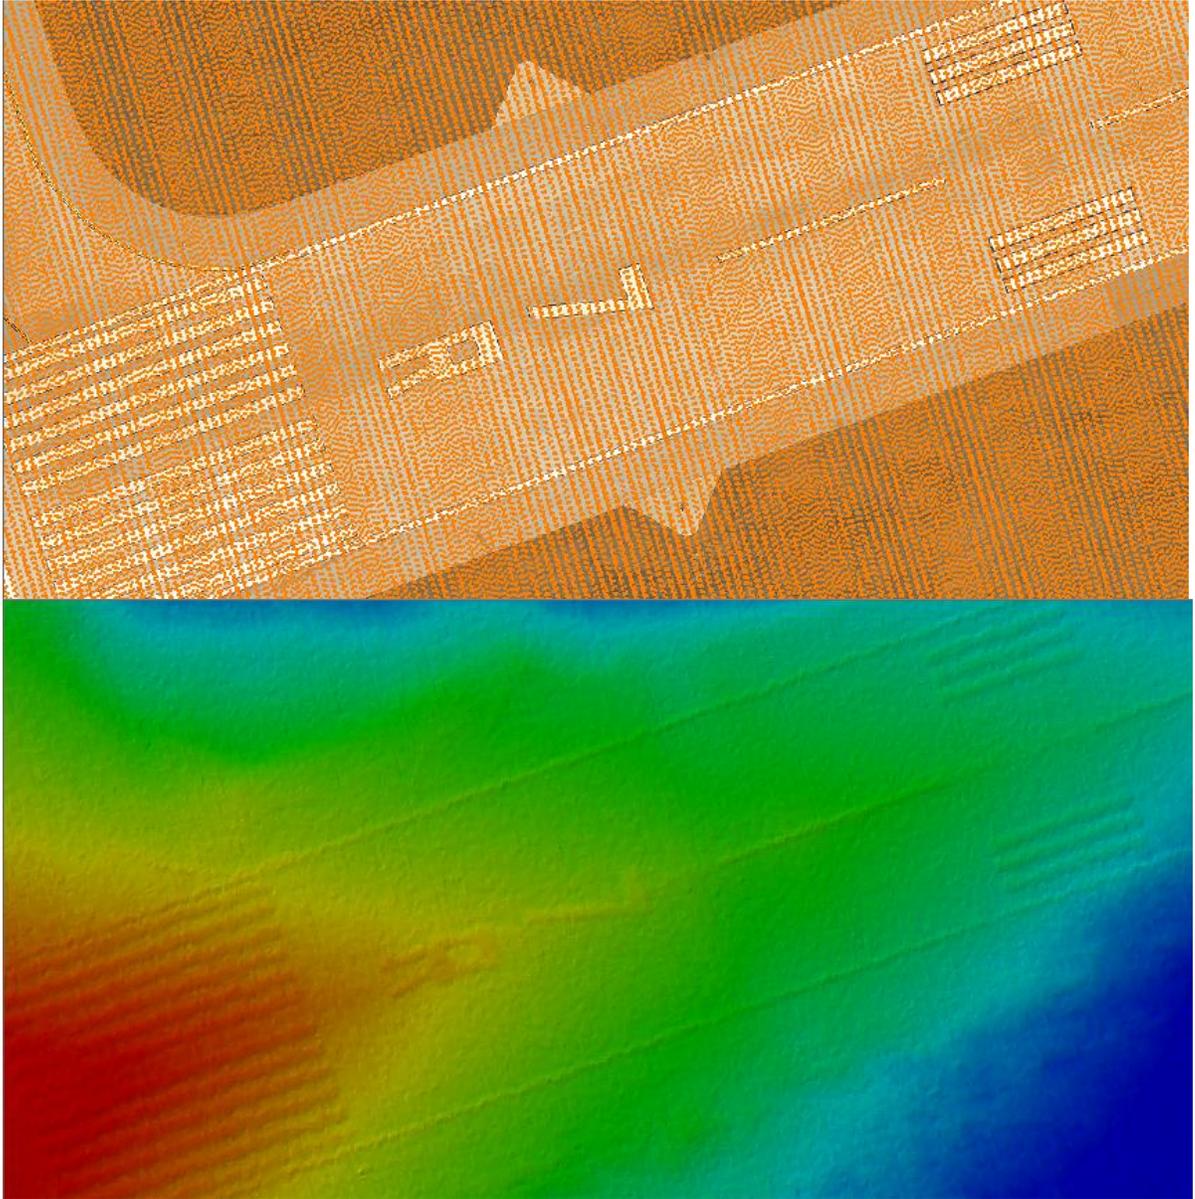
- Runway stripes seem to float above the average ground terrain based on the super reflective surfaces. See below of an example of the runway bias.

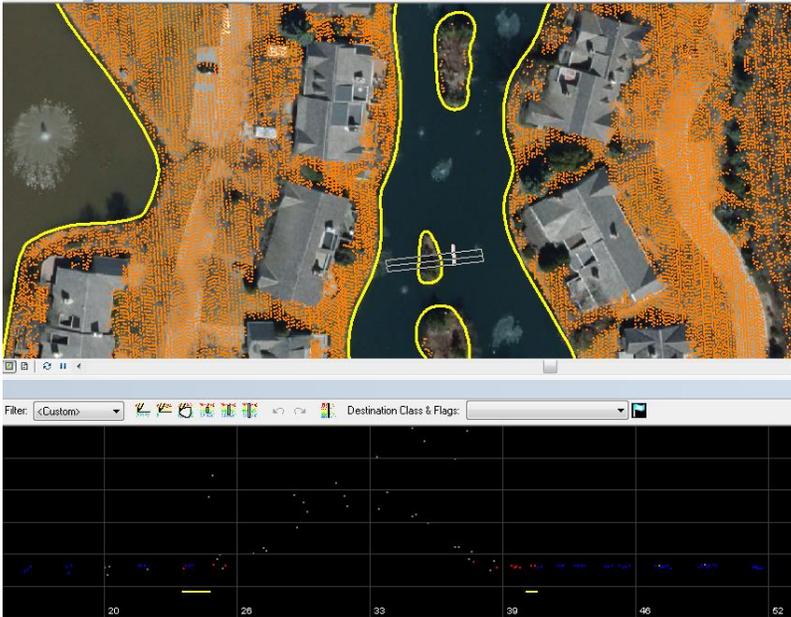
- Missing ground points in island breakline. Breakline capturing an island has been compiled but the ground points are missing. See below for an example.

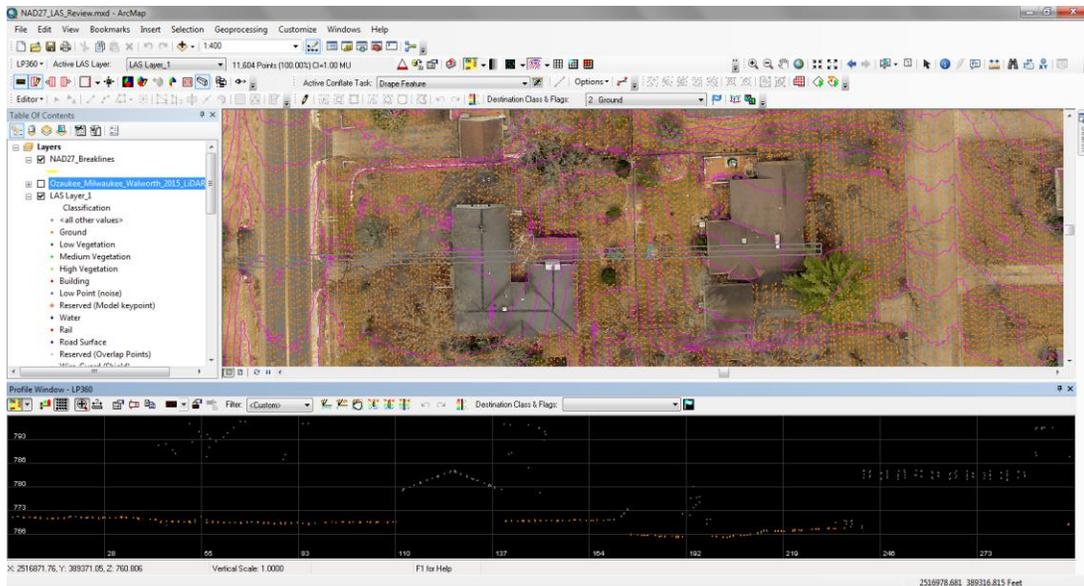
- Some minor deck points in the QC review were found but overall the deck points were eliminated. Please look to clean up the QC deck call made on both files.

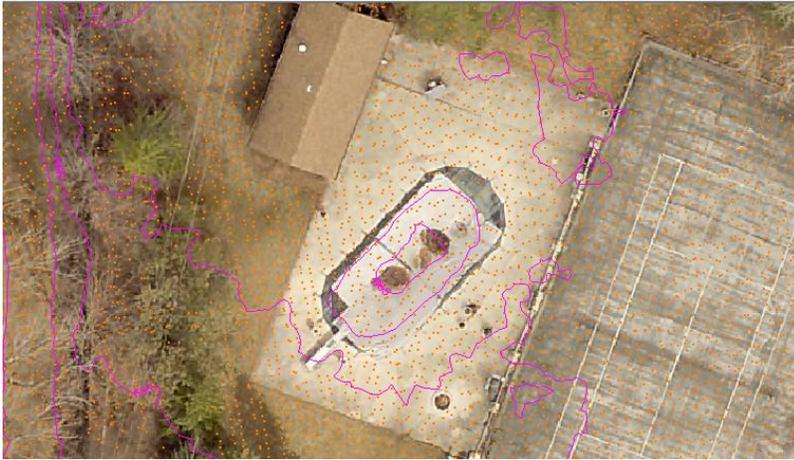
- Ground points in pools. In our 10% review we found a few pools that affected the contouring around a specific pool which the ground points should be removed. Below is a screen capture of the contouring affect with the pool. Edit calls were only made where ground points in pools affected the contours.

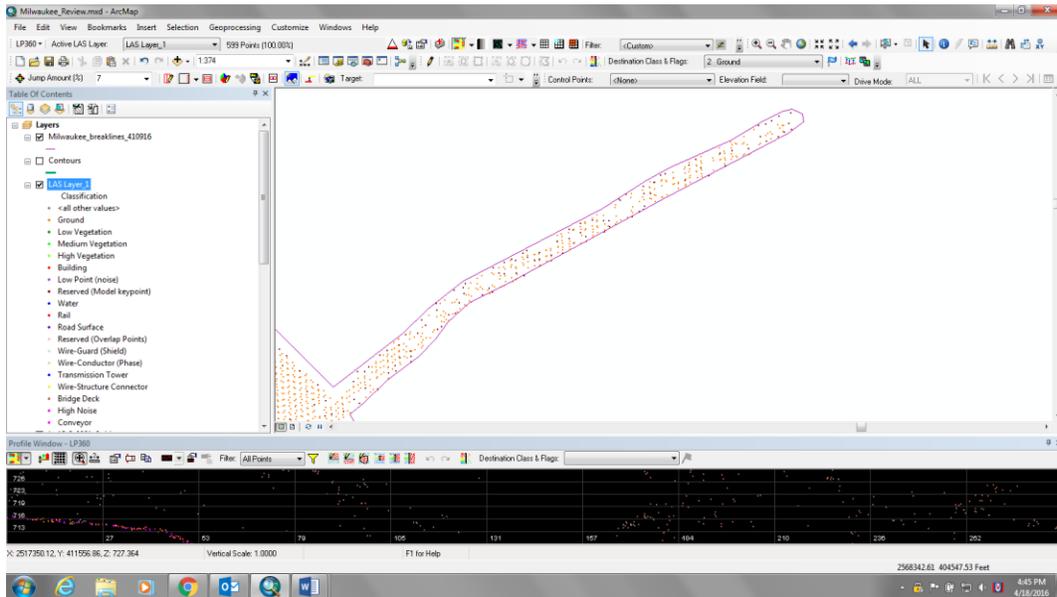
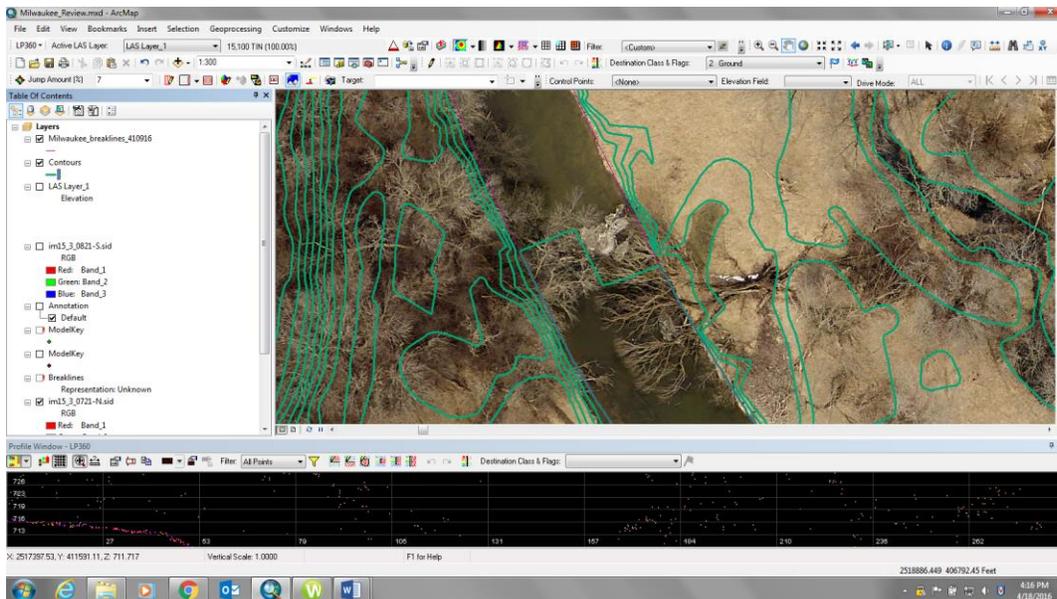
Points outside of breakline. Shoreline has points cleared but the breakwater wall did not have any points cleared away from breakline.

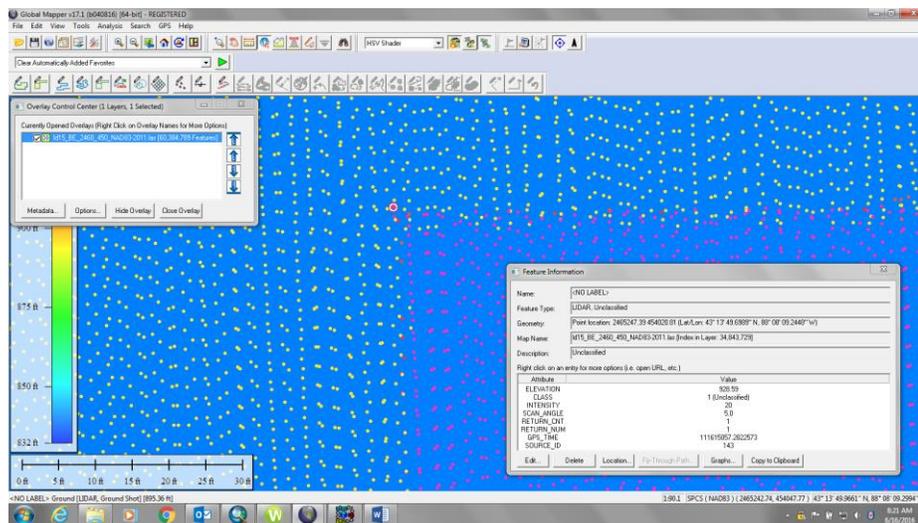
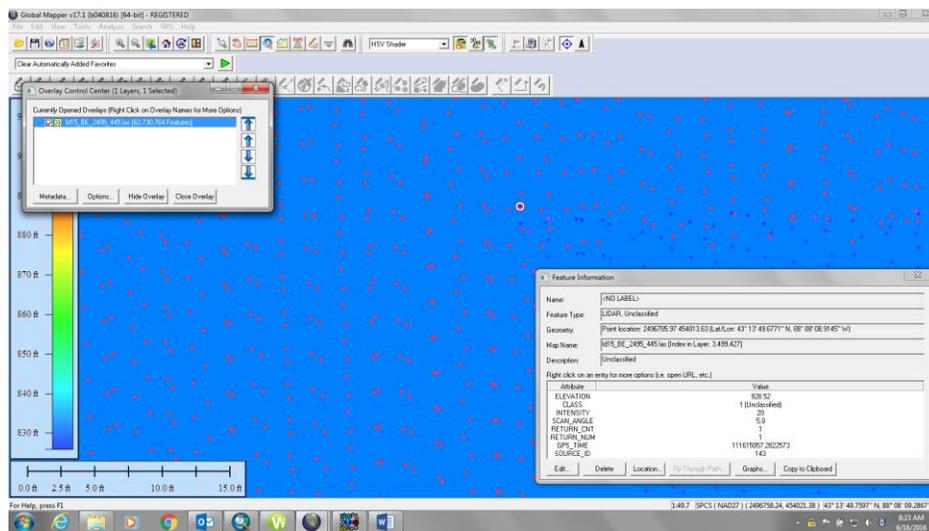
Converting from NAD83/2011 to NAD27, the sample point computed found is inconsistent between datums:

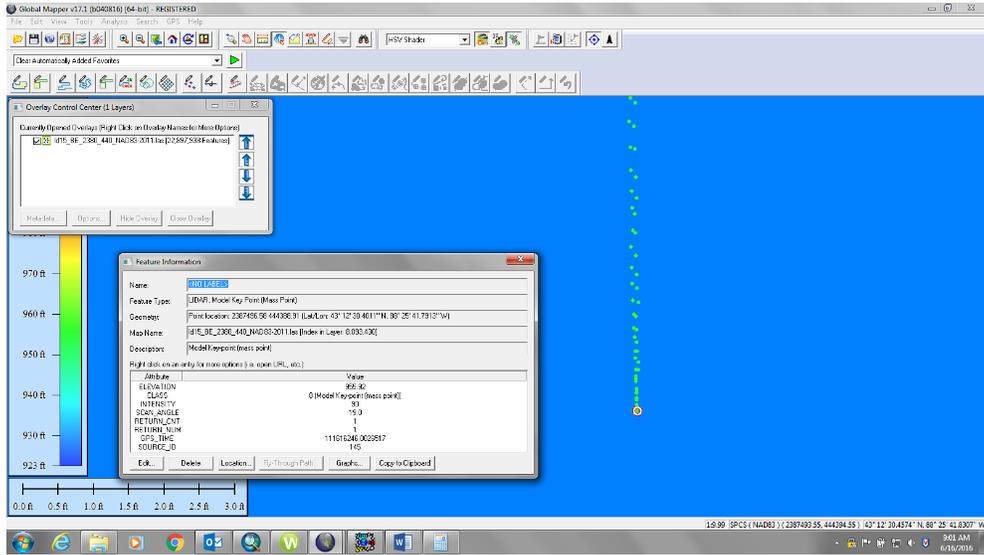
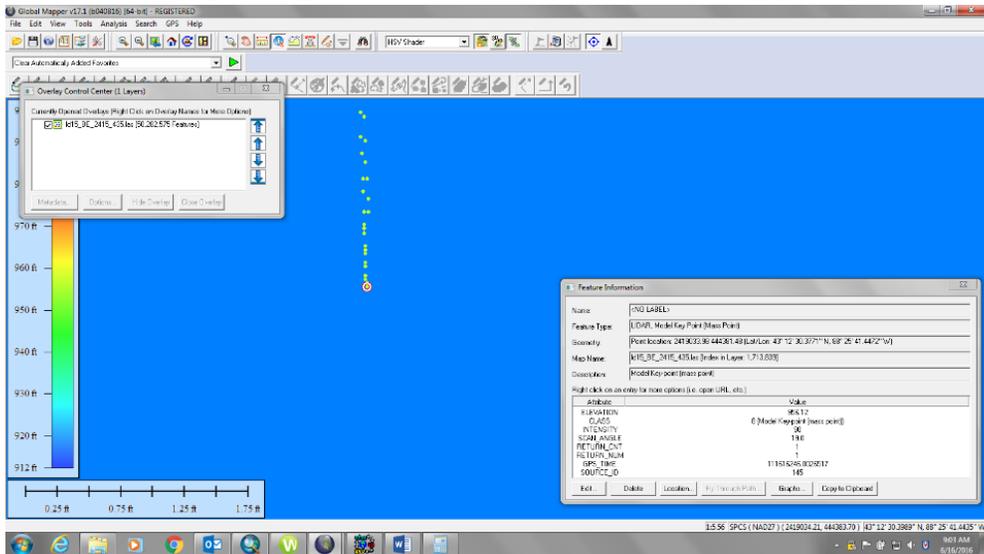
Converting from NAD83/2011 to NAD27, the sample point computed found is inconsistent between datums:
