Elevation QC Report

Project: Carroll Co. GA **Contractor:** Kucera International Inc.

Elevation Type: LIDAR **Format:** LAS **Grid Spacing:** 5 ft **Tile size:** 2677x5759

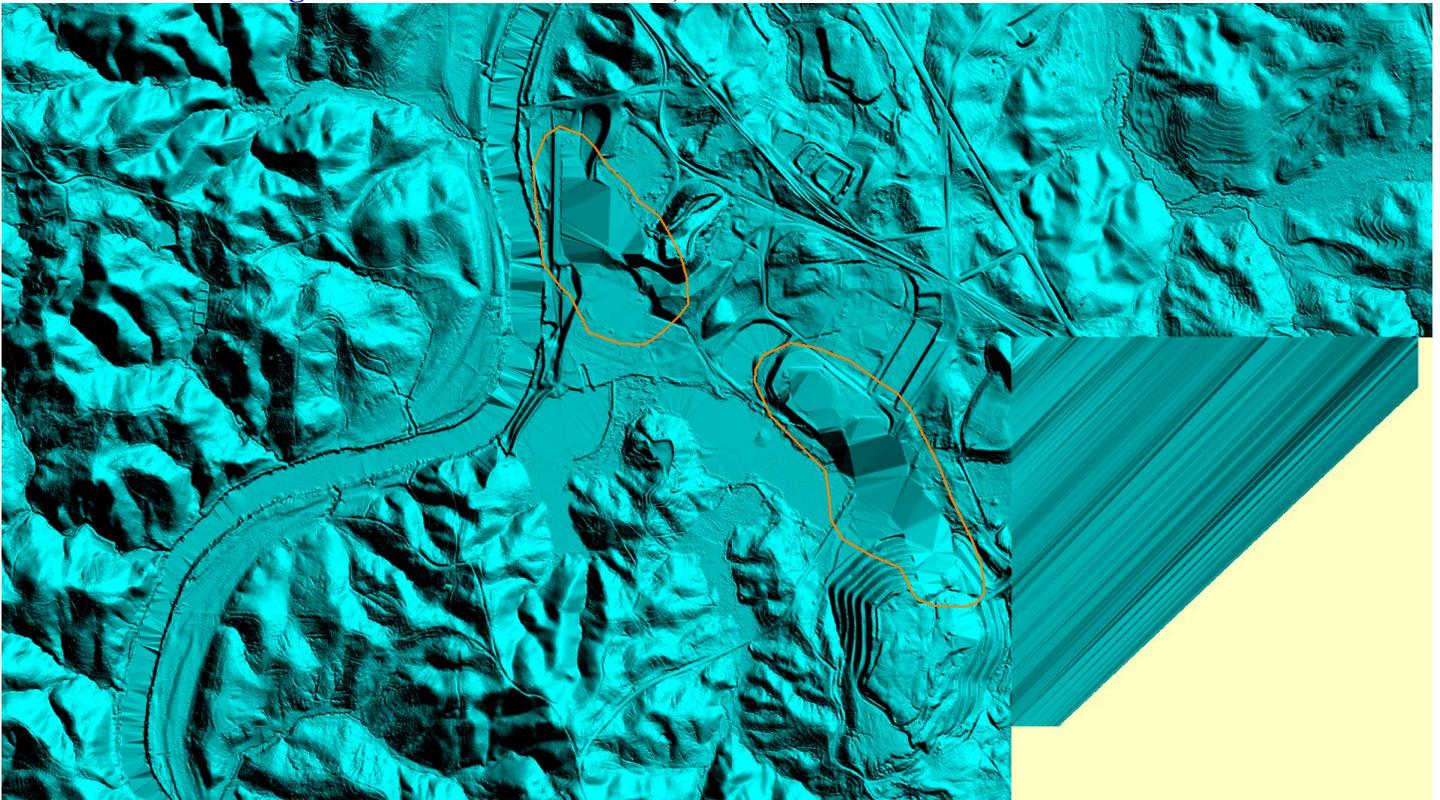
One area of missing data was found. See error on the following pages.

Small areas of missing data @ $33^{\circ} 27' 41.8073''$ N, $84^{\circ} 54' 7.6434''$ W
