# USGS/FEMA Region IX – Orange County, CA LiDAR

Report Produced for U.S. Geological Survey

USGS Contract: G10PC0013

Report Date: 7/31/2012

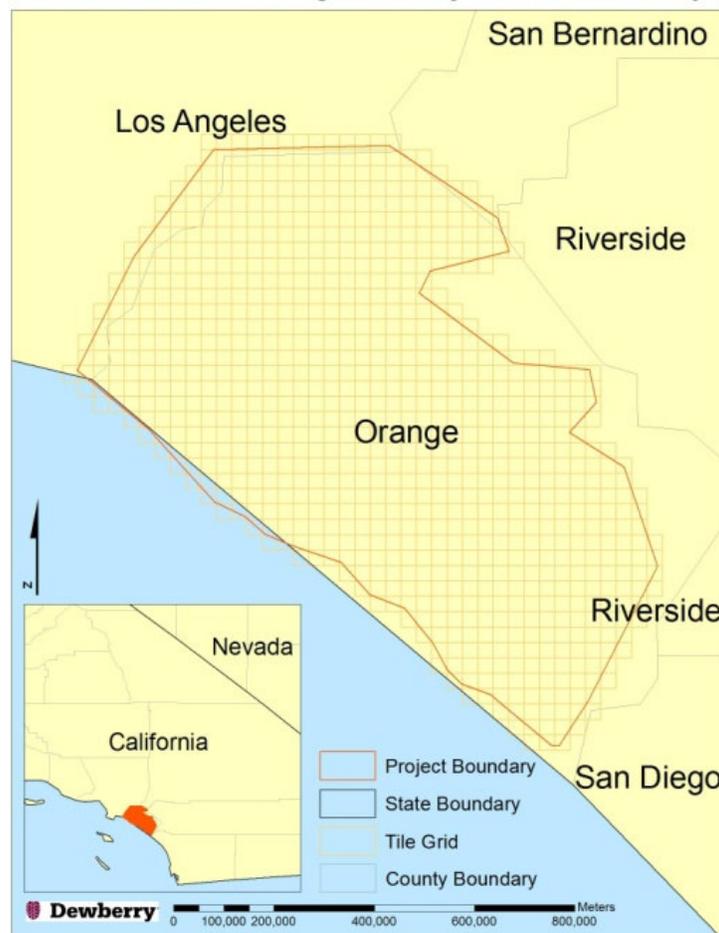
Figure 1: Project Map

Eight hundred sixty-eight (868) tiles were delivered for the project. Each tile's extent is 1,500 meters by 1,500 meters.

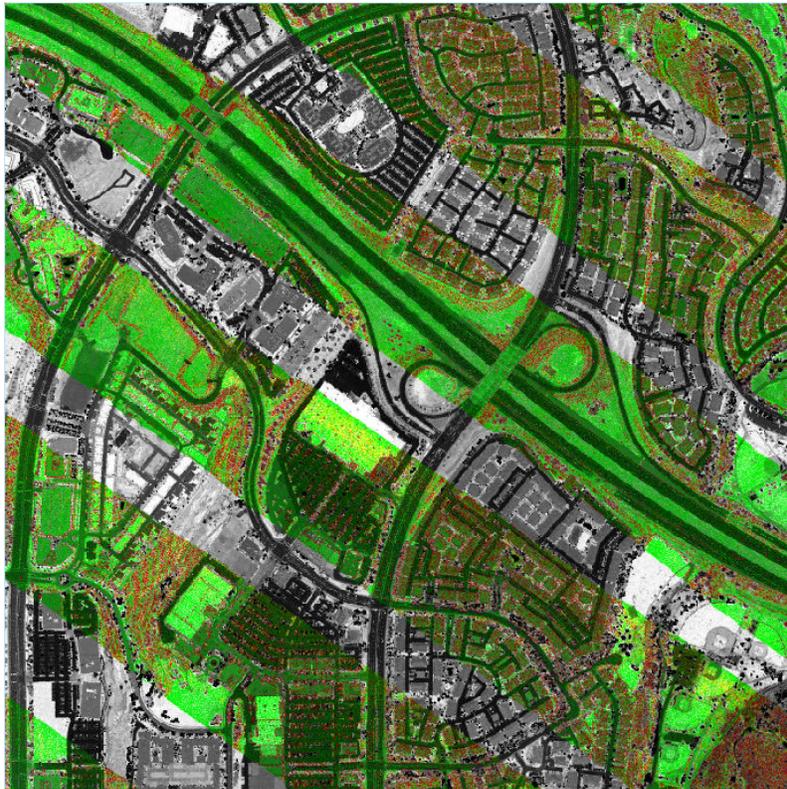
Once the initial ground routine has been performed on the data, Dewberry creates Delta Z (DZ) orthos to check the relative accuracy of the LiDAR data. These orthos compare the elevations of LiDAR points from overlapping flight lines on a 1 meter pixel cell size basis. If the elevations of points within each pixel are within 10 cm of each other, the pixel is colored green. If the elevations of points within each pixel are between 10 cm and 20 cm of each other, the pixel is colored yellow, and if the elevations of points within each pixel are greater than 20 cm in difference, the pixel is colored red. Pixels that do not contain points from overlapping flight lines are colored according to their intensity values. DZ orthos can be created using the full point cloud or ground only points and are used to review and verify the calibration of the data is acceptable. Some areas are expected to show sections or portions of red, including terrain variations, slope changes, and vegetated areas or buildings if the full point cloud is used. However, large or continuous sections of yellow or red pixels can indicate the data was not calibrated correctly or that there were issues during acquisition that could affect the usability of the data. The DZ orthos for Orange County California showed that the data was calibrated correctly with no issues that would affect its usability. The figure below shows an example of the DZ orthos.

Figure 3: DZ orthos created from the full point cloud. Some red pixels are visible along embankments, sloped terrain, and in vegetated land cover, as expected. Open, flat areas are green indicating the calibration and relative accuracy of the data is acceptable.

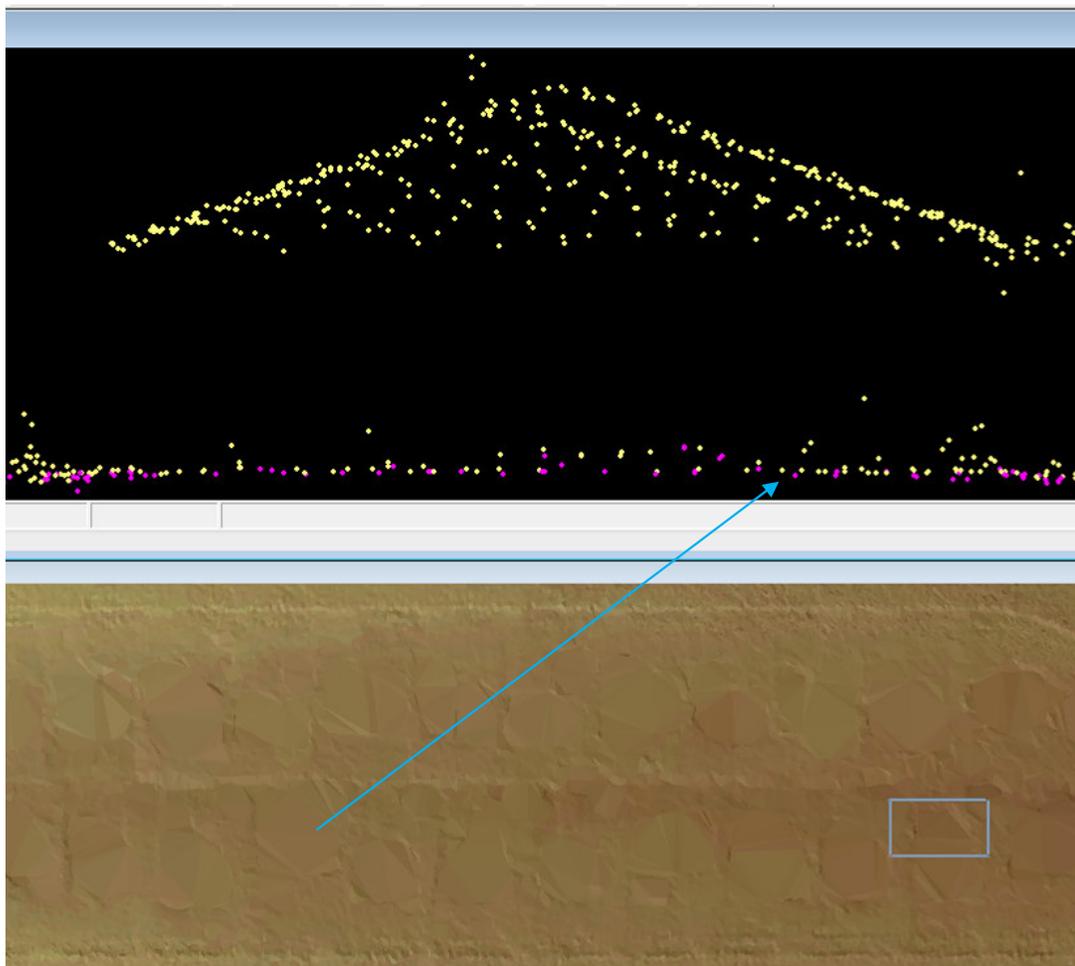
*Figure 4 – Tile number 11SMT111465. Profile with points colored by class (class 1=yellow, class 2=pink) is shown in the top view and a TIN of the surface is shown in the bottom view. The arrow identifies low vegetation points. A limited number of these small features are still classified as ground.*

- a. *Artifacts:* Artifacts are caused by the misclassification of ground points and usually represent vegetation and/or man-made structures. The artifacts identified are usually low lying structures, such as porches or low vegetation used as landscaping in neighborhoods and other developed areas. These low lying features are extremely difficult for the automated algorithms to detect as non-ground and must be removed manually. The vast majority of these features have been removed but a small number of these features are still in the ground classification. The limited numbers of features remaining in the ground are usually 0.3 meters or less above the actual ground surface, and should not negatively impact the usability of the dataset.

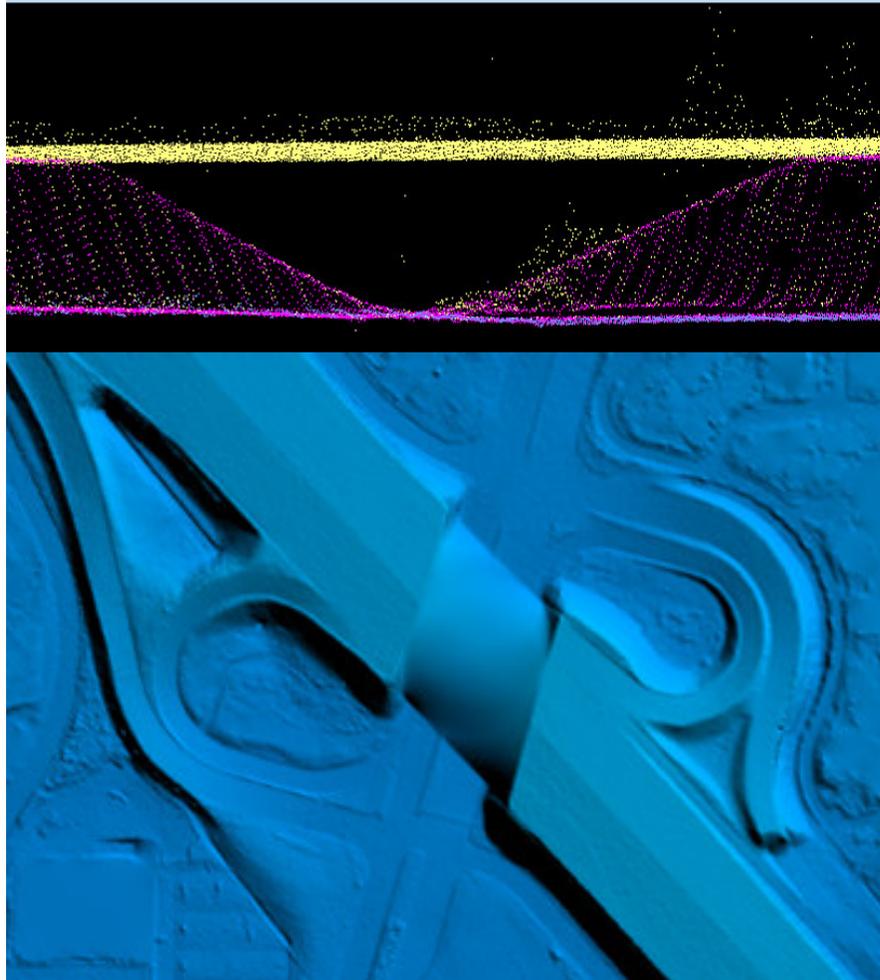
*Figure 5 – Tile number 11SMT171390. The DEM in the bottom view shows a visual artifact because the surface model is interpolating from the slope leading to the bridge to the lower ground points on either side of the bridge points that were removed. The surface model must make a continuous model and in order to do so, points are connected through interpolation. This can cause visual artifacts when there are features with large elevation differences. The profile in the top view shows the LiDAR points of this particular feature colored by class. All bridge points have been removed from ground (pink) and are unclassified (yellow). There are no ground points that can be modified to correct this visual artifact.*

- b. *Bridge Removal Artifacts:* The DEM surface models are created from TINs or Terrains. TIN and Terrain models create continuous surfaces from the inputs. Because a continuous surface is being created, the TIN or Terrain will use interpolation to triangulate across a bridge opening from legitimate ground points on either side of the actual bridge. This can cause visual artifacts or “saddles.” These “artifacts” are only visual and do not exist in the LiDAR points or breaklines.

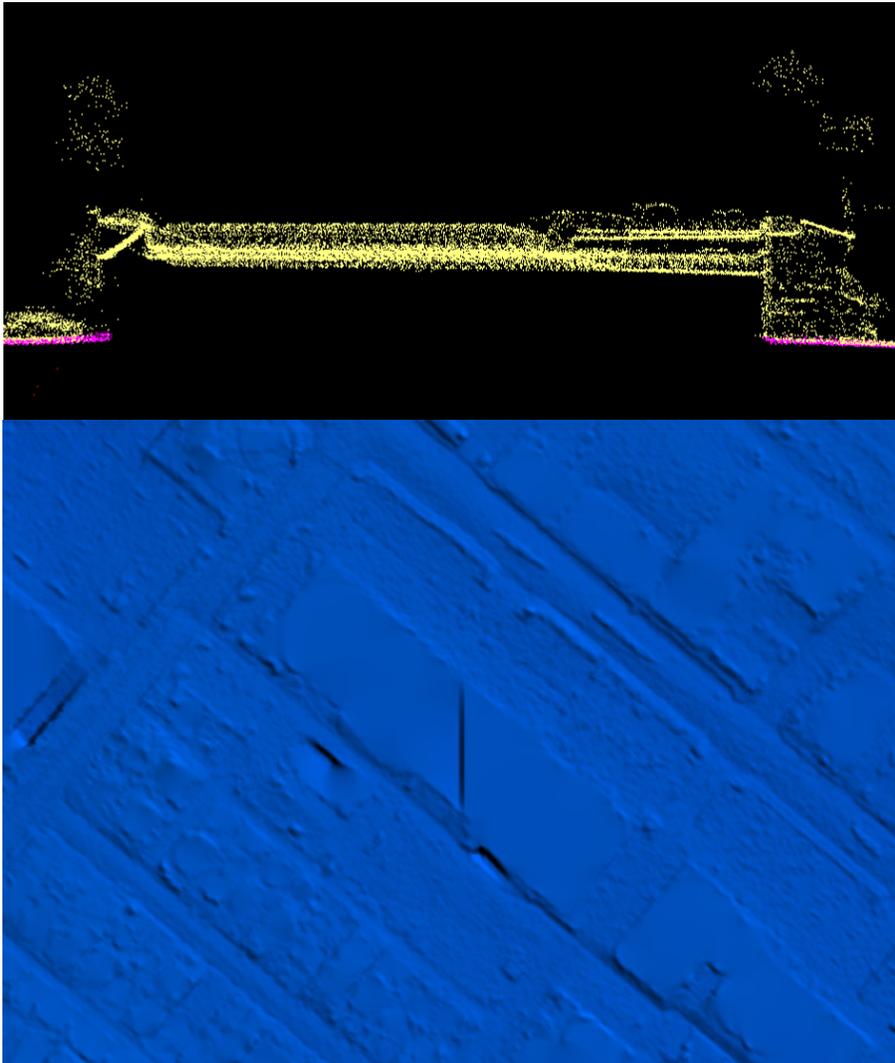
*Figure 6 – Tile number 11SMT141210. The DEM in the bottom view shows a visual artifact because the surface model is interpolating between the available ground points on either side of the building points that were removed. The surface model must make a continuous model and in order to do so, points are connected through interpolation. This can cause visual artifacts in areas where the ground elevation is slightly lower on one side of building than the other. The profile in the top view shows the LiDAR points of this particular feature colored by class. All building points have been removed from ground (pink) and are unclassified (yellow) or classified as noise (red). There are no ground points that can be modified to correct this visual artifact.*

- C. *Building Removal Artifacts:* Large buildings, unique construction, and buildings built on sloped terrain or built into the ground can make a noticeable impact on the bare earth DEM once they have been removed, often in the form of large void areas with obvious triangulation or interpolation across the area and general lack of detail in the ground where the structure stood. In a few areas, this interpolation has resulted in visual artifacts within building footprints. These “artifacts” are only visual and do not exist in the LiDAR points.

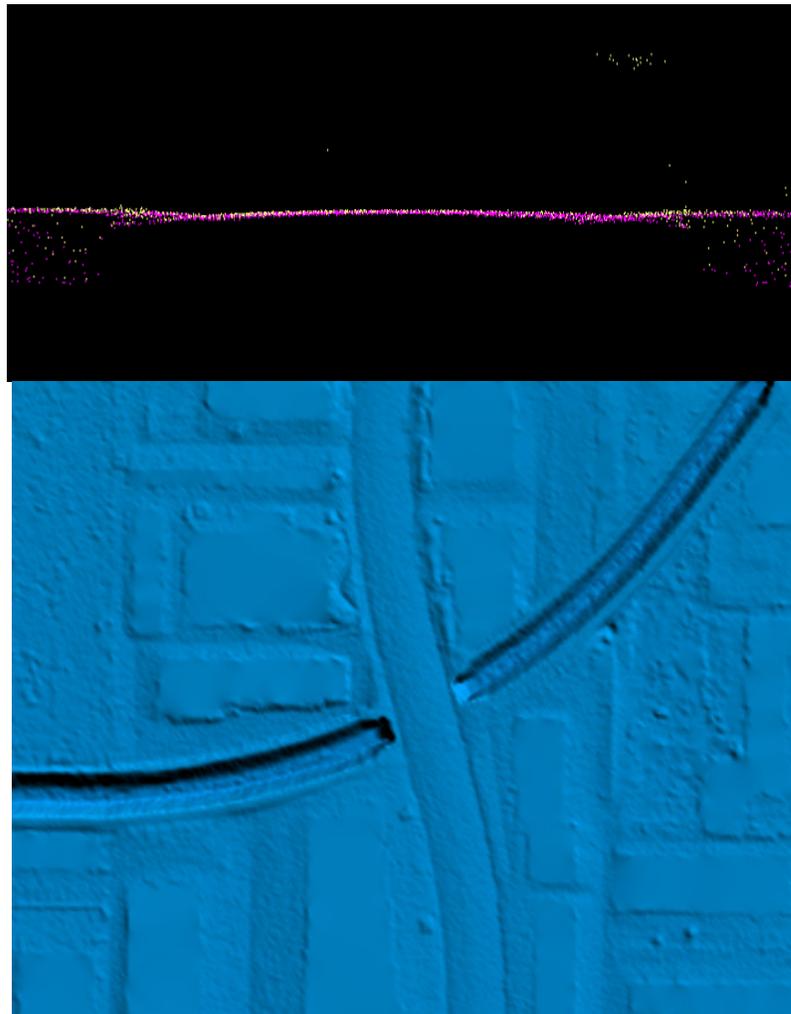
*Figure 7– Tile number 11SMT186405. Profile with points colored by class (class 1=yellow, class 2=pink) is shown in the top view and the DEM is shown in the bottom view. This culvert remains in the bare earth surface. Bridges have been removed from the bare earth surface and classified to class 1.*

- d. *Culverts and Bridges:* Bridges have been removed from the bare earth surface while culverts remain in the bare earth surface. In instances where it is difficult to determine if the feature is a culvert or bridge, such as with some small bridges, Dewberry erred on assuming they would be culverts especially if they are on secondary or tertiary roads. There were also several large structures throughout the project area that Dewberry determined to be box culverts. Below is an example of a culvert that has been left in the ground surface.

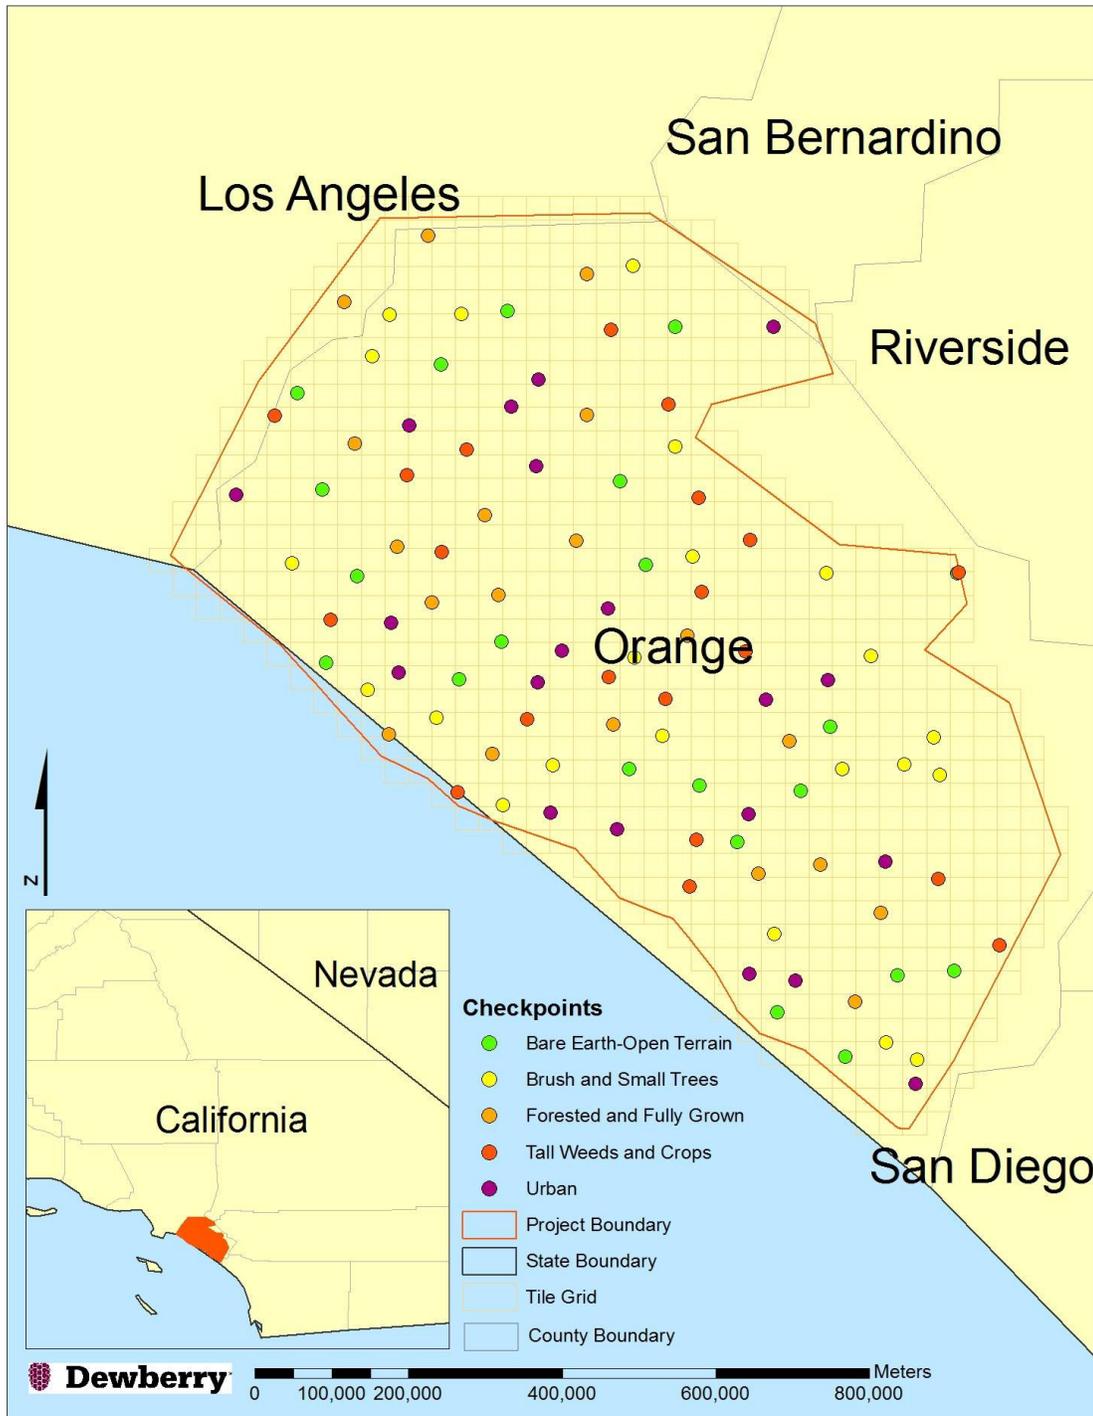
Figure 13 – Location of QA/QC Checkpoints

The figure below shows the location of the QA/QC checkpoints within the project area.

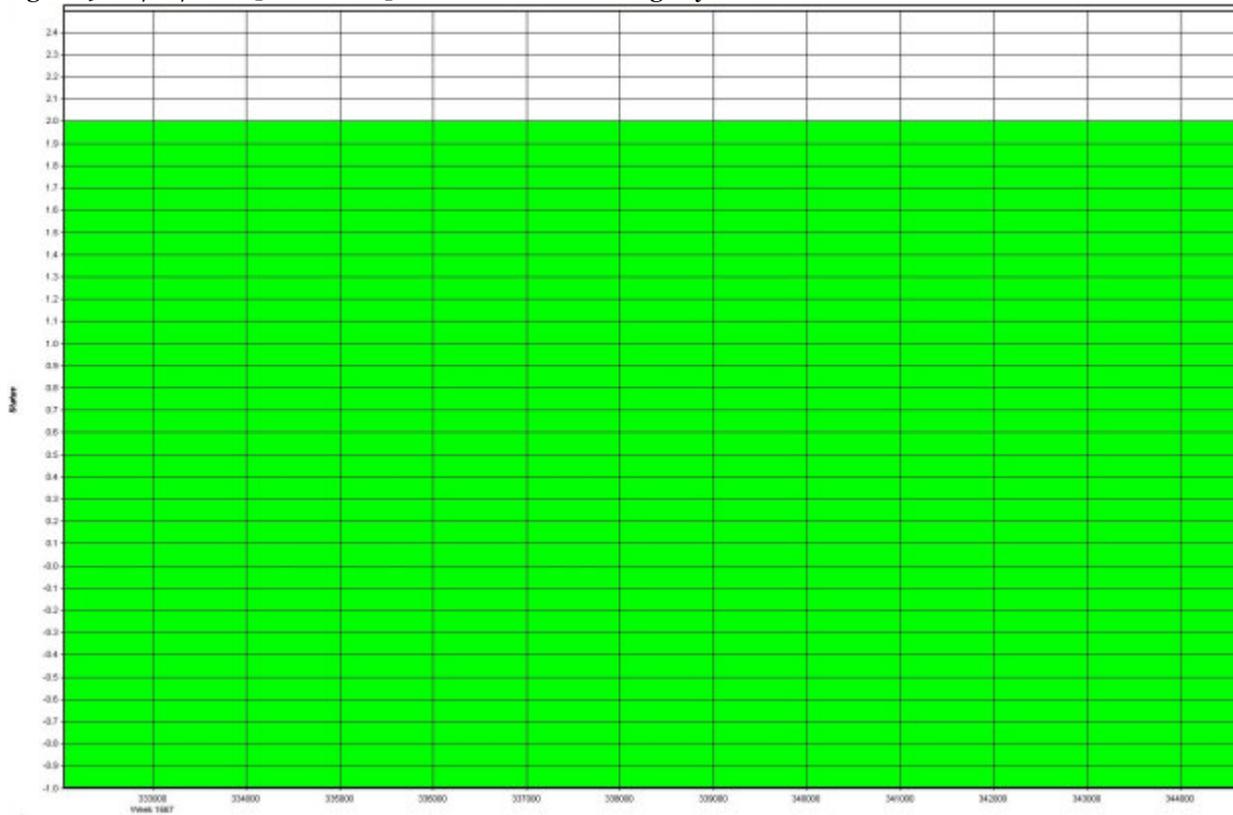
Figure 9: 12/21/2011 [Combined] - Float or Fixed Ambiguity

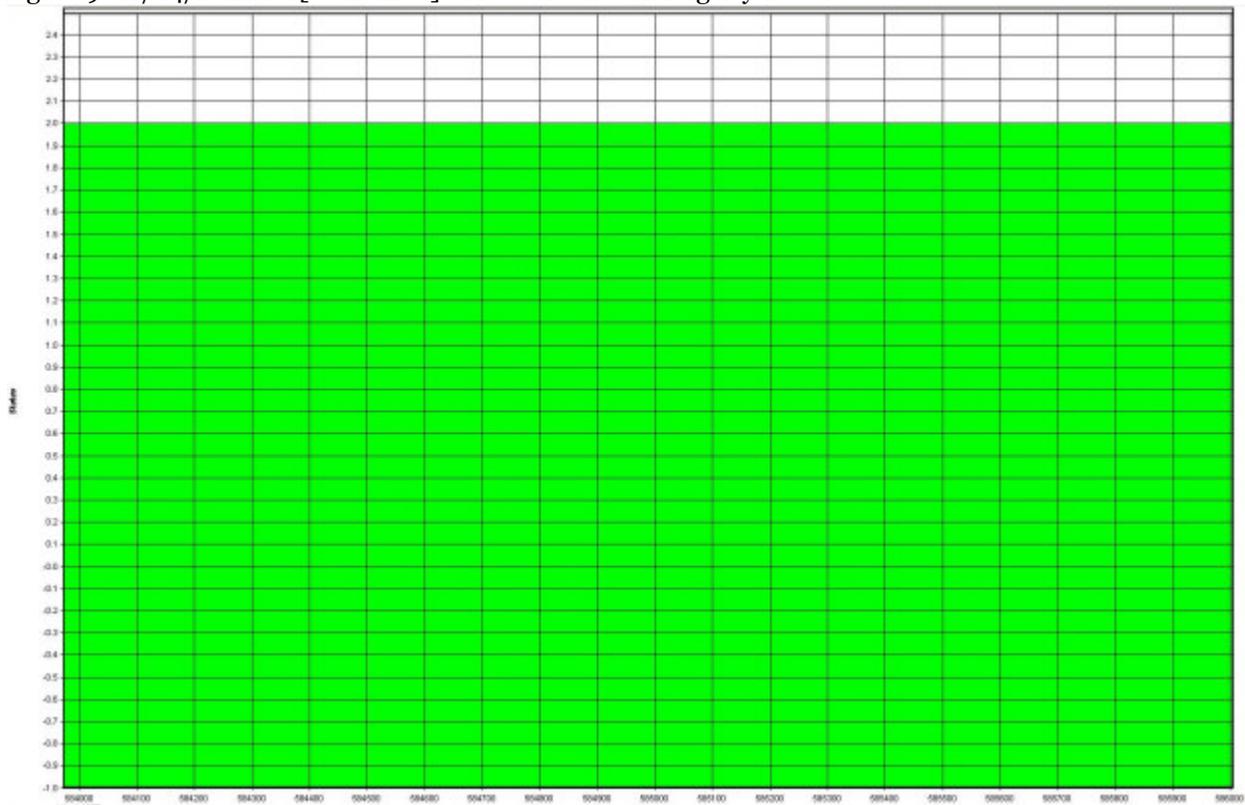
Figure 9: 12/24/2011AM [Combined] - Float or Fixed Ambiguity

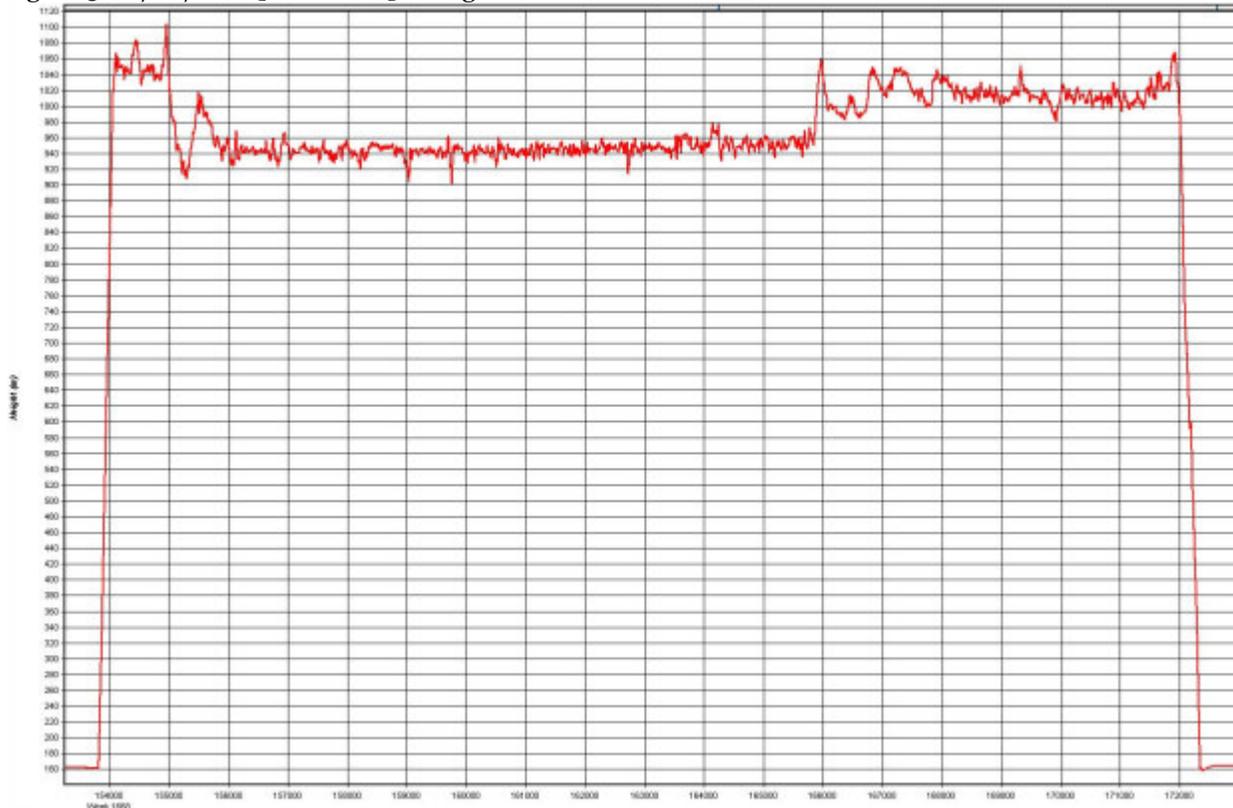
Figure 3: 12/26/2011 [Combined] - Height Profile Plot

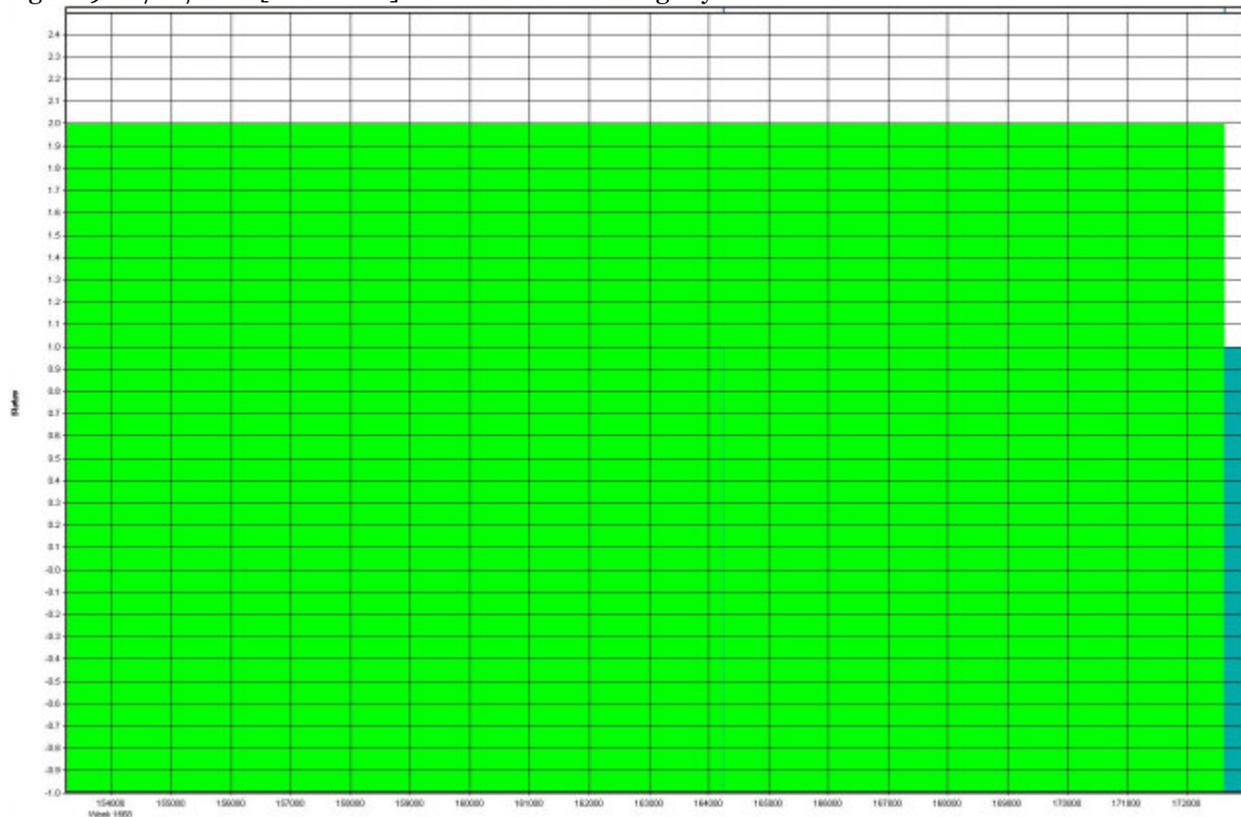
Figure 9: 12/26/2011 [Combined] - Float or Fixed Ambiguity

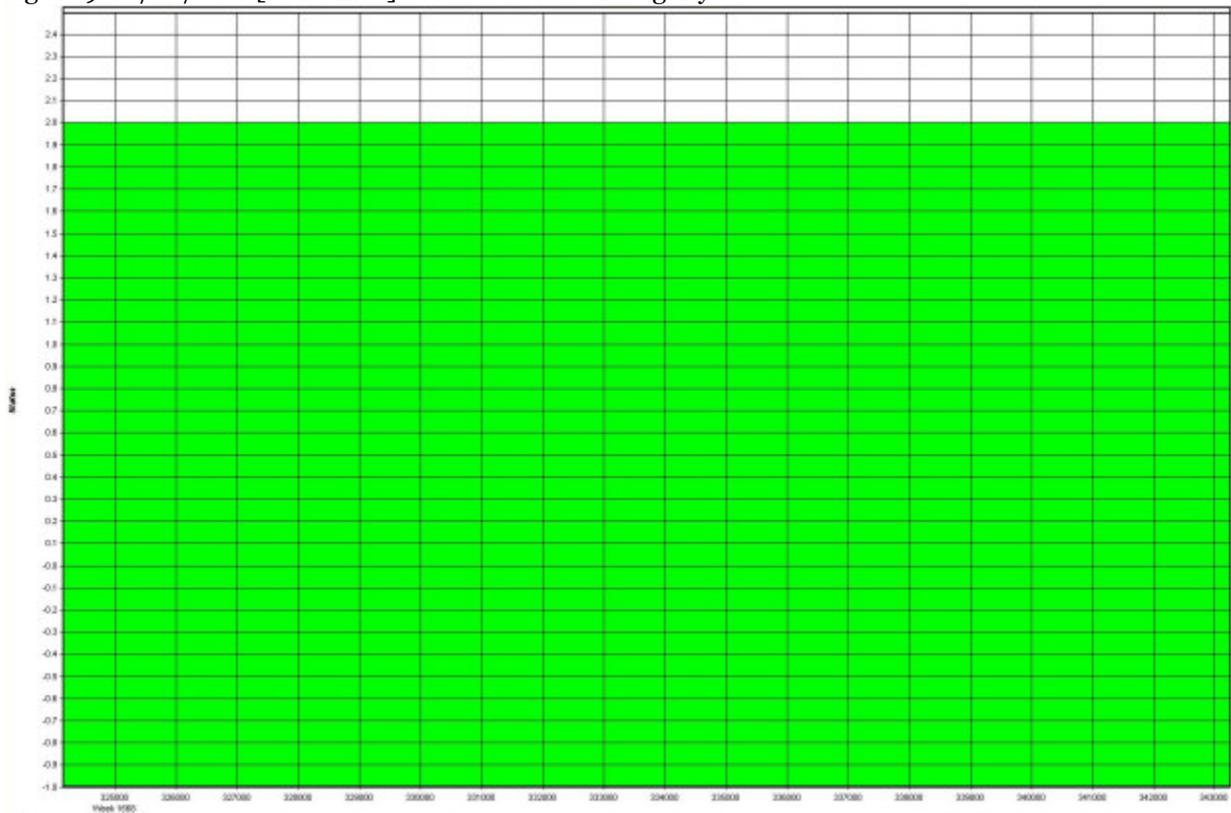
Figure 9: 12/28/2011 [Combined] - Float or Fixed Ambiguity

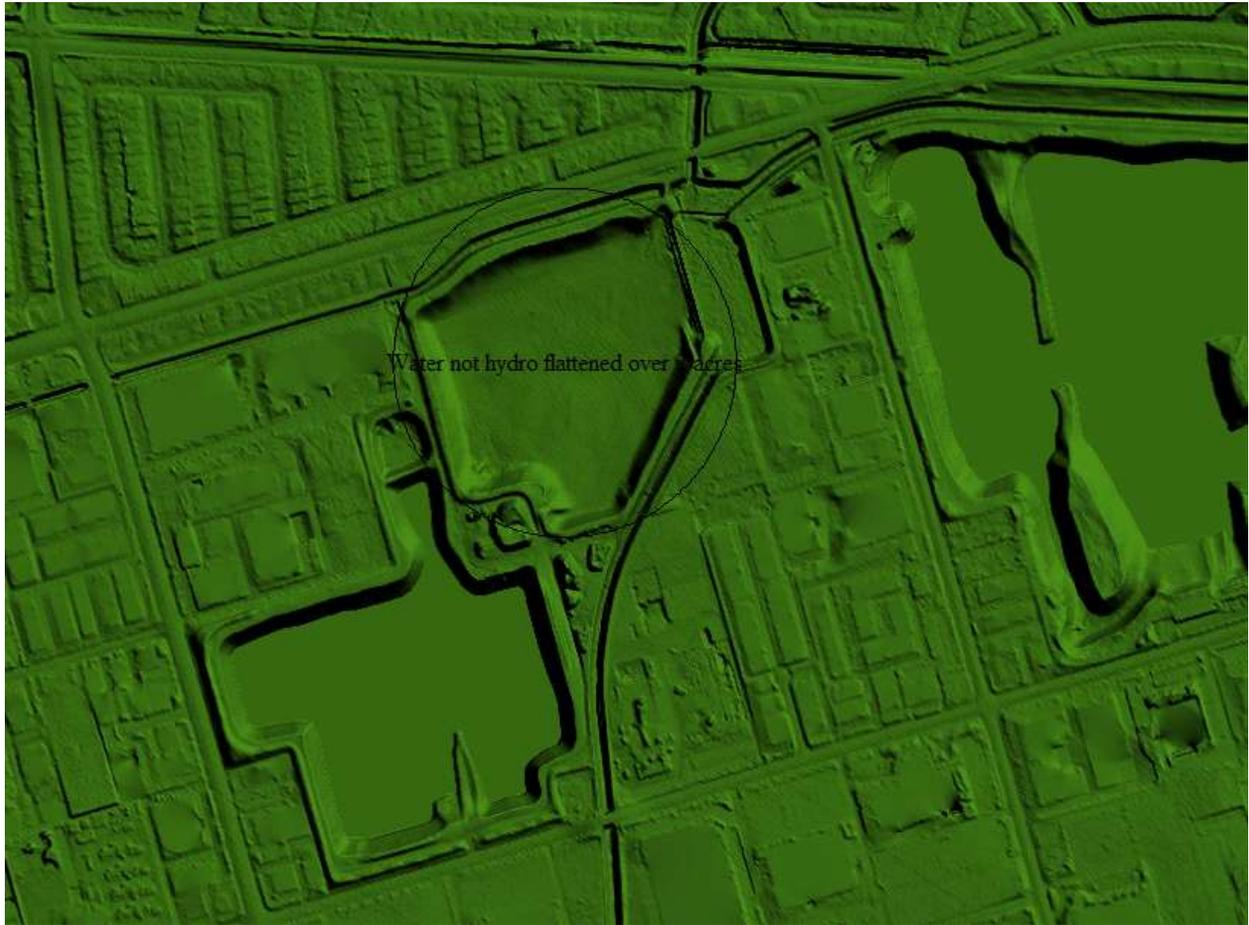
Reviewer identified a minimum of 3 waterbodies greater than 2 acres not hydroflattened. These errors are documented in a shapefile created by the reviewer at NGTOC named errors.shp. In the pdf, "Dewberry Response to USGS Review Orange County 10012012" Dewberry explains that one of four calls regarding breaklines/waterbodies was incorrect, from viewing the intensity images it can be determined that no water existed at the time of acquisition. The other three calls were addressed, corrected, and new DEM and LAS files were redelivered to the reviewer via ftp site on 10/02/12. Reviewer visually inspected the redelivered DEMs and found them acceptable.

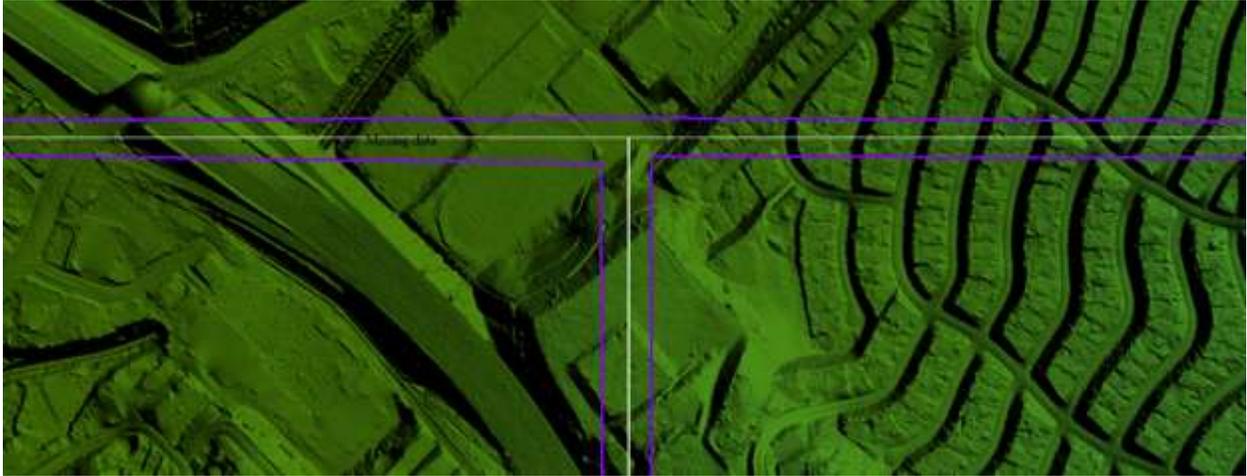
Reviewer identified 4 areas where data voids exist between tiles. The voids are located near the North, South, East and West extents of the project boundary. These errors are documented in a shapefile created by the reviewer at NGTOC named errors.shp. In the pdf, "Dewberry Response to USGS Review Orange County 10012012" Dewberry explains that these gaps were due to processing errors that occurred with the partial tiles along the project boundary. The 21 tiles where this error occurred have been reprocessed and redelivered. Reviewer visually inspected the redelivered DEMs and found them acceptable.

There were four locations called out by USGS for data voids or missing data. Fortunately, there were no true data density, data voids. The gaps identified were due to processing errors that occurred with the partial tiles along the project boundary. The twenty-one tiles where this error occurred have been reprocessed and redelivered.

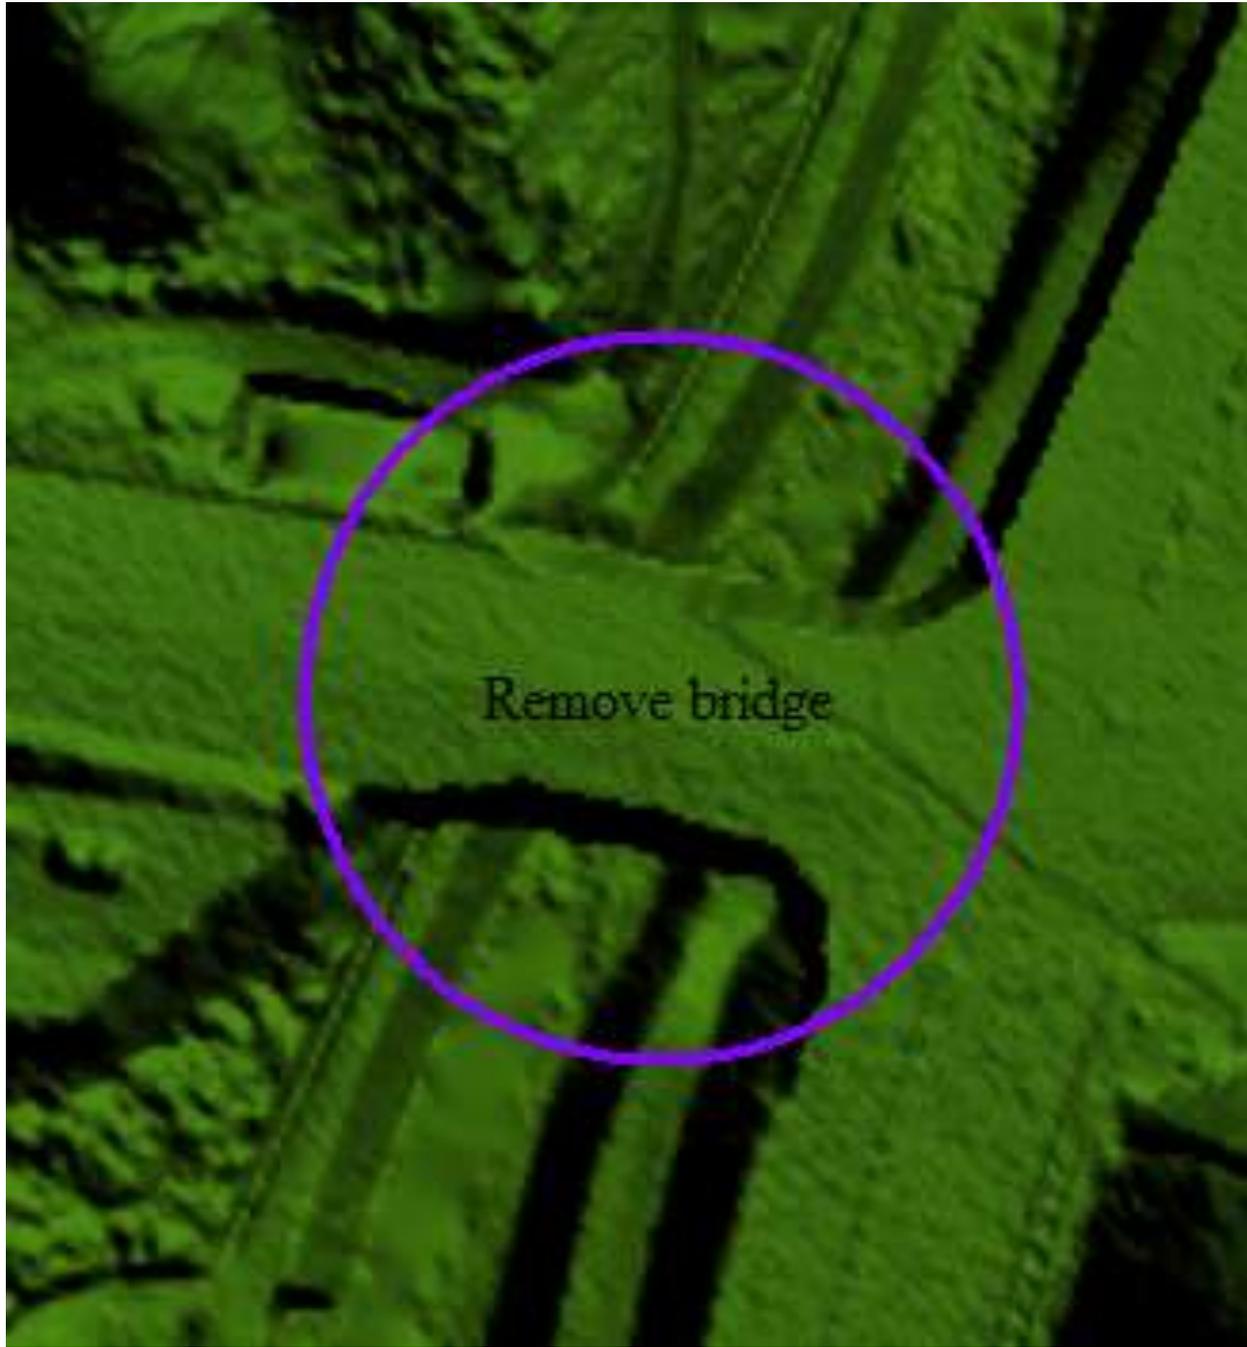
Reviewer identified bridges remaining in bare earth surface. These errors are documented in a shapefile created by the reviewer at NGTOC named errors.shp. See following image and comments for updated information.

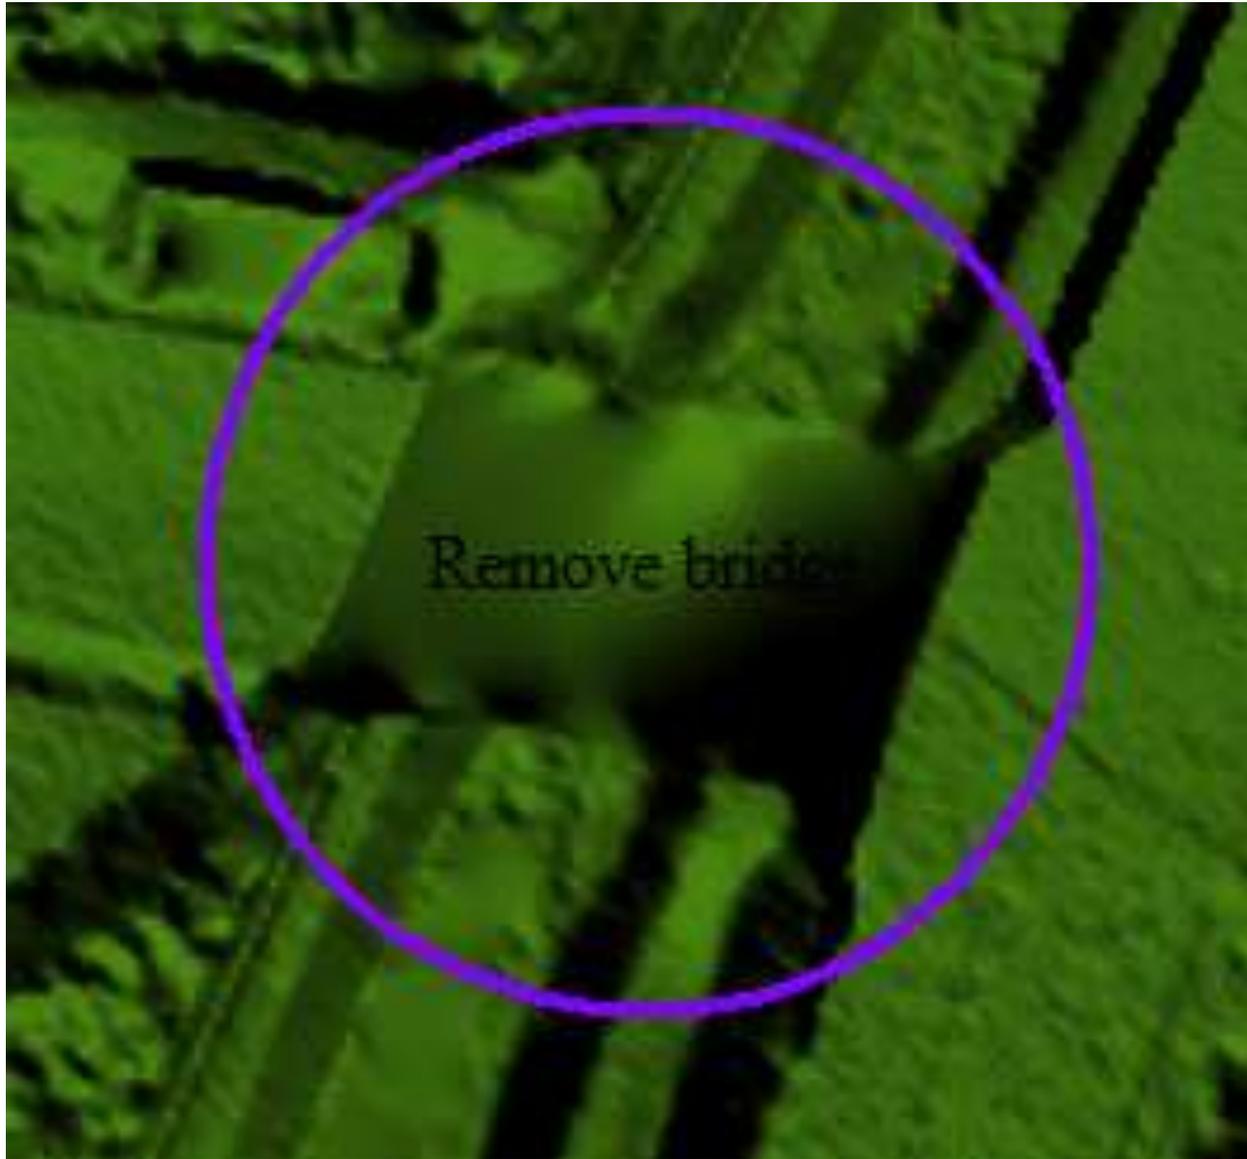
In the pdf, "Dewberry Response to USGS Review Orange County 10012012" Dewberry explains that these were originally believed to be culverts, but have been removed from the bare earth surface, DEMs were redelivered to reviewer via ftp site on 10/02/12. Reviewer visually inspected the redelivered DEMs and found them acceptable.

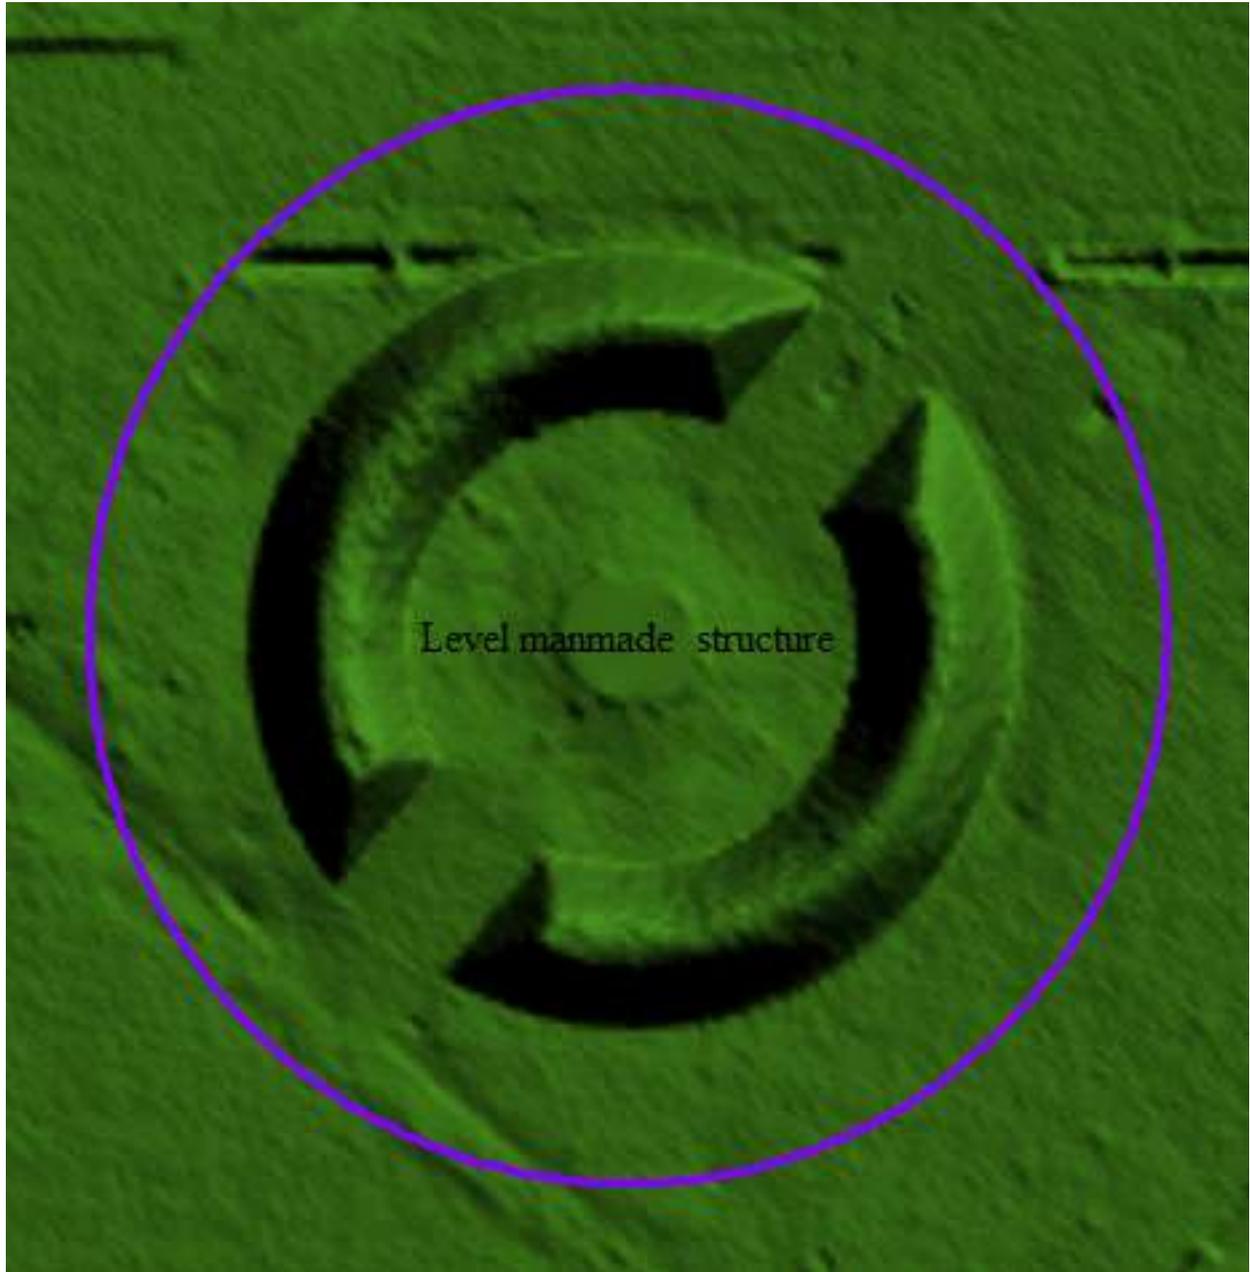
Reviewer identified a man-made structure in bare earth surface. This error is documented in a shapefile created by the reviewer at NGTOC named errors.shp. In the pdf, "Dewberry Response to USGS Review Orange County 10012012" Dewberry explains that in this instance earthen mounds have been formed around the feature and have been correctly included in the ground classification. Reviewer accepts this response.

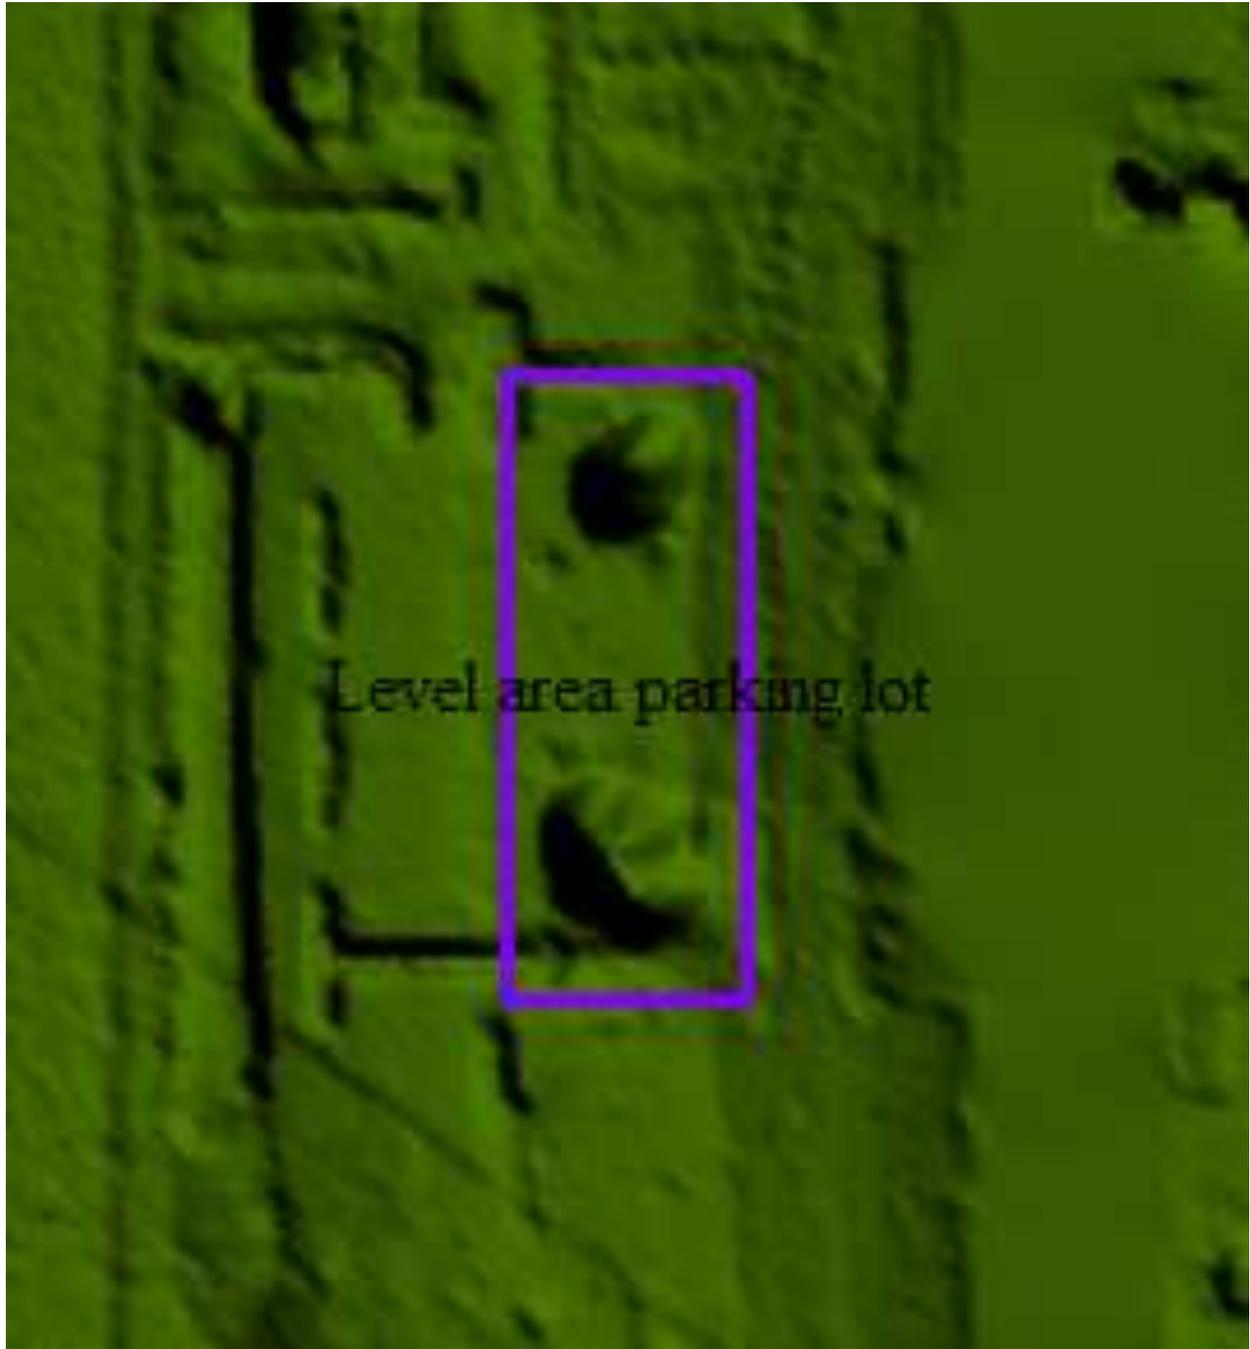
Reviewer identified areas of extreme elevation change within man-made parking lot that needs further removal. This error is documented in a shapefile created by the reviewer at NGTOC named errors.shp.
