# USGS/FEMA Region IX – Orange County, CA LiDAR

Report Produced for U.S. Geological Survey

USGS Contract: G10PC0013

Report Date: 7/31/2012

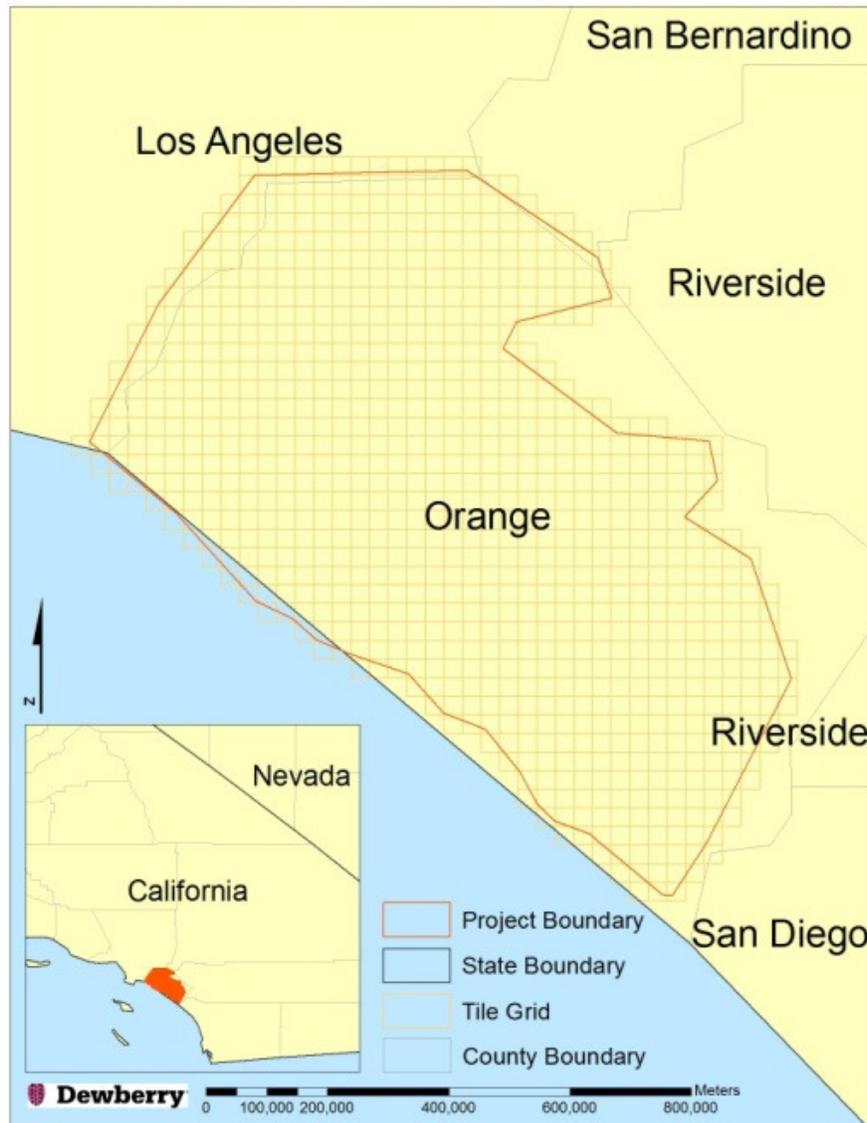
Figure 1: Project Map

Data was formatted according to tiles with each tile covering an area of 1500m by 1500m. A total of 868 tiles were produced for the project encompassing an area of approximately 681 sq. miles.

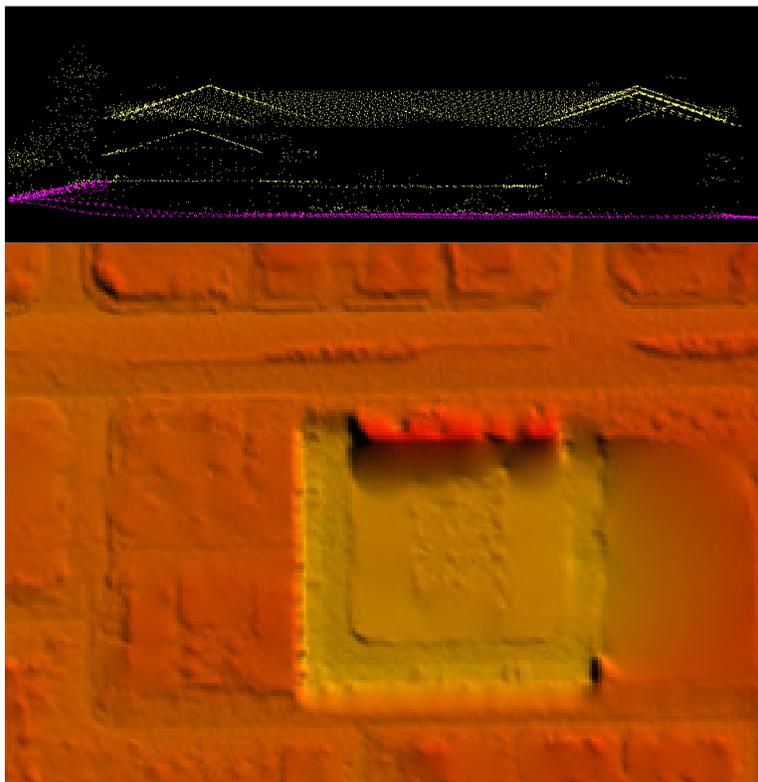
Figure 2 - Tile 11SMT096435. The DEM in the bottom view shows a visual artifact because the surface model is interpolating between the available ground points on either side of the building points that were removed. The profile in the top view shows the LiDAR points of this particular feature colored by class. All building points have been removed from ground (pink) and are unclassified (yellow). There are no ground points that can be modified to correct this visual artifact.

There were eleven locations where comments were made to remove structure related artifacts. The DEM surface models are created from terrains. Terrain models create continuous surfaces from the inputs, in this instance LiDAR ground points. The surface model must make a continuous model and in order to do so, points are connected through interpolation. This can cause visual artifacts in areas where the ground elevation is higher on one side of the building than the other. This is common throughout California where many homes are built into hillsides. As these “artifacts” are only visual and do not exist in the LiDAR points, no modifications were made to the LAS or DEMs in 10 of these areas. Modifications were made to 1 area where highpoints could be removed from the ground to create a cleaner surface model. Examples are shown below.

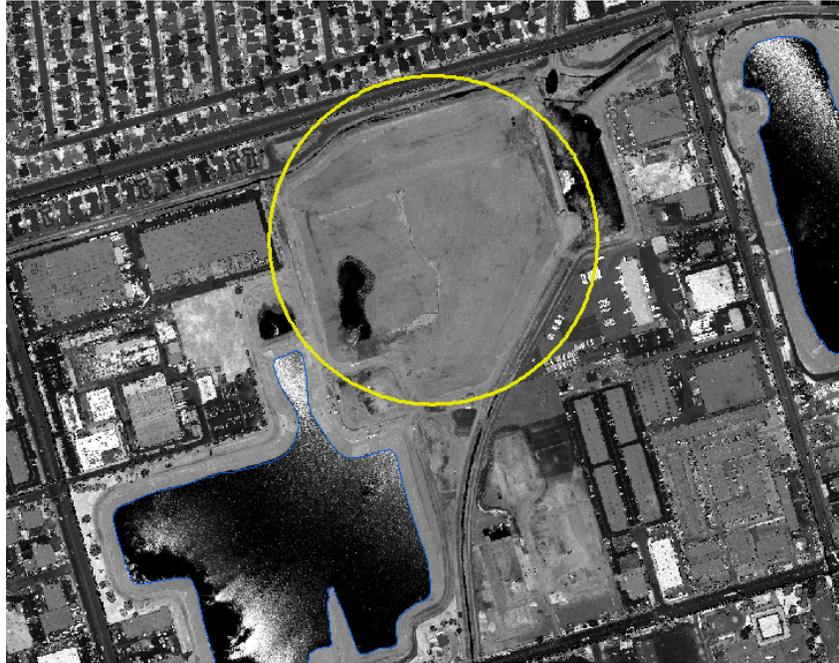
Figure 19 - Tile 11SMT201465. As the intensity imagery shows, the breaklines delivered to USGS correctly capture the water bodies in the area that are 2 acres or greater.

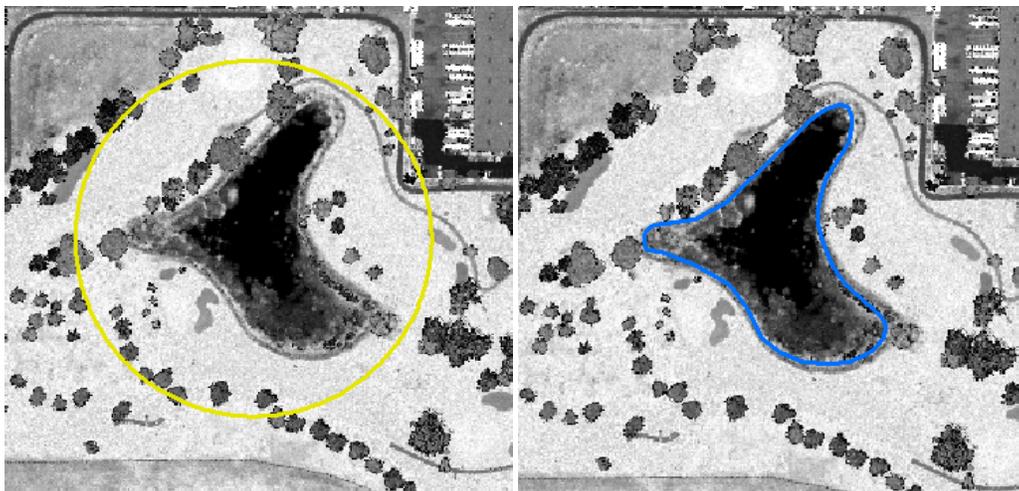
Figure 22 - Tile 11SMT036390. The intensity image showing the collected breaklines from the first delivery is on the left. The modified breaklines from this delivery are shown in the intensity image on the right. Dewberry added one pond to the delivered breaklines. The LAS and DEMs have been corrected to reflect the addition of these features.
