FINAL REPORT OF SPECIFIC PURPOSE LIDAR SURVEY

LiDAR, Breaklines and Contours for Taylor County, Florida

State of Florida
Division of Emergency Management
Contract 07-HS-34-14-00-22-469
Task Order 20070525-492718a
PDS Task Order B

October 30, 2009

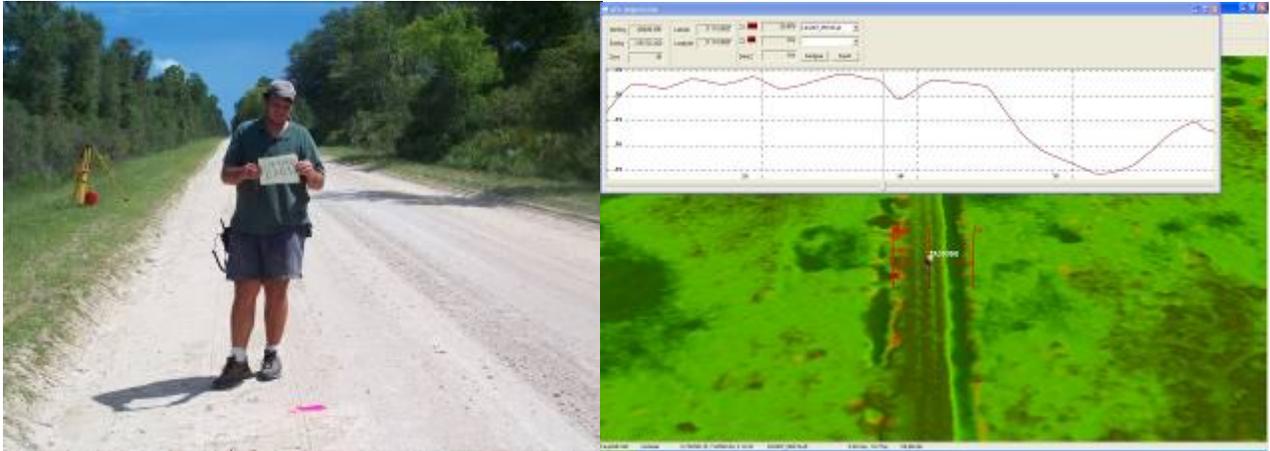
Figure 15 — Checkpoint TA009M6, Uneven Terrain, Not Used

The points in Figures 11 - 16, which were classified as CAT 1, were located on dirt/sand roads and did not meet the location specification for bare-earth and low grass – these points were not used in the vertical accuracy assessment:

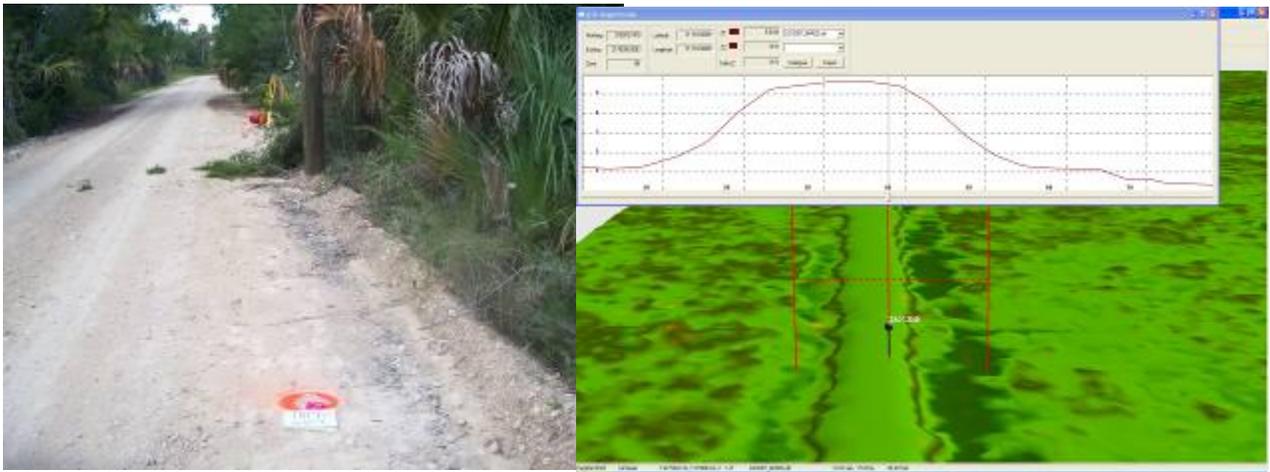
Figure 16 — Checkpoint TA013M5, Uneven Terrain and Trees on Either Edge of Road, Not Used

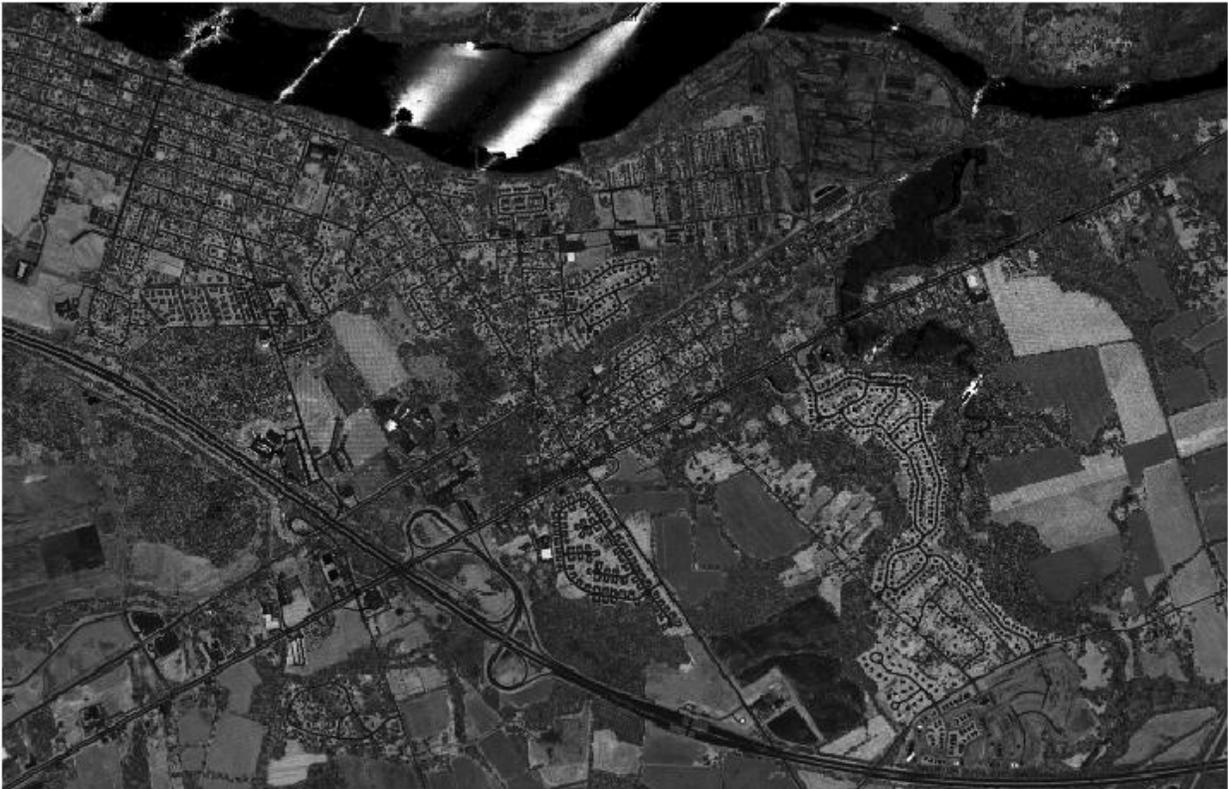
Figure 11 is an example of a LiDAR intensity image, showing streaks over rivers and areas of standing water; such intensity streaks exist in LiDAR datasets nationwide. QA reviews identified the presence of anomalous LiDAR intensity values within the coastal regions of Taylor. The PDS team has reviewed the issue and while it was determined that the anomalies do not cause any of the datasets to fall short of the specifications of the project nor do they affect the overall integrity of the data, these anomalies have been corrected in the LAS data. This report documents the root cause, the geographic extent of the anomalies for this county, the geographic extent of areas exceeding the vertical specification of the contract expressed as % of the total county area, and modifications performed on the dataset to correct these anomalies.

Figure 11. LiDAR intensity streaks over water and marshy areas

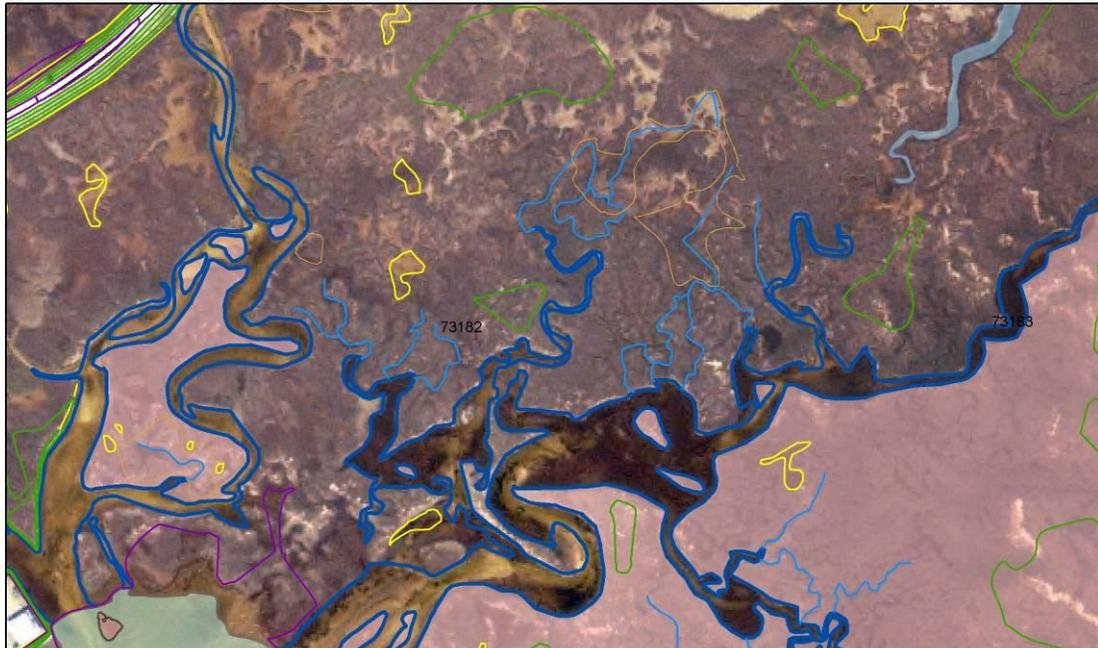
Linear hydrographic features are correctly captured as three-dimensional breaklines – single line features if the average width is 8 feet or less and dual line features if the average width is greater than 8 feet. Each vertex maintains vertical integrity. Figure 2 shows example breaklines and contours of linear hydrographic features.

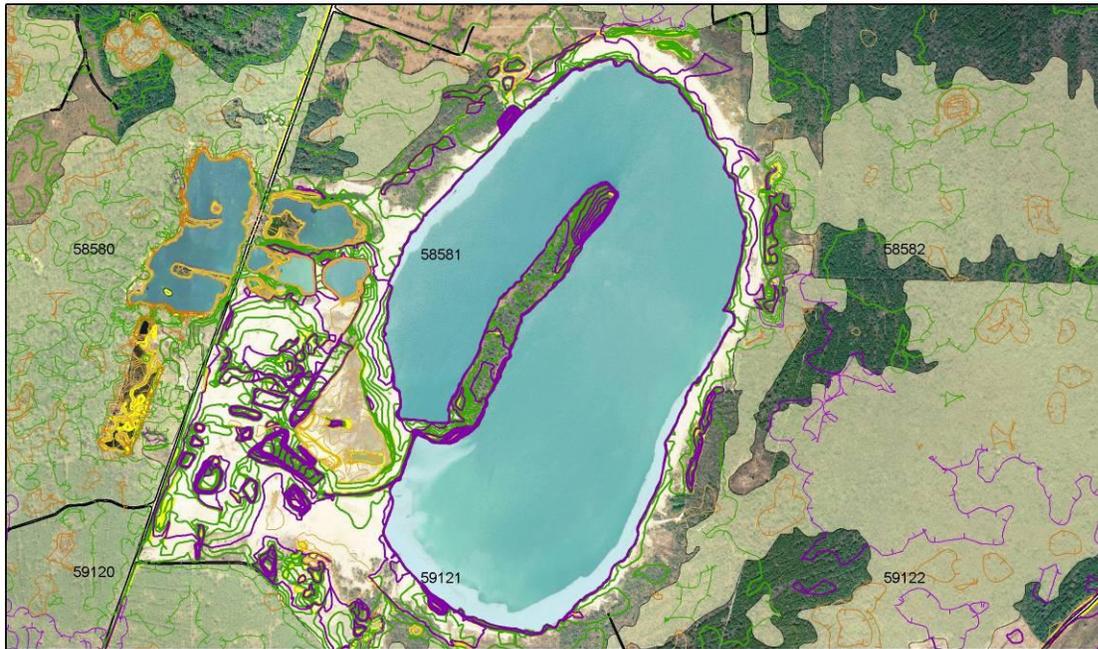
Closed water body features with an area of one-half acre or greater are correctly captured as two-dimensional closed polygons with a constant elevation that reflects the best estimate of the water elevation at the time of data capture. “Donuts” exist where there are islands within a closed water body feature. Figure 3 shows example breaklines and contours of closed water body features.

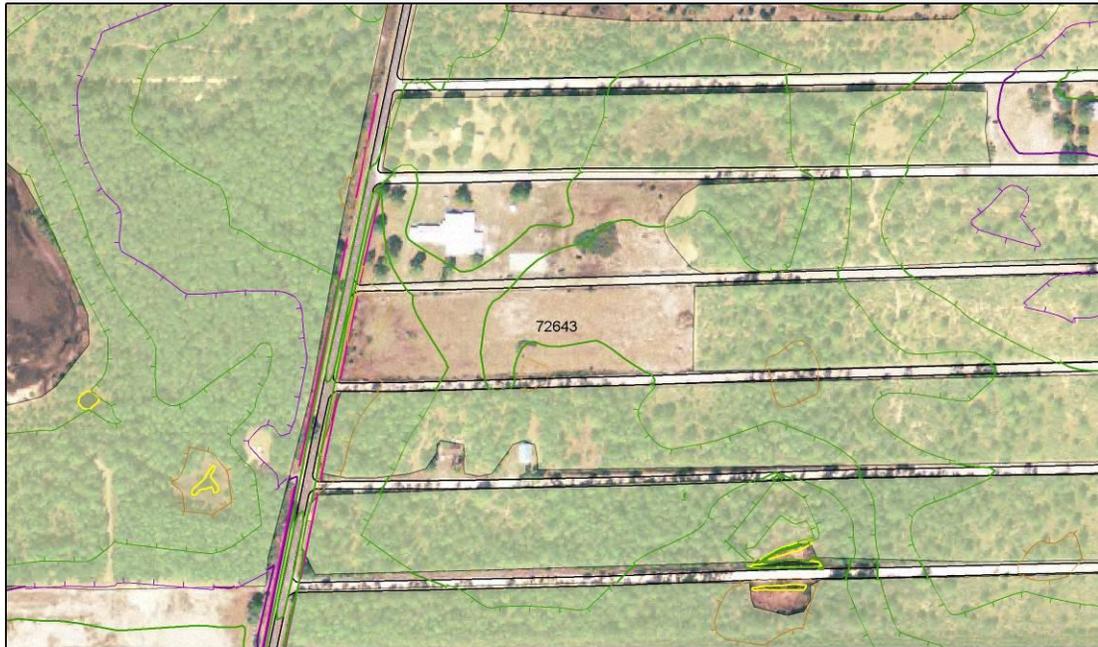
Road edge of pavement features are correctly captured as three-dimensional breaklines on both sides of paved roads. Box culverts are continued as edge of pavement unless a clear guardrail system is in place; in that case, culverts are captured as a bridge or overpass feature. Each vertex maintains vertical integrity. Figure 4 shows example breaklines and contours of road features.

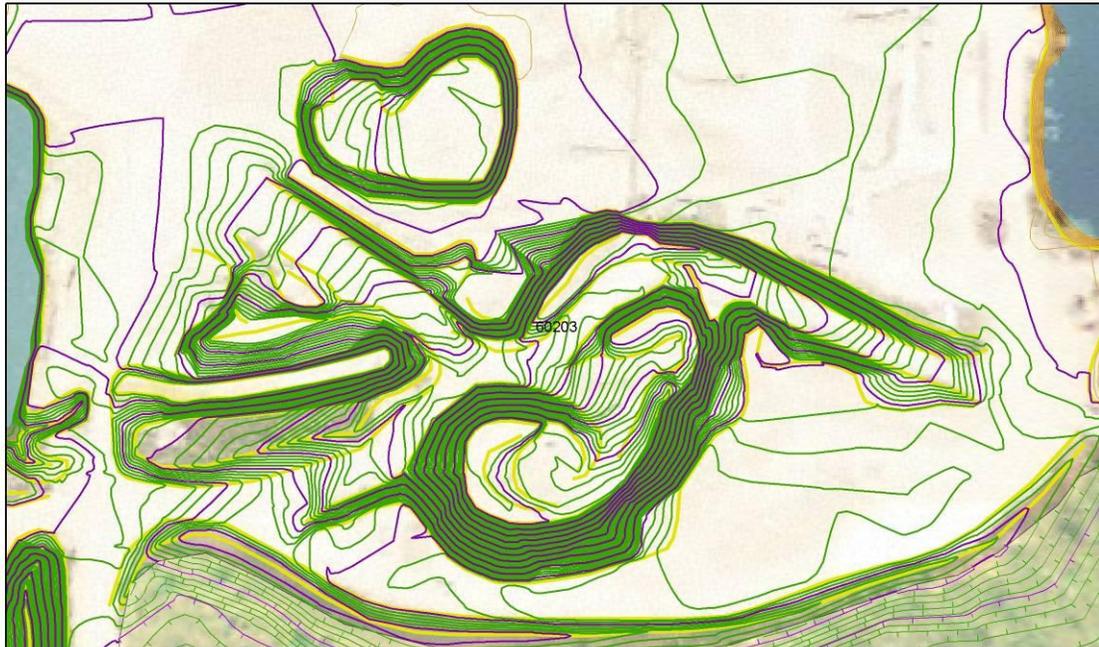
Figure 6. Example soft feature breaklines and contours from tile #60203

Soft features such as ridges, valleys, top of banks, etc. are correctly captured as three-dimensional breaklines so as to support better hydrological modeling of the LiDAR data and contours. Each vertex maintains vertical integrity. Figure 6 shows example breaklines and contours of soft features.

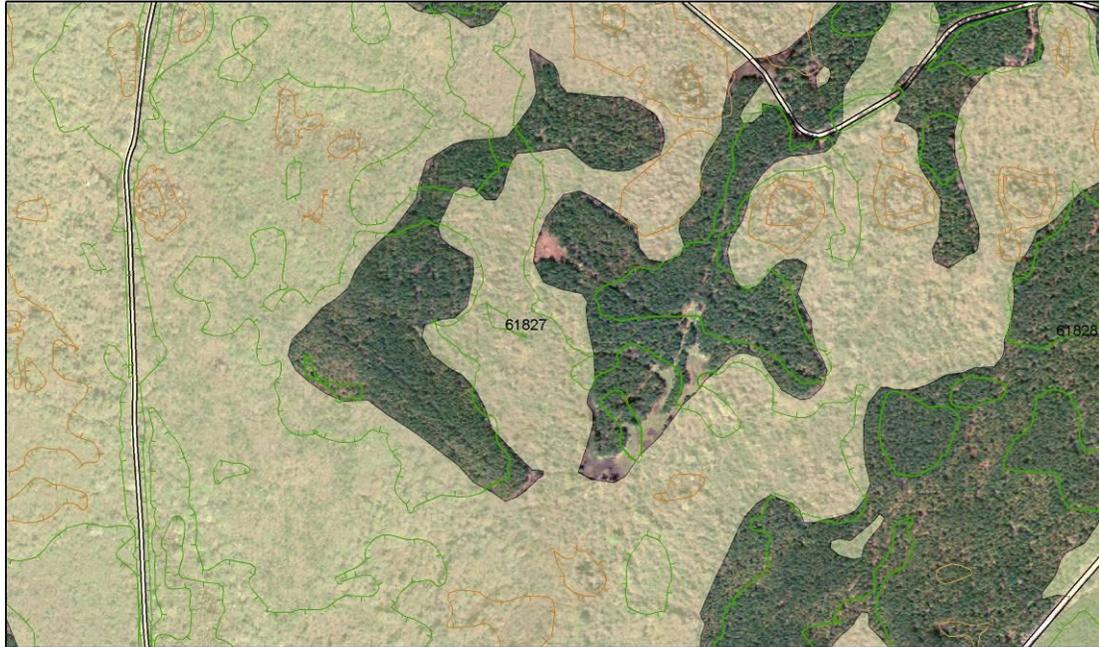
Figure 8. Example low confidence area feature breaklines and contours from tile #61827

The apparent boundary of vegetated areas (1/2 acre or larger) that are considered obscured to the extent that adequate vertical data cannot be clearly determined to accurately define the DTM are correctly captured as two-dimensional features with no z-values. Figure 8 shows example breaklines and contours for low confidence areas.
