Lidar Quality Assurance and Quality Control Report for Jasper County, South Carolina

**Vertical Accuracy Assessment Report:
Lidar Data for Jasper County, South Carolina**

National Oceanic and Atmospheric Administration (NOAA)
Coastal Services Center

November 2007

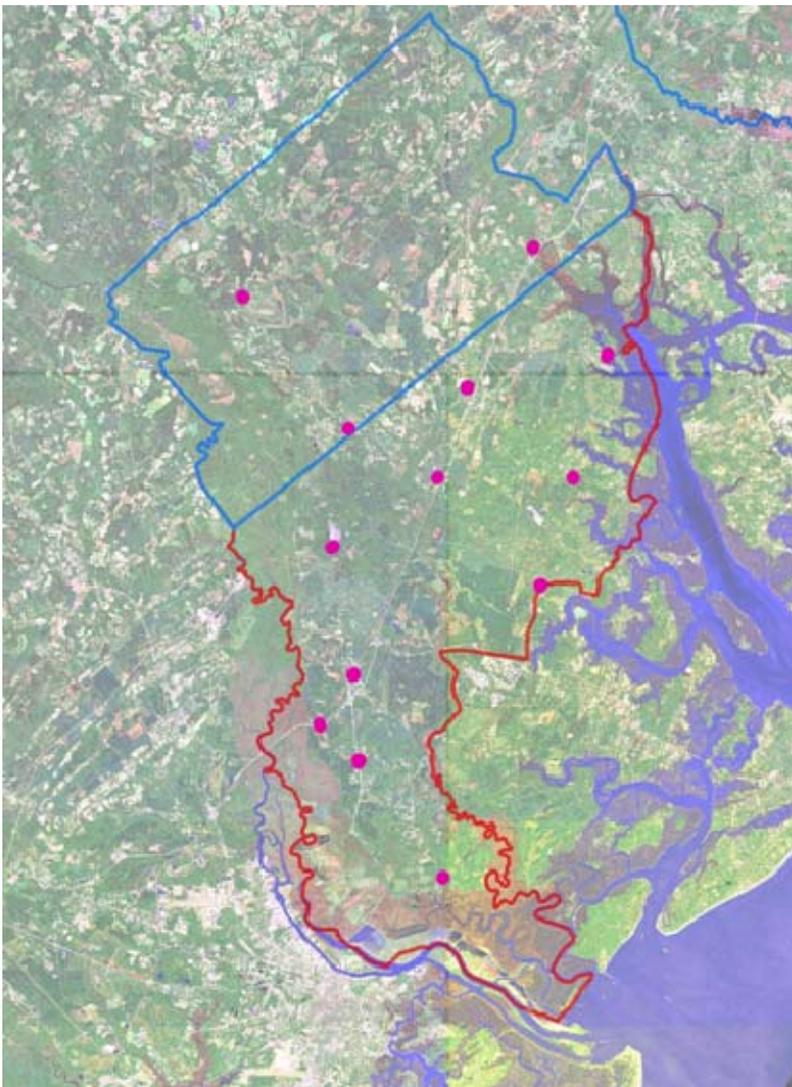
Figure 1. Location of Sample Sites in Jasper County

There were 13 “test sites” where points representing the target land covers were collected (Figure 1). The surveyed points were grouped in one of five different land cover categories, and photographs of each point were taken to provide information on its specific land cover aspects. The five land cover categories are 1) bare earth, 2) urban, 3) forest, 4) scrub/shrub, and 5) weeds and crops. These groups were used to compute errors across the spectrum of different land covers.

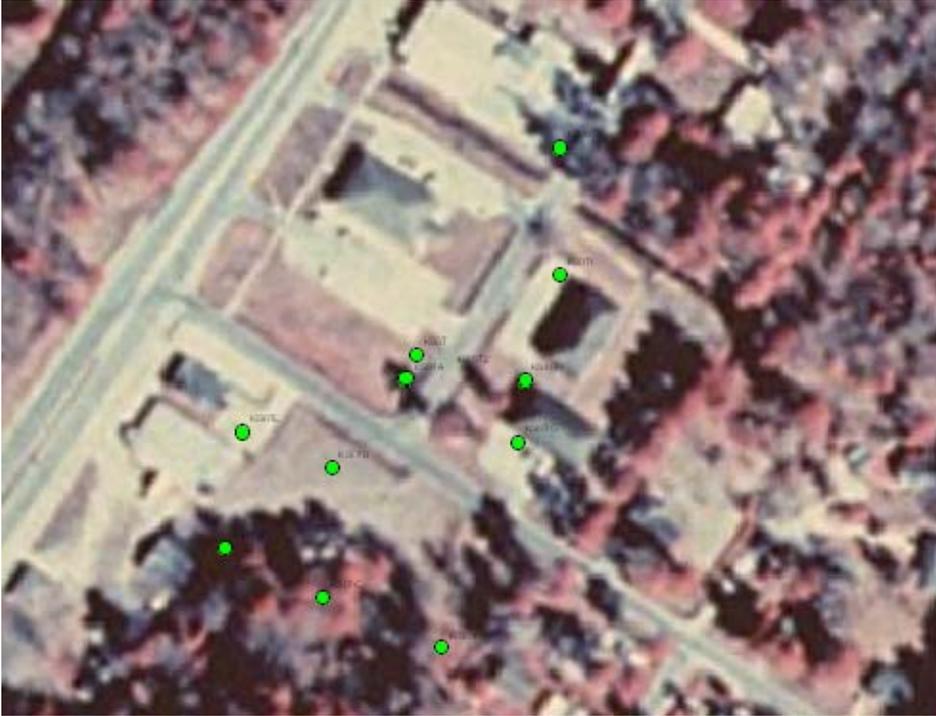
Figure 2. Example of Point Collection at a Test Site

The five different land cover types did not always occur within each test site, and at some sites more than one point per land cover type was collected (Figure 2). The point collection included the two subcollection areas, Inland Jasper County (Figure 1, blue outline) and Coastal Jasper County (Figure 1, red outline). A total of 130 points were collected, with 42 points in open terrain, 19 points in weeds and crops, 21 points in scrub/shrub, 26 points in forest, and 22 points in built-up or urban land covers.

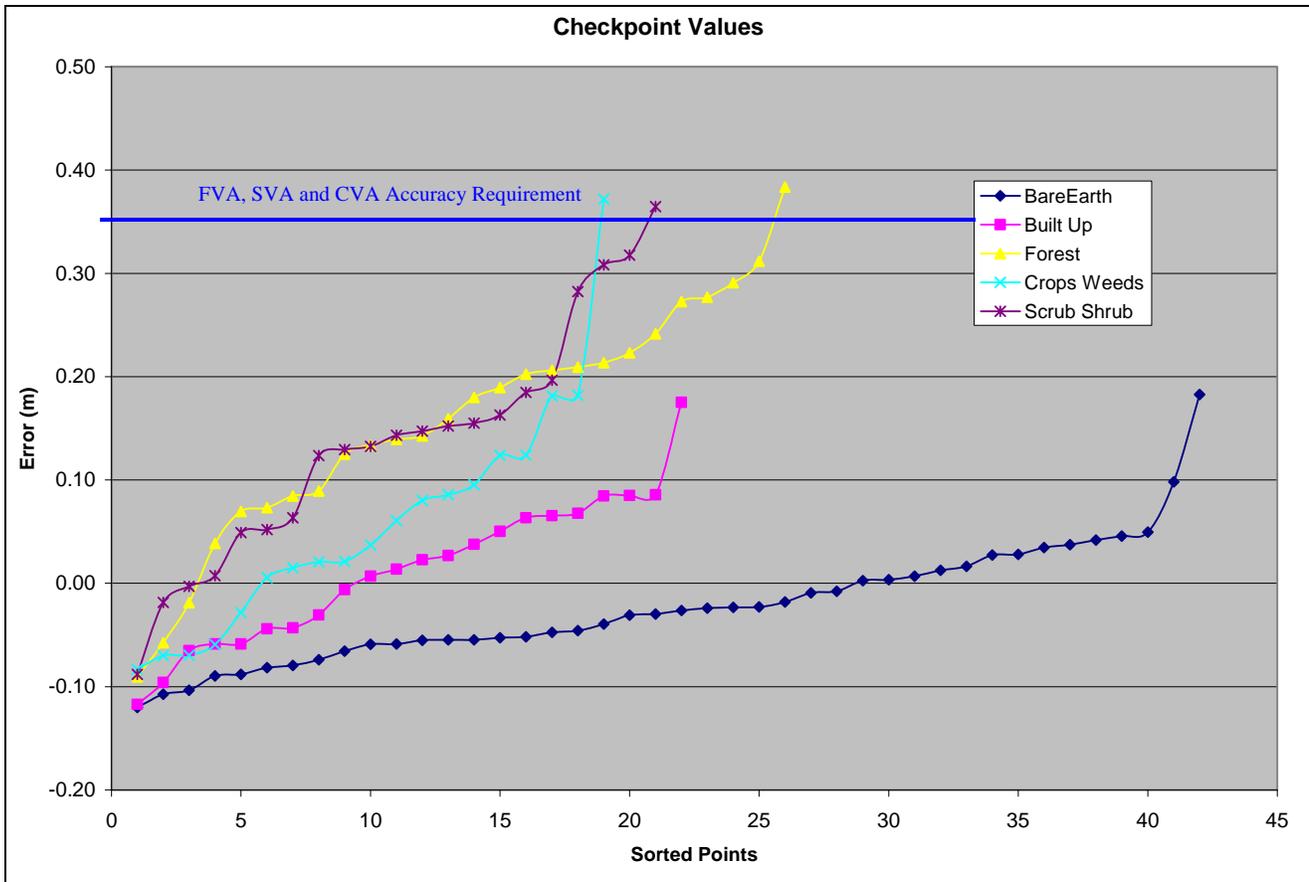
Figure 3. Sorted Check-Point Values

The error values for each land cover type show a fairly normal trend but do contain a few outliers (Figure 3). The overall error is low, which tends to highlight any deviations from the “normal” curve. The mean of the data is slightly above the actual surveyed surface and reflects the presence of incomplete vegetation removal (Table 3; Figure 4). This is a common problem, since taller grasses, branches, weeds, and twigs are difficult to remove fully without decimating the data.

Skewness (an argument for not using the RMSE x 1.96 methods to determine Accuracy_z) is below 0.5 for forest, built-up (urban), and scrub/shrub, and above 1 for open terrain (bare earth) and weeds and crops. The skewness for bare earth and weeds/crop classes appears to be the result of 1 (weeds/crops) or 2 (open terrain) points at the high end of the error distribution (Figure 3).

The data passed the FVA and CVA measures specified in the initial statement of work (SOW) (Table 1, Figure 3). The measured FVA is 12 cm (29.4, NOAA Coastal Services Center specification; 36.3 cm, FEMA specification) and the CVA is 30 cm (36.3 cm, FEMA specification). Only three of the 130 points fell outside of the FEMA 36.3 cm specification (Figure 3).

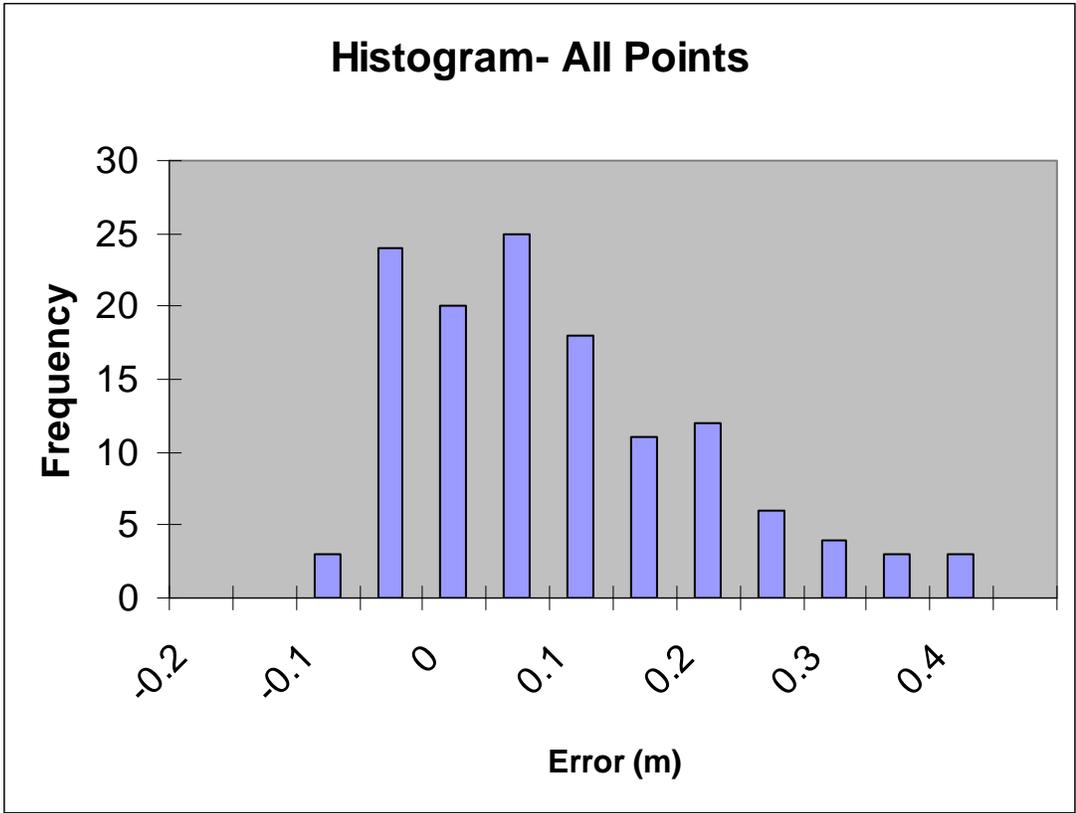
Figure 4. Error Histogram of All Ground Control Points (GCPs)

Given that the largest error within the 130 points was just over the 95% accuracy requirement, it appears that this data set is very consistent throughout the land covers and can be used with confidence in all types of settings. A large fraction of the data is within 10 cm of the surveyed ground elevation (Figure 4).

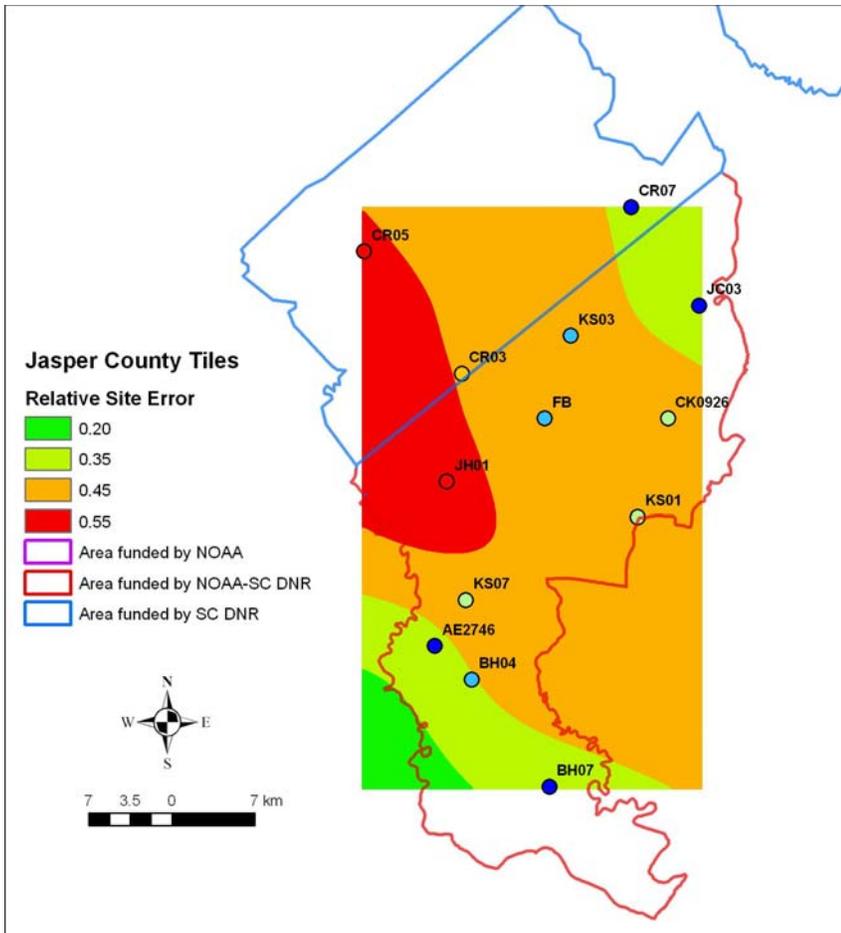
Figure 5. Error Trends in Jasper County

An aspect of remote sensing data collected with GPS is the spatial correlation of the error across the collection area associated with the changing quality of positional information (i.e., changes in PDOP, or positional dilution of precision). To define this variation, the accuracies of each point were normalized (divided) against the $Accuracy_z$ of its associated land cover classification. The mean of the normalized values was then generated for each “test site” to produce a relative site error. The site error was then mapped and a mathematical surface (spline) created to model the variation (Figure 5). It appears that the northwestern portion of the county may have a slight bias towards poorer values, but in most cases, the average is well below the accuracy requirements. In fact, the largest average test site errors are about the same as the RMSE values (approximately 0.5 of the $Accuracy_z$) such that there are no distinct outlier error locations (i.e. all sites had an acceptable level of accuracy).

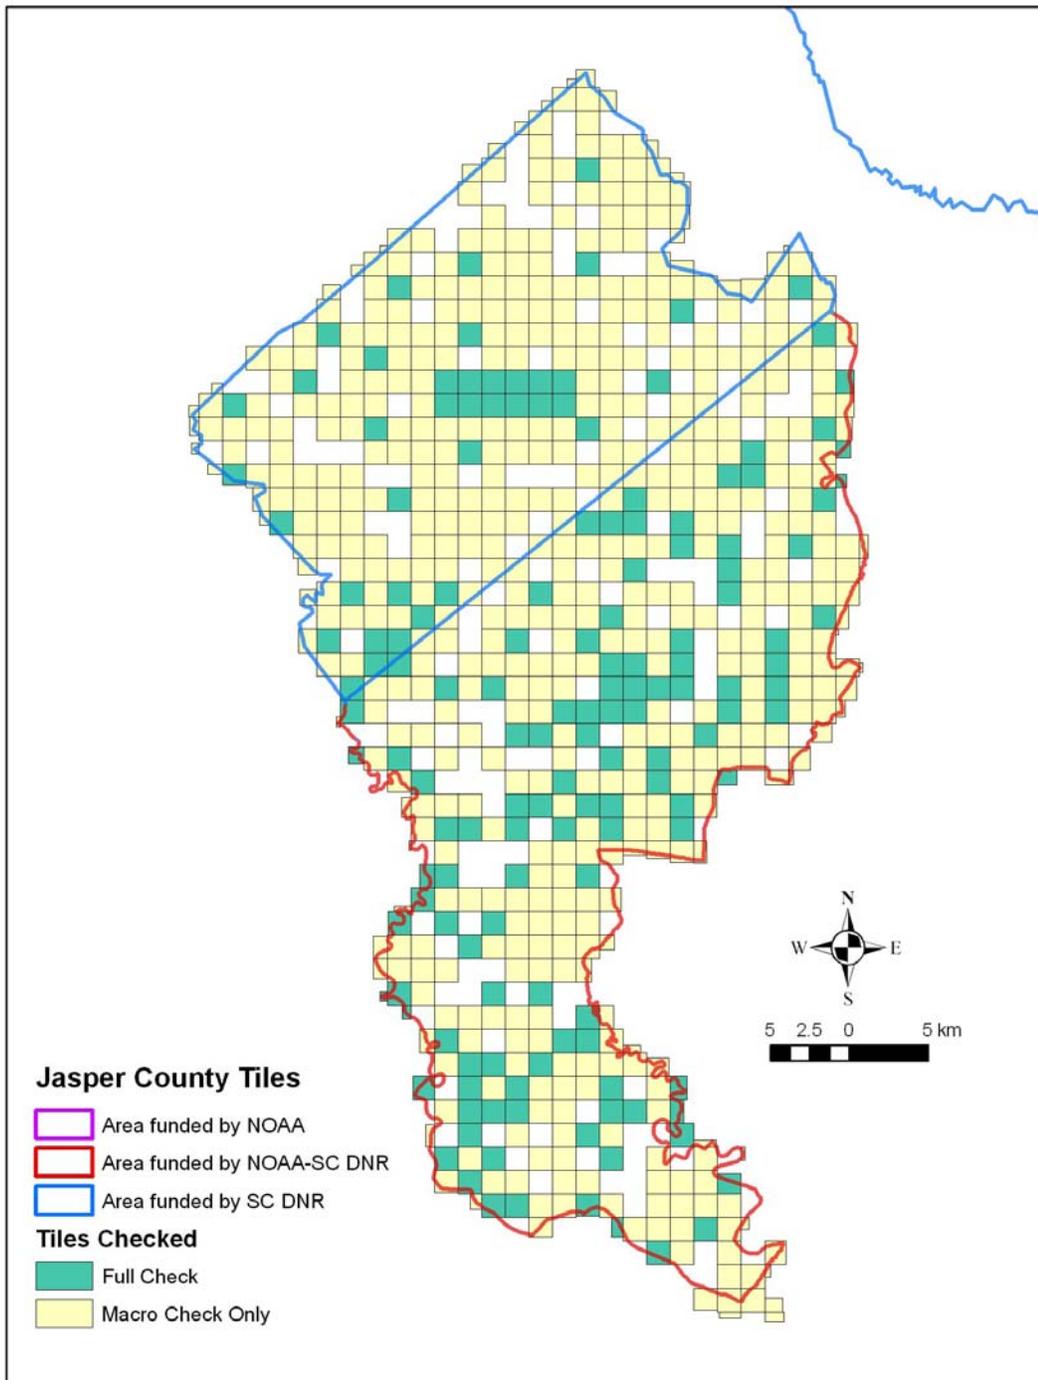
Figure 6. LAS Files in Jasper County Checked, and the Level of Review

The LAS files were checked for macro issues such as existence of data within each file, correct projection, correct file name, classification of data, return information, intensity, and format. This was an integrity check to see that all the files were received and were not corrupted. For this portion of the QA, 80% of the files were checked. The LAS files were then checked for micro problems, which would include checking for point density, flight line match, corn rows or other artifacts, high or low values, feature removal, and point smoothing, among other usability aspects. This level of review was carried out for approximately 25% of the tiles. Taken in total, almost every LAS tile was reviewed at some level (Figure 6).

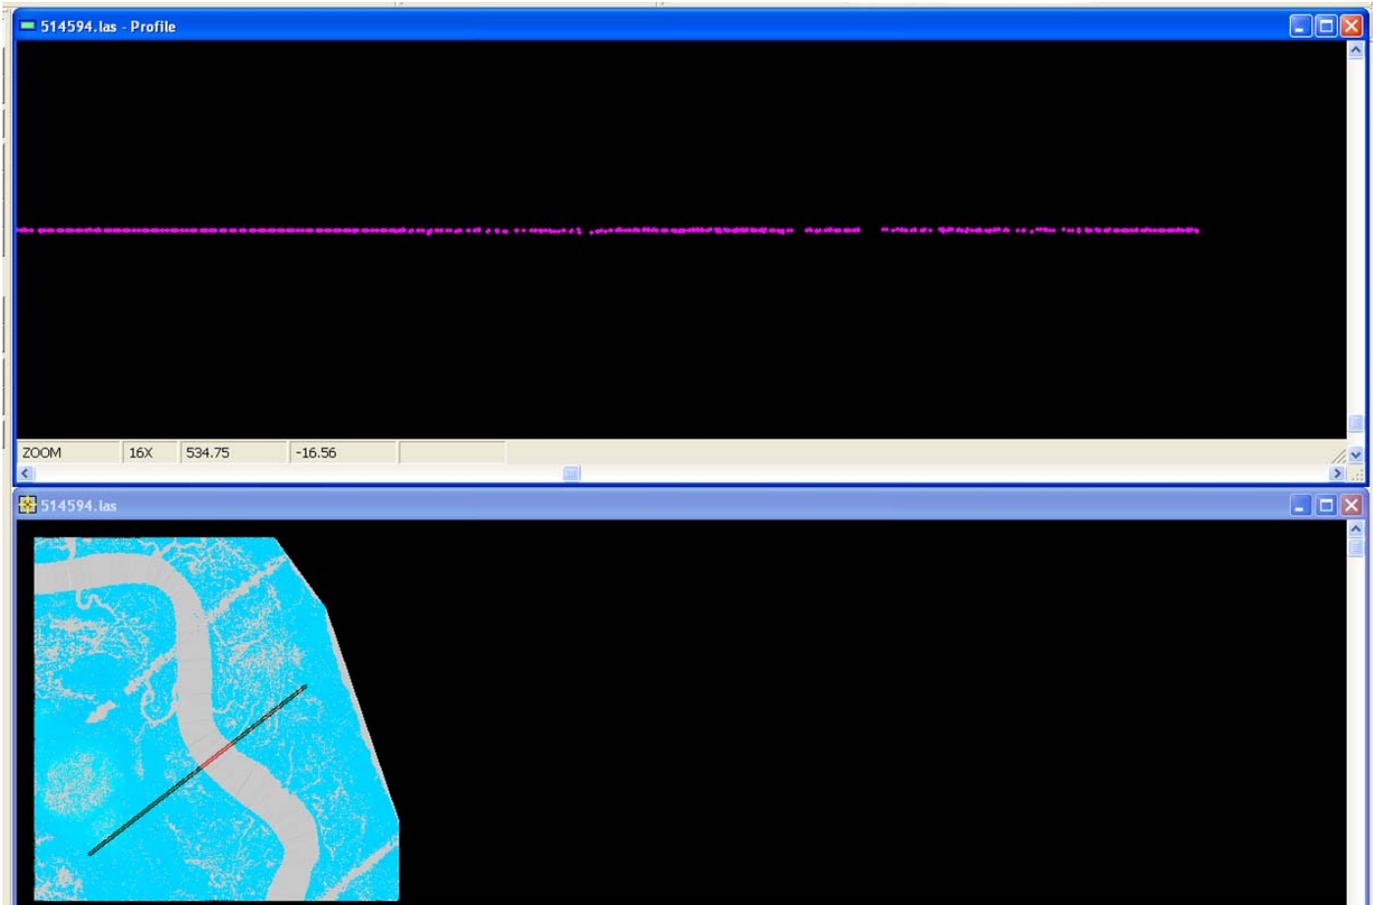
Figure 7. Example of Flat Terrain; Profile Is over 1.0 km

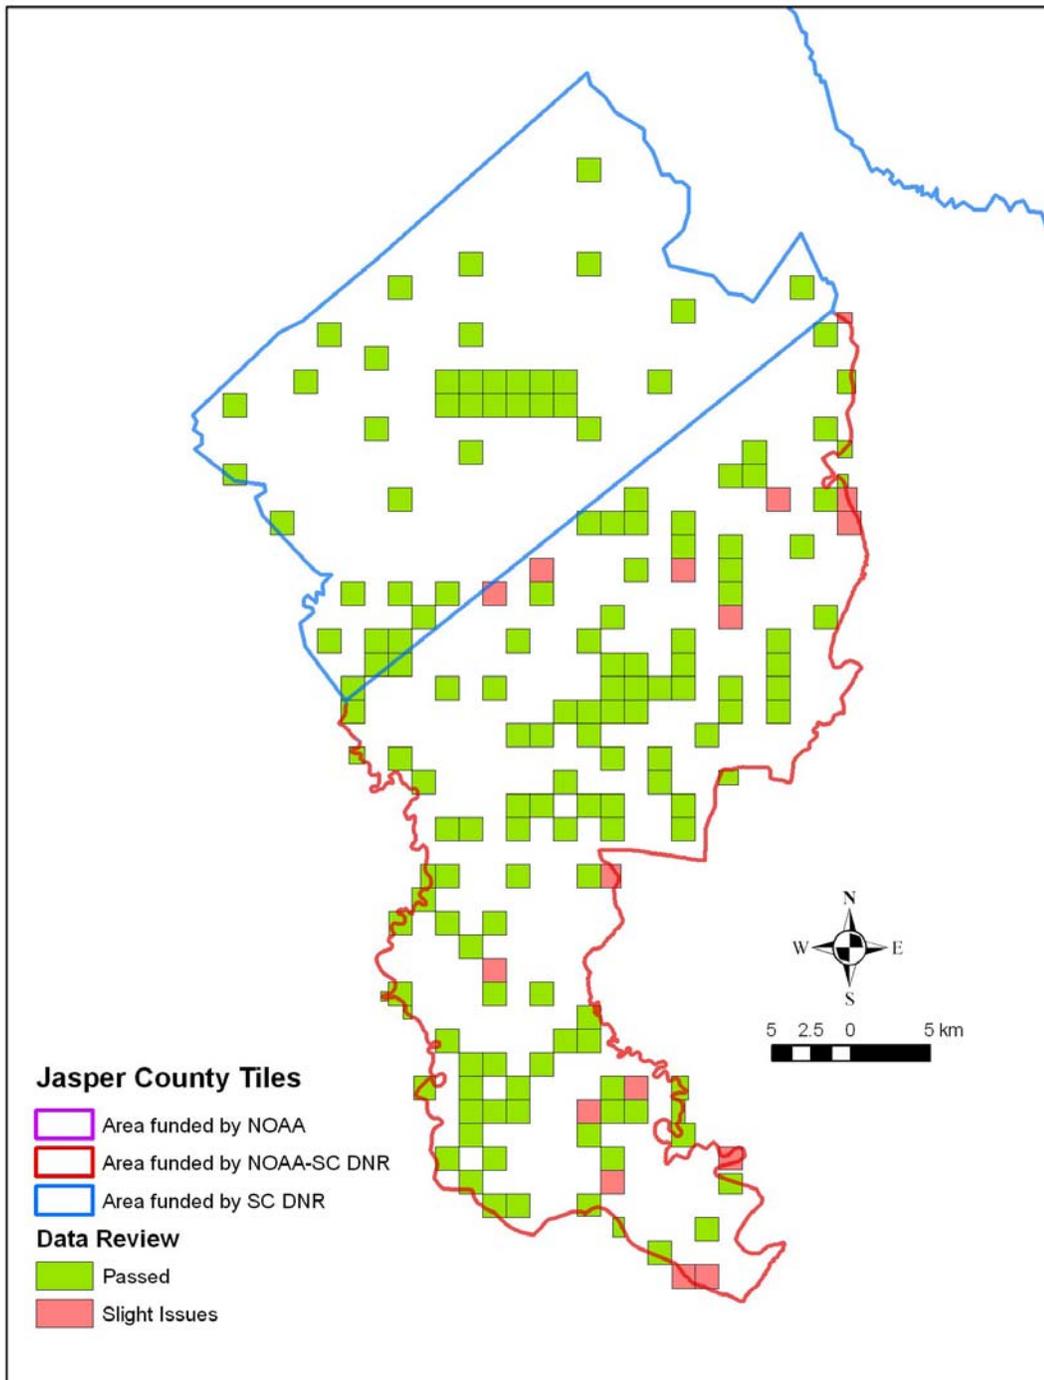
Figure 8. Jasper Tiles Reviewed at Micro Level

In general, the LAS files were very clean of artifacts, and very few qualitative issues were noted. This is consistent with the high quality of the data documented in the accuracy assessment. Some tile-specific issues were noticed, but for the most part these were relatively minor. Of the 200 LAS tiles reviewed in depth, only 16 showed notable issues (Figure 8).

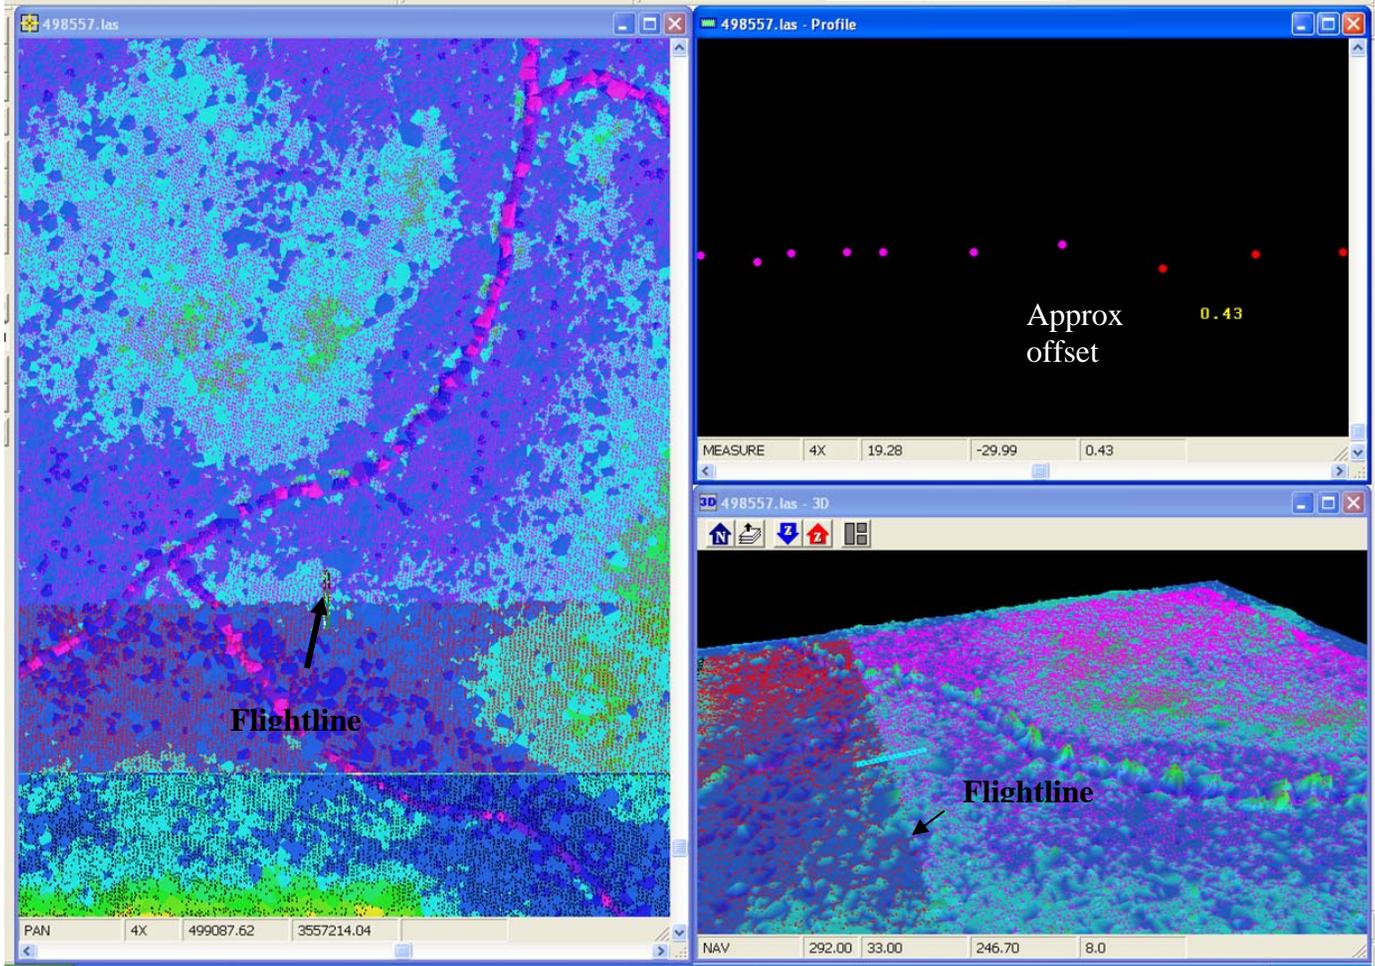
These issues were generally minor, difficult to find, and for the most part related to flight line matches. The terrain is exceedingly flat in most of the county, so very small offsets become visible. The offsets noted were typically less than 20 cm, which is well within the accuracy specifications of the data. There were, however, some tiles with flight line mismatches greater than 20 cm (Figure 9). Flight line mismatches were much less noticeable in tiles where the overlap points were kept; in some tiles, or sections of tiles, the overlap points were removed and this 1) appeared to increase the appearance of flight line mismatches or 2) may have been required because there was some slight flight line mismatches. Flight line mismatches were addressed by Photo Science to the satisfaction of the NOAA Coastal Services Center QA team.

Given the very flat terrain, slight flight line mismatches may be important for modeling water flow. Mismatches below about 10 cm were difficult to see in the data, but above that, they started to become noticeable. Previous QA reports from Florida counties (Northwest Florida Water Management District) suggested that 20 to 30 cm was about the cutoff between acceptable and unacceptable. For the terrain in Jasper County, the cutoff may be a bit lower; 15 cm seems to be about where the difference can be discerned as changes in terrain contours. Only a few tiles had flight line mismatches above this threshold to begin and all were corrected.

Figure 9. Example of Flight Line Mismatch and Approximate Offset of about 40 cm

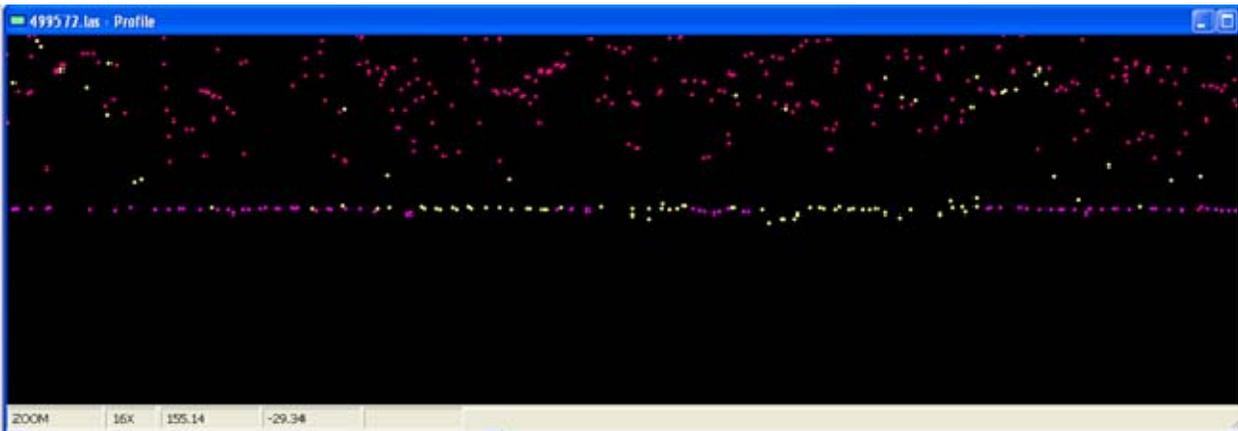
Figure 10. Overaggressive Point Removal. The yellow points are unclassified points that appear to be bare earth. Removal of the points from the data reduces the effective point density and, thus, the accuracy of the terrain model. The cases where this occurred were reviewed and classifications modified if they were judged to reduce the surface accuracy.

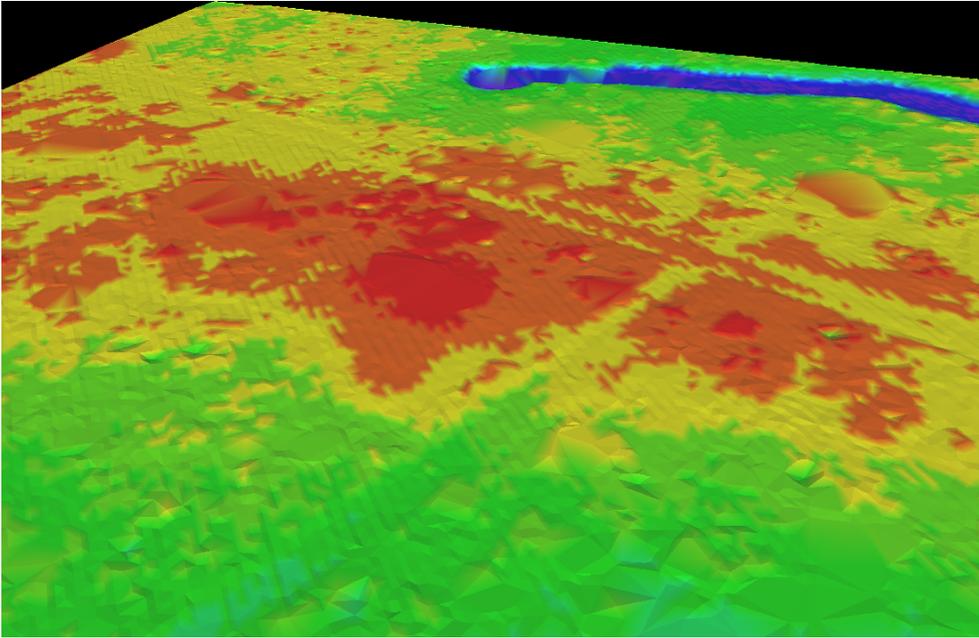
Figure 11. Corn Rows (about 6 to 9 cm) Remain in Data Set

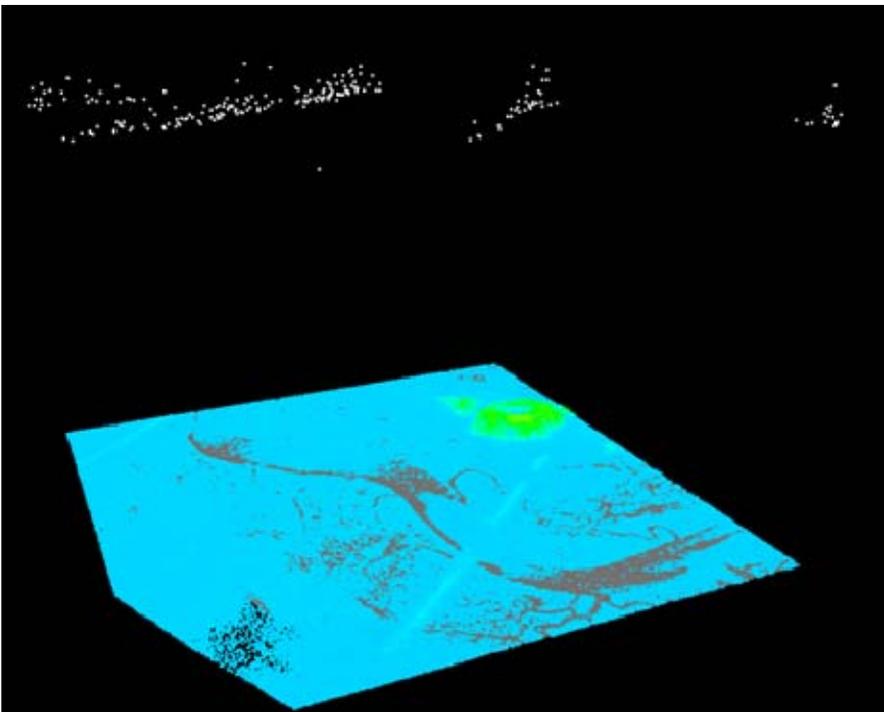
Figure 12. Potential Birds or Clouds about 1500 Meters above the Ground Surface. This issue was noticed in several tiles along the rivers in Jasper County. This is not a problem for most applications, since the points are unclassified, but they should be removed for creation of a digital surface model (e.g., tops of trees, houses).

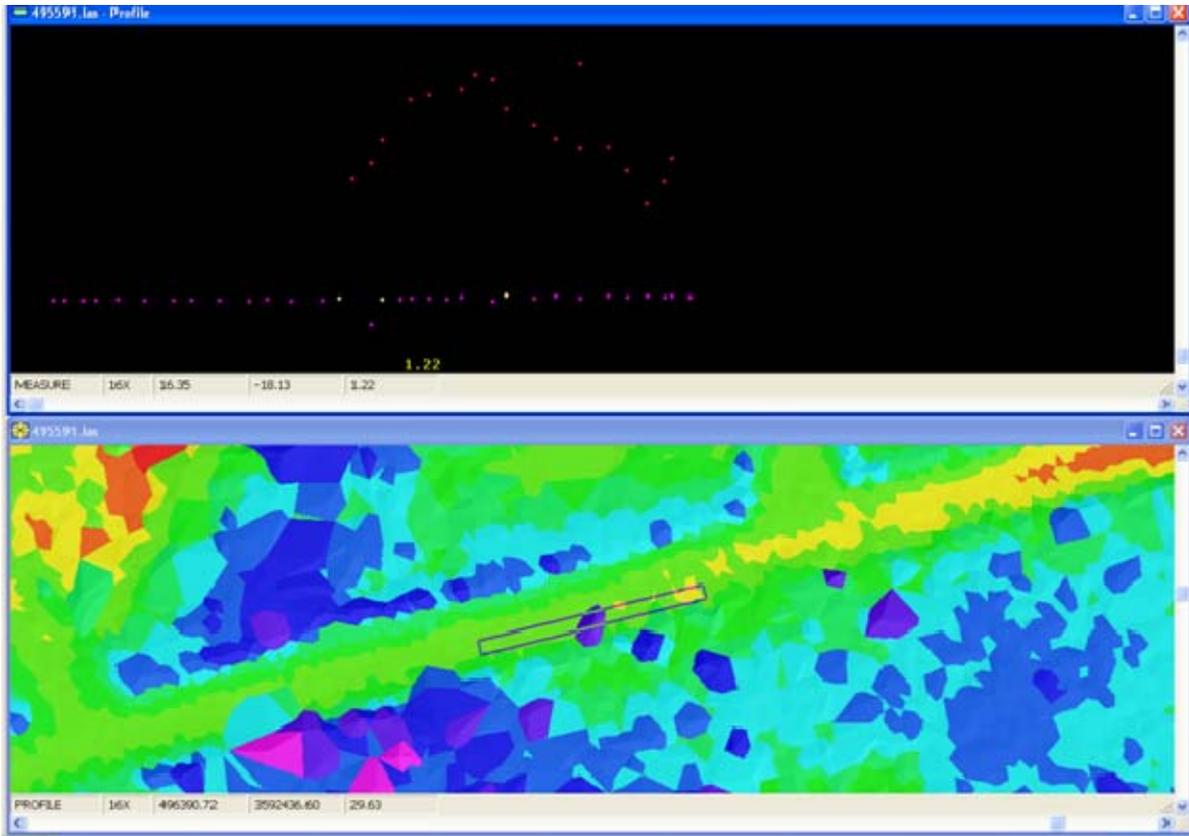
Figure 13. Slight Pit (1.22 meters) on Flat Road with Other Pits Appearing to the East (right). This is typically caused by one low point that appears to affect the adjacent points (i.e., the two adjacent yellow points in the profile defined as unclassified are likely actually falling on the ground surface). These can be difficult to remove without highly manual processing.

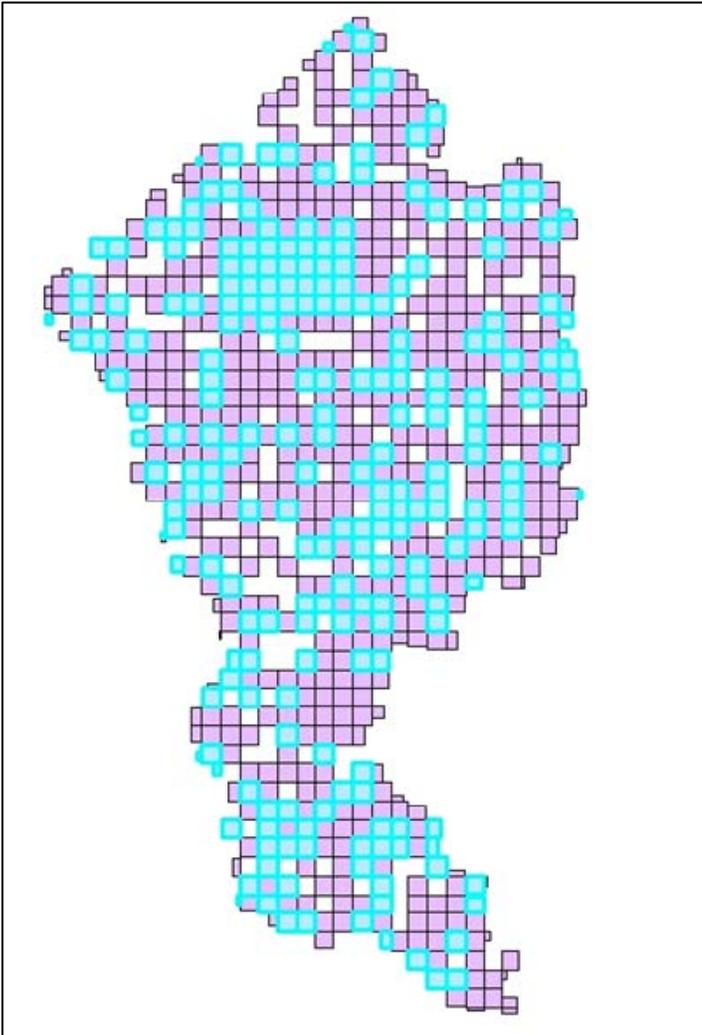
The QA procedure for the Jasper County, South Carolina, lidar determined that, overall, the DEM data were very good. The tiles chosen for review were randomly selected and represent approximately 30% of all tiles (Figure 14). If issues with a tile were discovered, the adjacent tiles were also examined. The DEM data are expected to be a highly used product and include both the lidar and break line information. Some minor issues with the DEMs were found, and they were submitted to Photo Science for review. Photo Science corrected, to the satisfaction of the QA team, the issues raised during the review.

Figure 14. DEMs Reviewed (highlighted in blue)

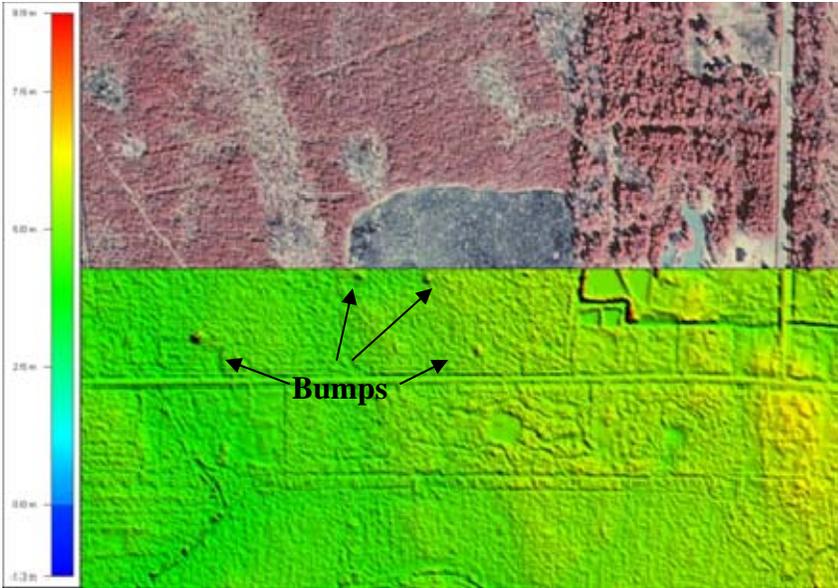
Figure 15. Slight Bumps in Flat Terrain That May Be Hay Bales or Other Non-Ground Features

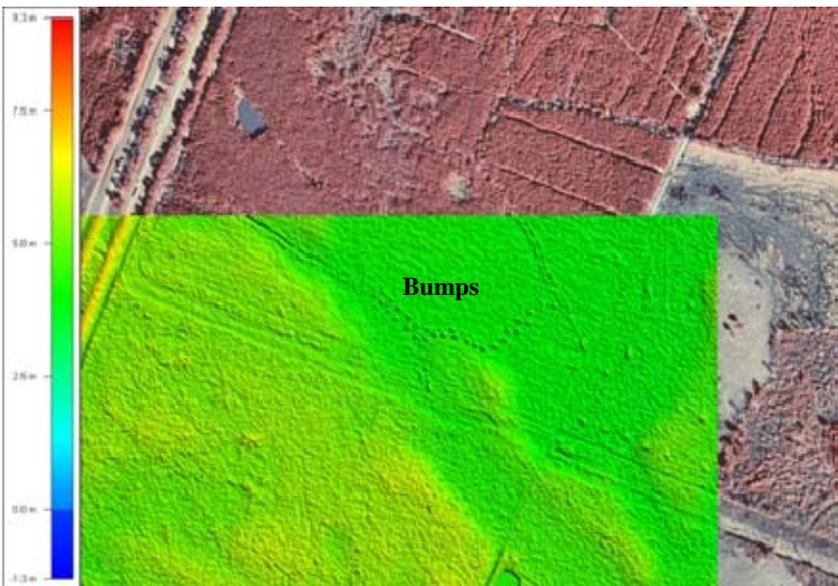
Figure 16. Unknown Features along Road

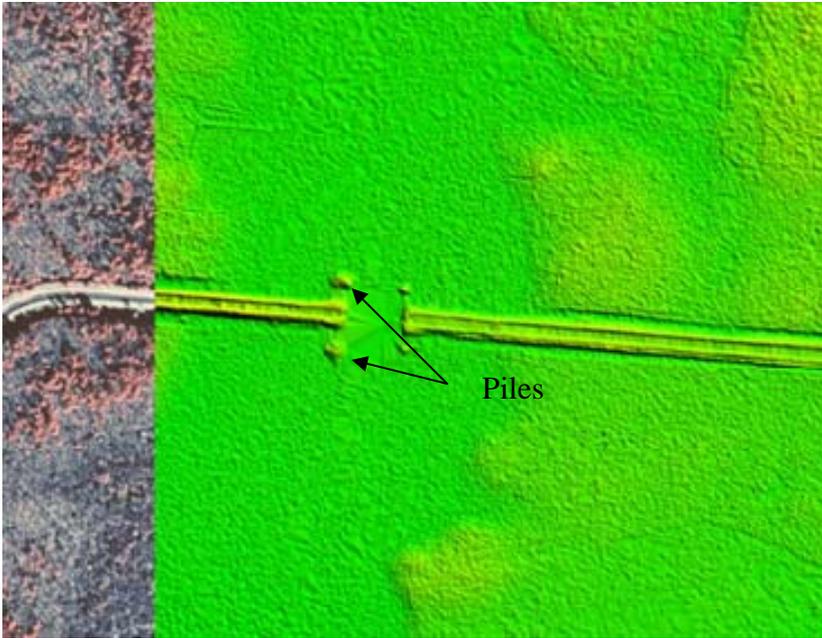
The biggest problem is with the five sets of inland tiles (Figure 17); they were redone by Photo Science. The other tiles were checked, but the issues were mainly small, localized artifacts, and the professional opinion indeed determined the artifacts to be ground features. The following figures are examples of the minor issues that were found. Given that about 200 tiles were checked, the list is small, which highlights the overall quality of the data set. All the issues have been addressed to the satisfaction of the QA team. The DEMs have been accepted as a very good data set.

Figure 17. Piles beside Bridge Not Removed?

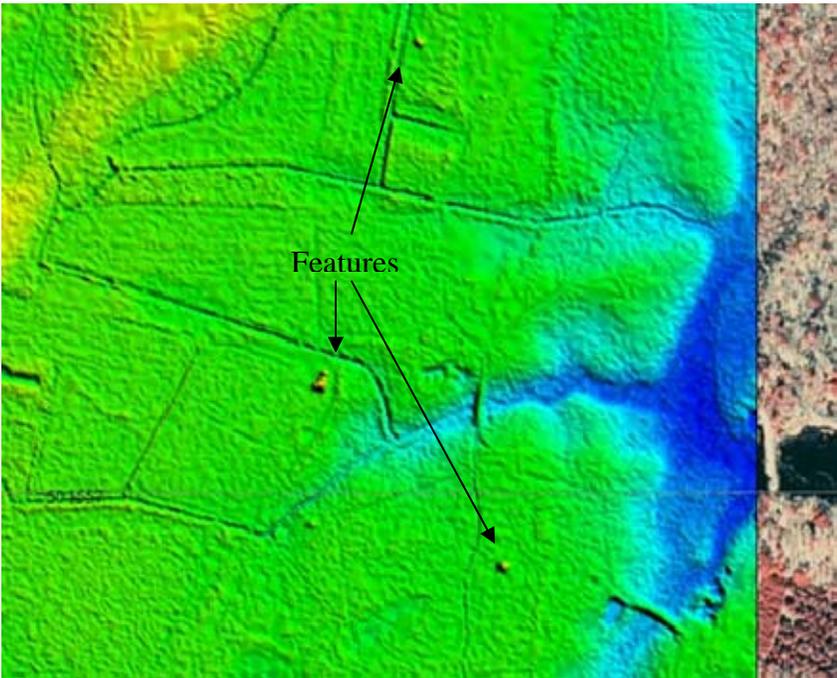
Figure 18. Incomplete Removal of Small Features Possible

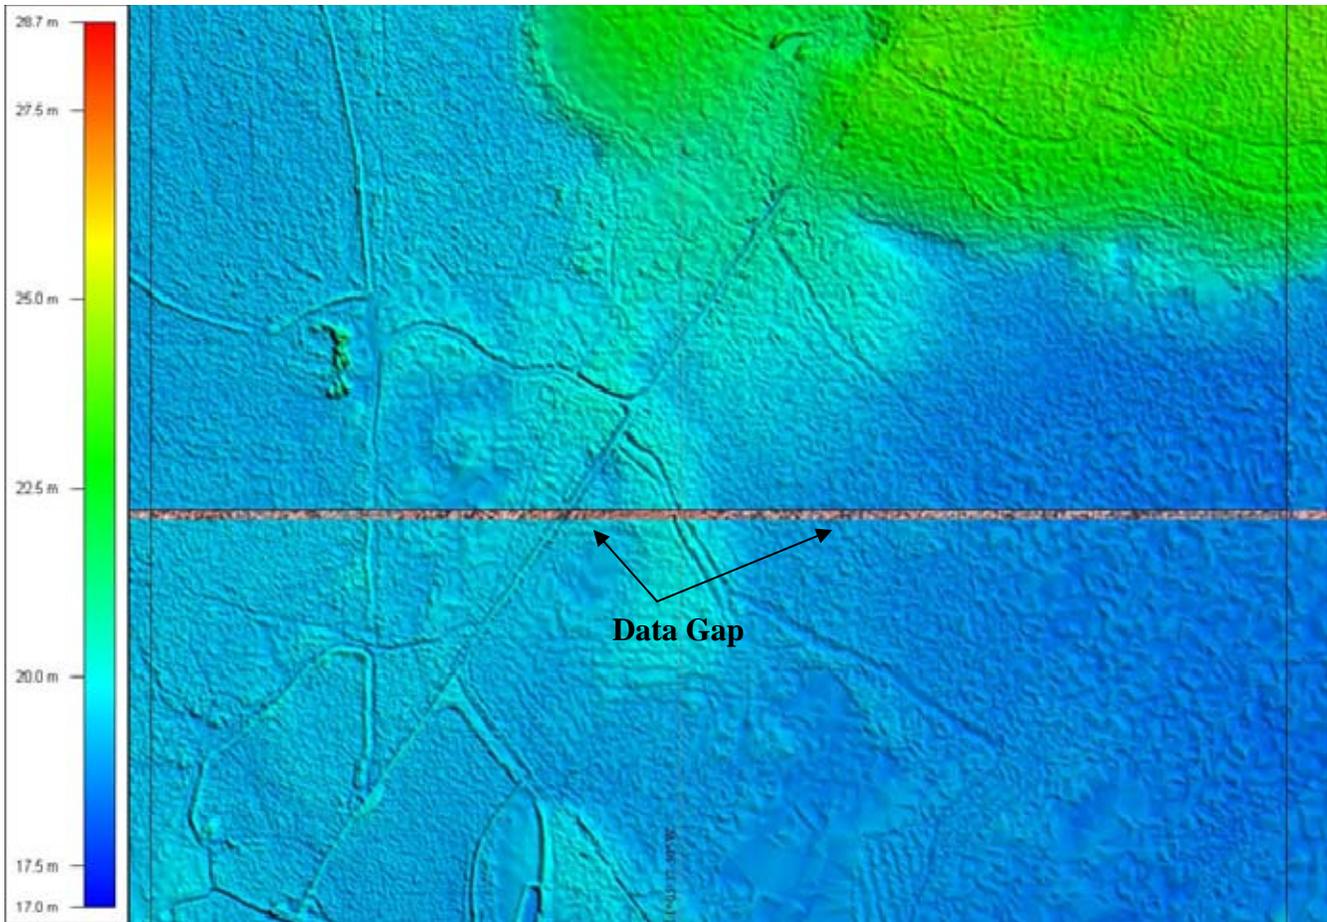
Figure 19. Example of the Gaps in Data between Several Tiles. This issue was corrected by Photo Science.

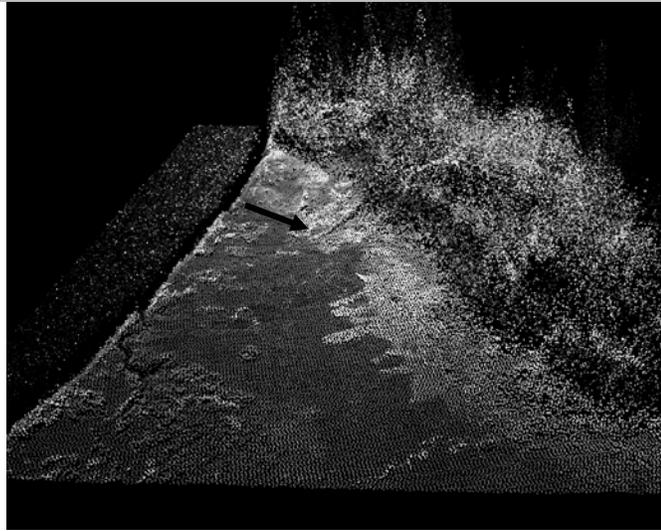
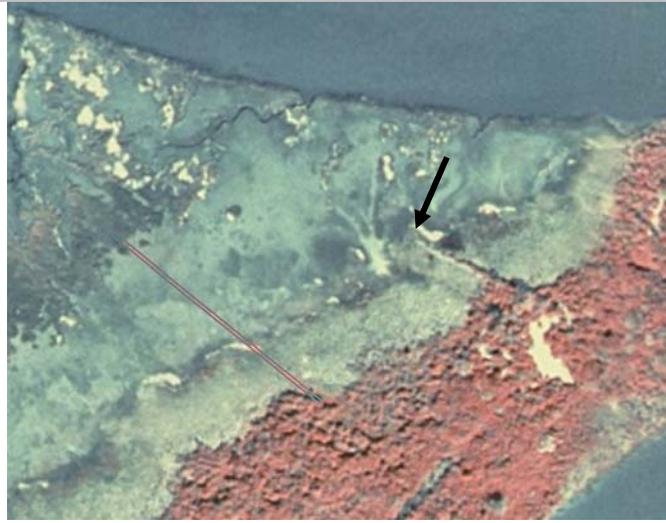
Figure 20. Coastal Area Examined for Lidar Use

An example using these aspects of coastal habitats is presented in Figure 20. In this case, a coastal marsh with mixed habitats (Figure 20, A and B) is shown with the changes in lidar elevation (Figure 20, C). The intensity returns show the variations in vegetation or soil types and highlight the various habitats, along with the aerial image (Figure 20, B). Significantly, the marsh elevation, even when crossing different vegetation and soil types, only changes on the order of 30 cm (1 ft), which is consistent with the terrain. What is not seen are vegetative changes in elevation; that is, there is no discernable (large) change in elevation where different marsh plants and habitats intersect, which is a good indication that the ground surface is being measured and not the height of marsh vegetation.

A. 3D Intensity View of Coastal Marsh Area (arrow pointing to same feature as in B)

B. Aerial Photo of Marsh Area, with Profile (red) in Middle of Image

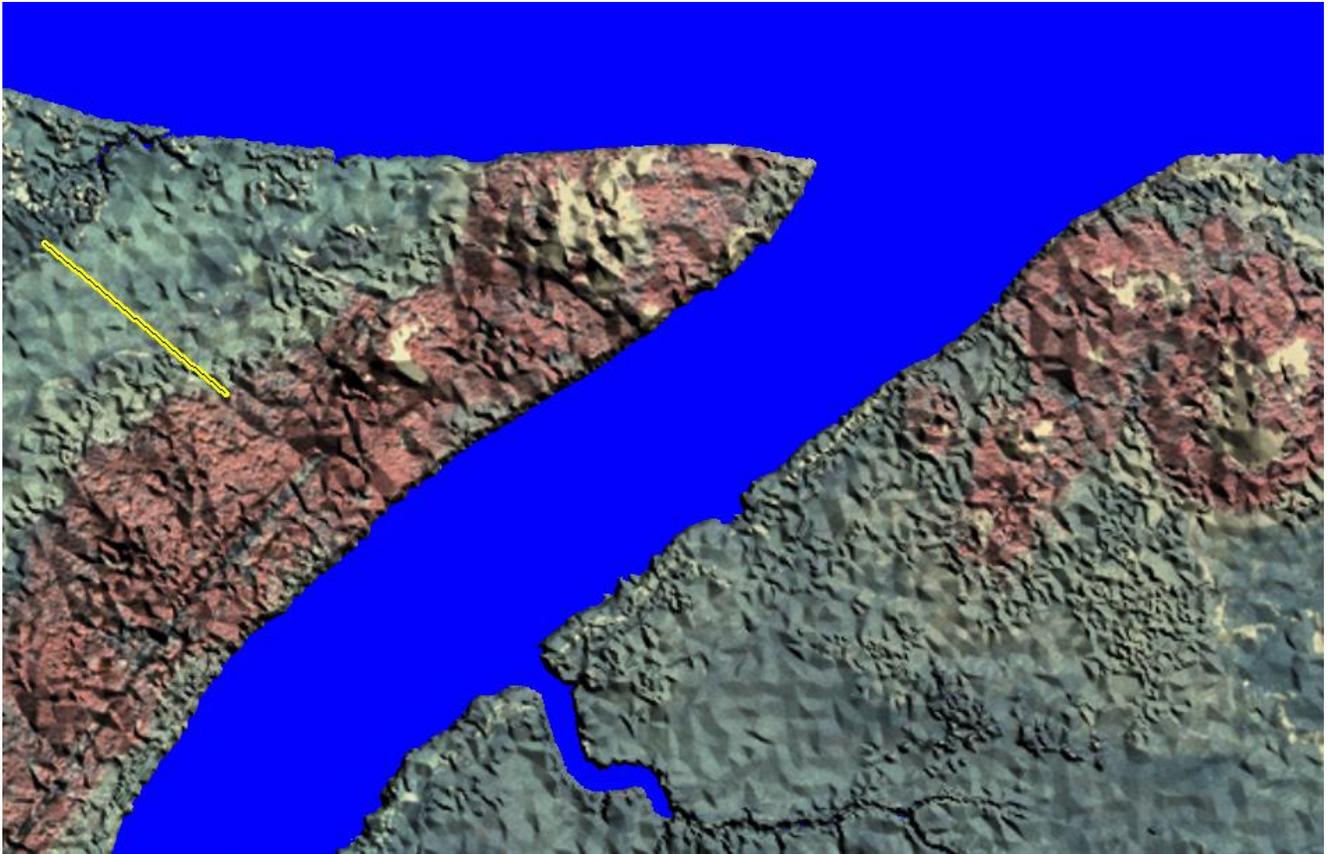
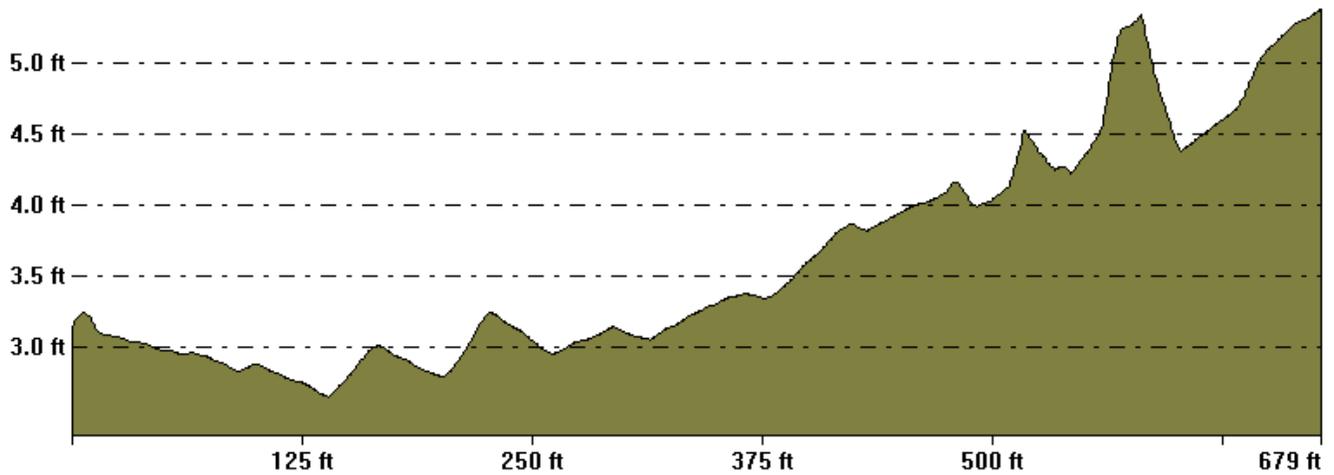
Figure 21. DEM with Image Overlay and Associated Profile in Coastal Area

The DEM of the same area with the aerial image overlaid (Figure 21) highlights the utility and consistency of the data, where only slight changes (1.5 ft) in elevation (across different vegetation) are consistent with the terrain. Also note that the sandy areas (whitish areas along riverbank) appear higher than the surrounding vegetated areas, which is consistent with the terrain and the apparent “side cast” of dredge material.
