Lidar Quality Assurance and Quality Control Report for Jasper County, South Carolina

**Vertical Accuracy Assessment Report:
Lidar Data for Jasper County, South Carolina**

National Oceanic and Atmospheric Administration (NOAA)
Coastal Services Center

November 2007

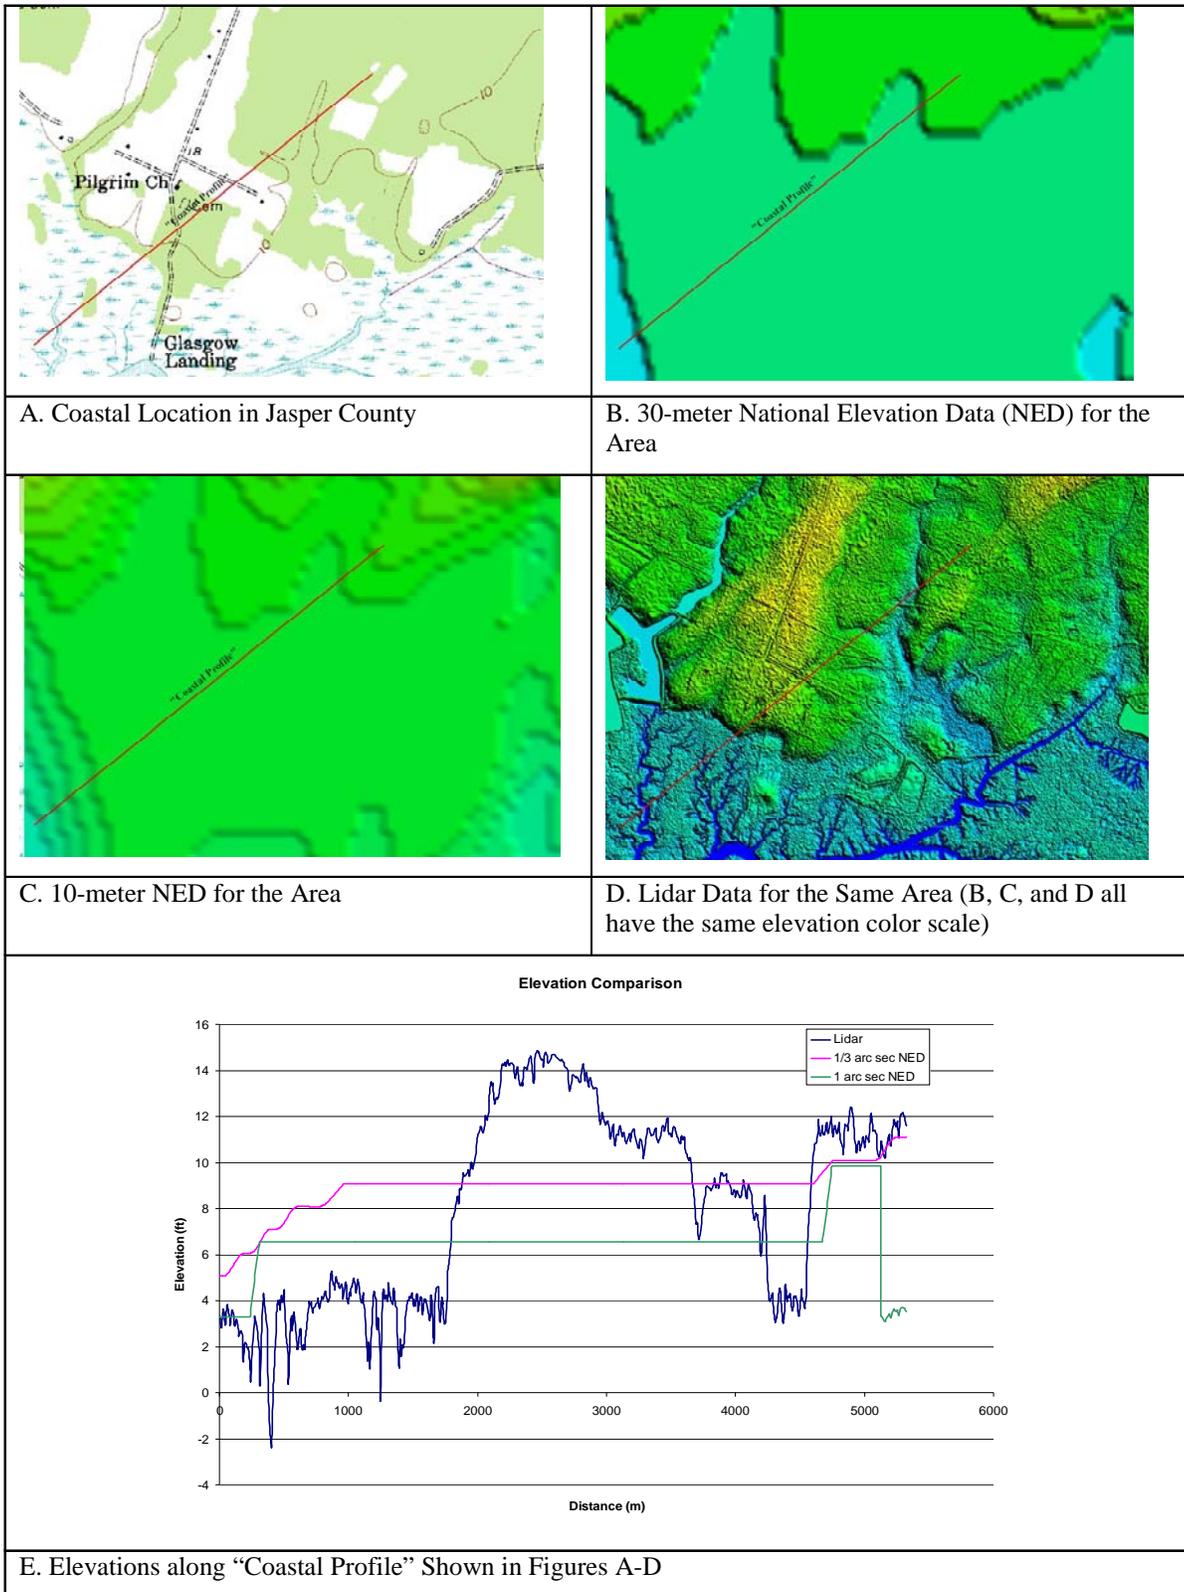
Figure 22. New Lidar Data Compared with Existing Data

The differences between the older data now available and the new Jasper lidar are striking. There is significantly more resolution (Figure 22, B-D) and a dramatic change in values (e.g., most places are one to two meters different than previously denoted).

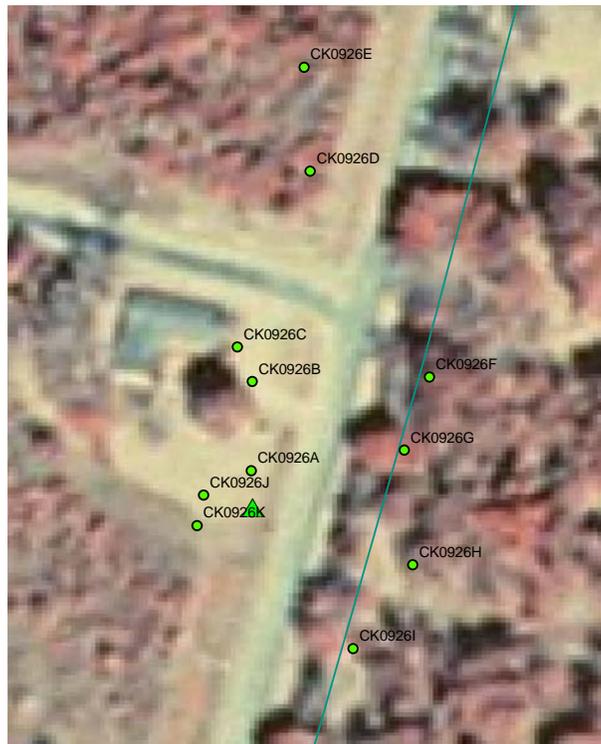
Figure 3. Example of point collection scene

elevations were established by trigonometric methods, where vertical angles and Electronic Distance Measuring Instrument distances were collected. A bi-pod with a prism was used as the target at the sample points. The height of the prism is subtracted from the computed elevation to determine the ground height. The points were collected within a distance of about 300 meters of the control points to minimize distance errors (Figure 3).
