LiDAR Quality Assessment Report

Territory of Guam

Guam_2012

Project Type: GPSC

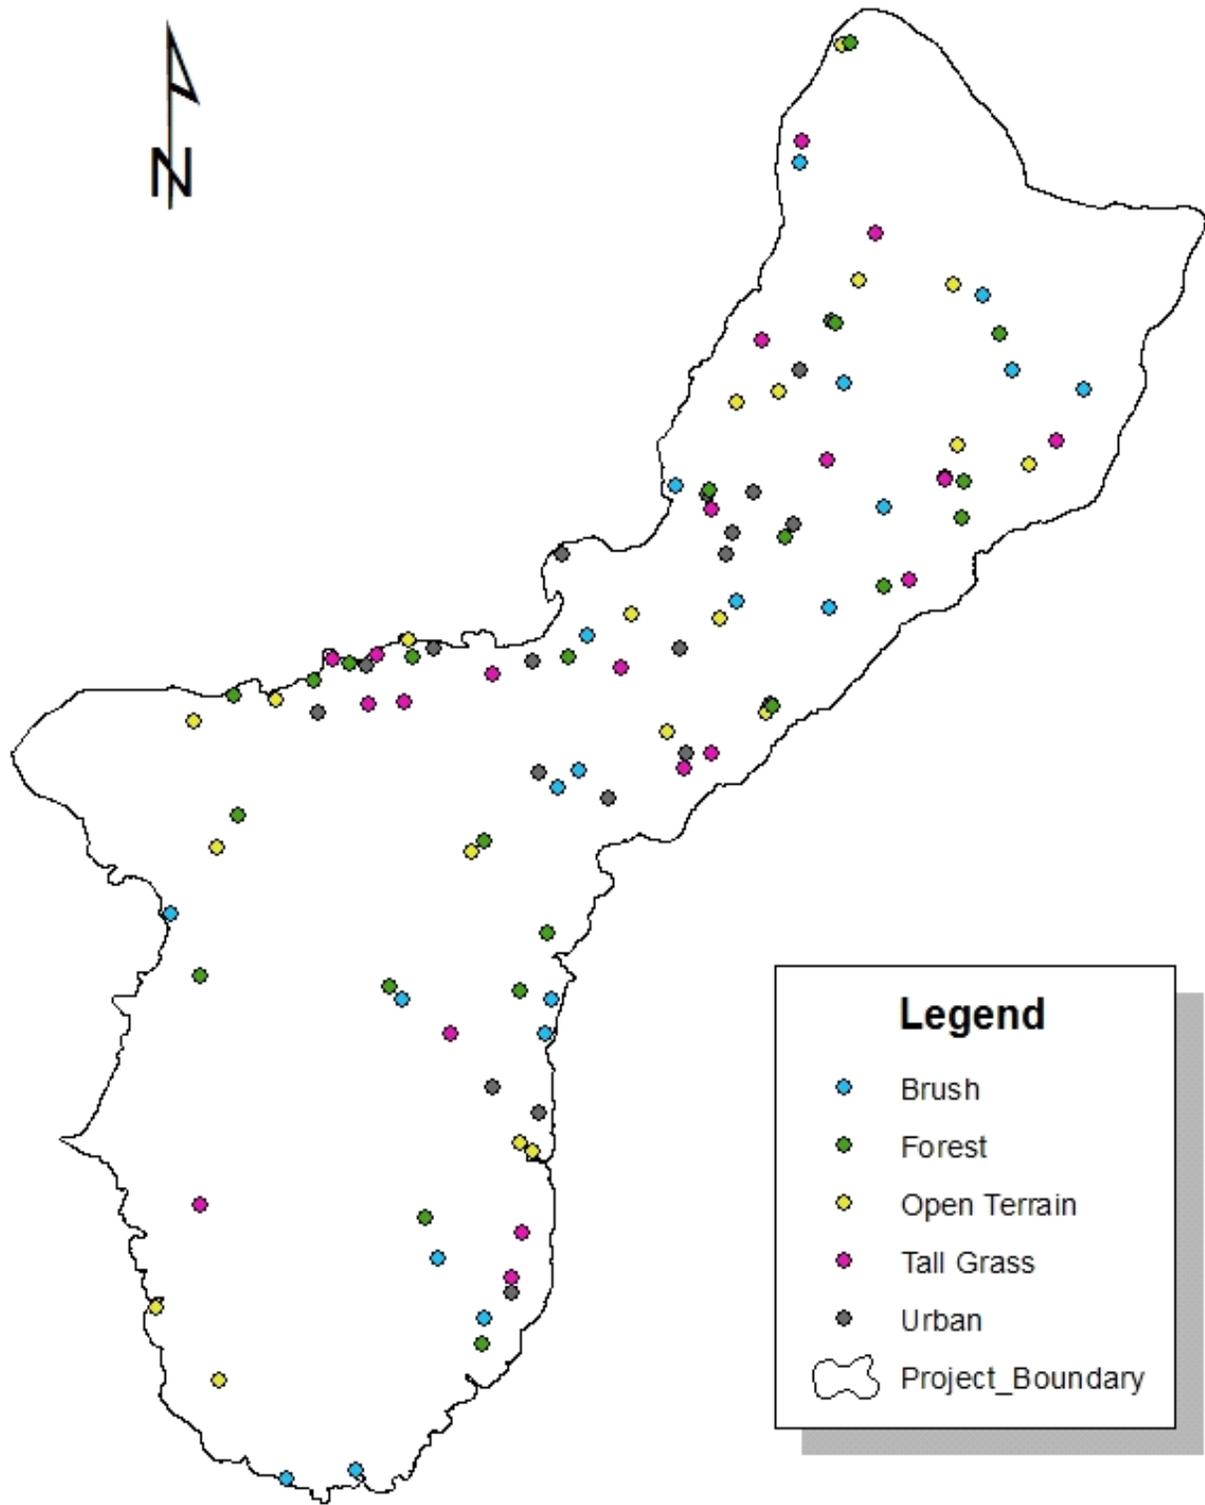
Checkpoint Distribution Image?

There are a minimum of 20 checkpoints for each land cover class represented. Points within each class are uniformly distributed throughout the dataset. USGS was able to locate independent checkpoints for this analysis. USGS accepts the quality of the checkpoint data for these LiDAR datasets.

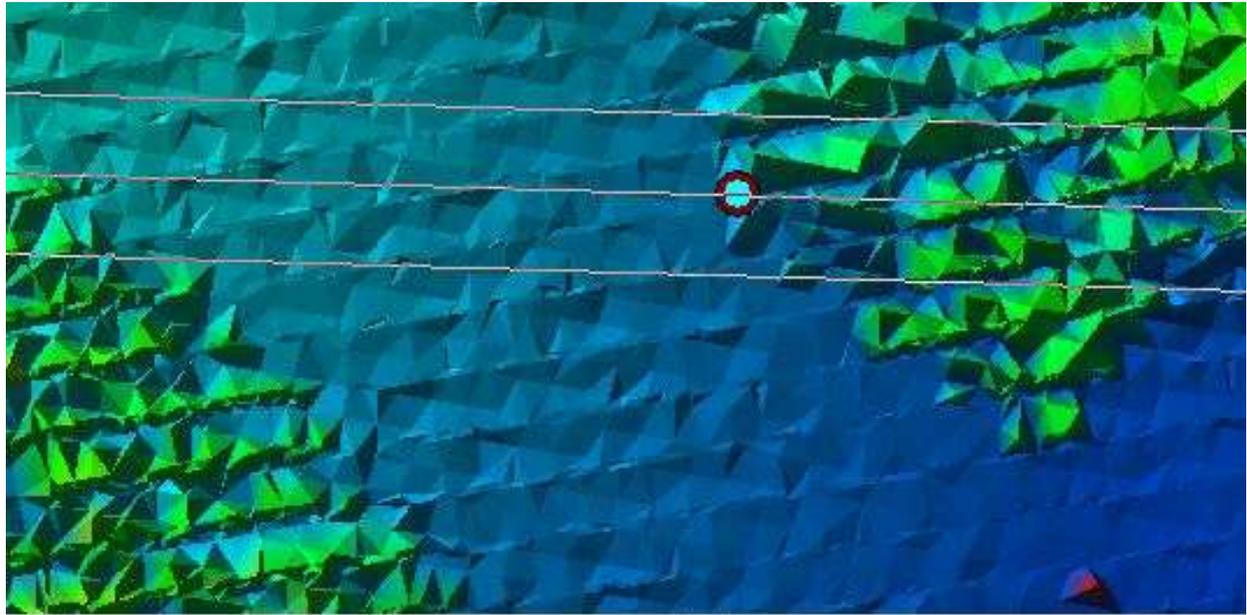
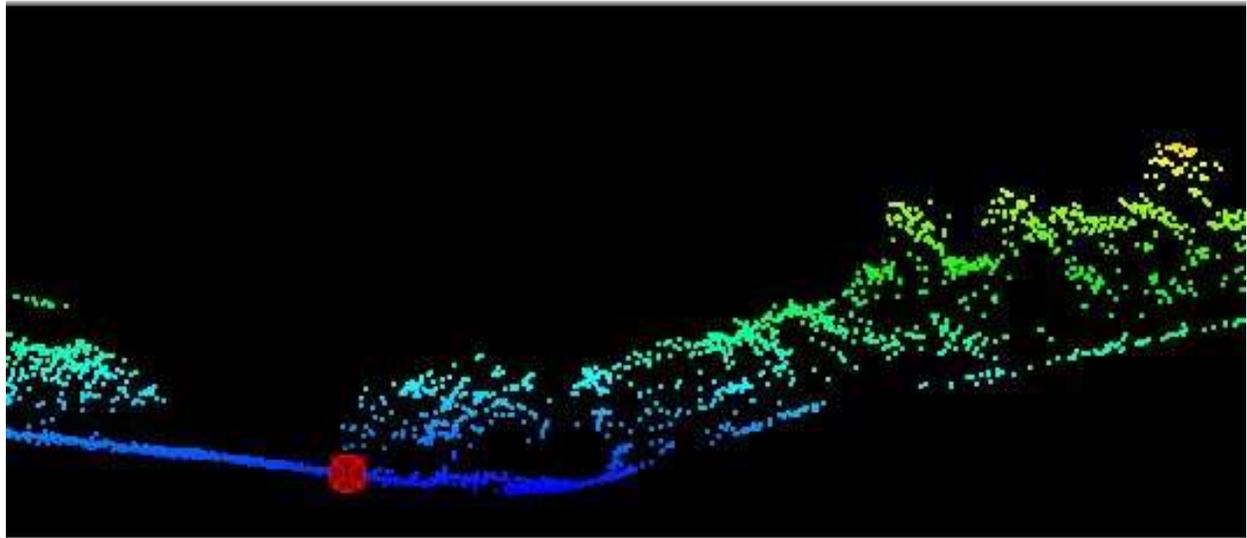
Check point 204: Removed from the vertical accuracy assessment for Swath FVA. This point is located in an area with tree cover; it has a z-error of -0.719 meters which indicates that the survey ground elevation is 0.719 meters less than the swath LAS TIN surface elevation.

**NGTOC's accuracy of Swath FVA is 16.8 cm after exclusion of the two points mentioned above.

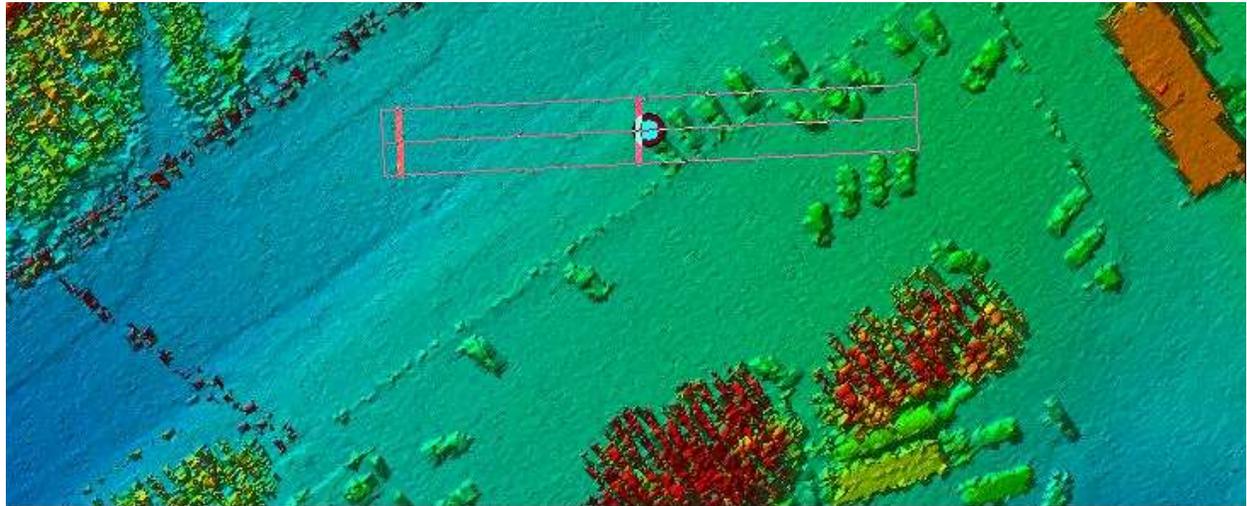
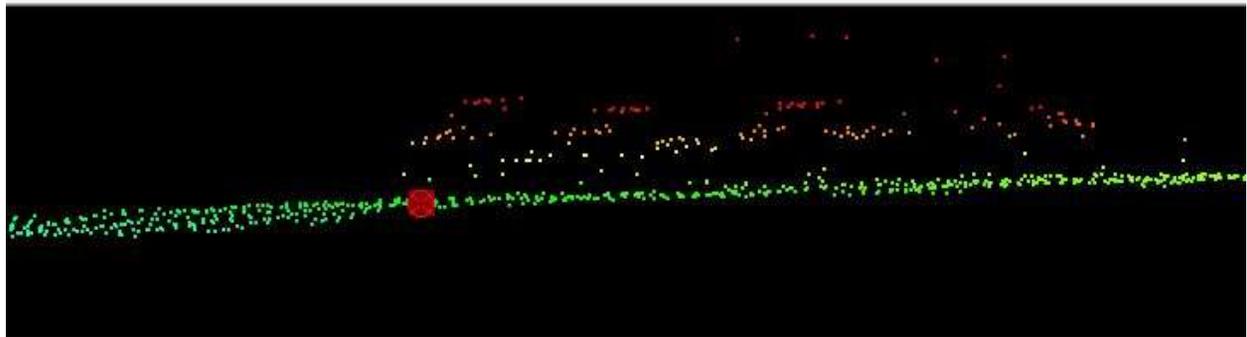
Check point 207: Removed from the vertical accuracy assessment for Swath FVA. This point is located in an area near a vehicle; it has a z-error of -1.007 meters which indicates that the survey ground elevation is 1.007 meters less than the swath LAS TIN surface elevation.

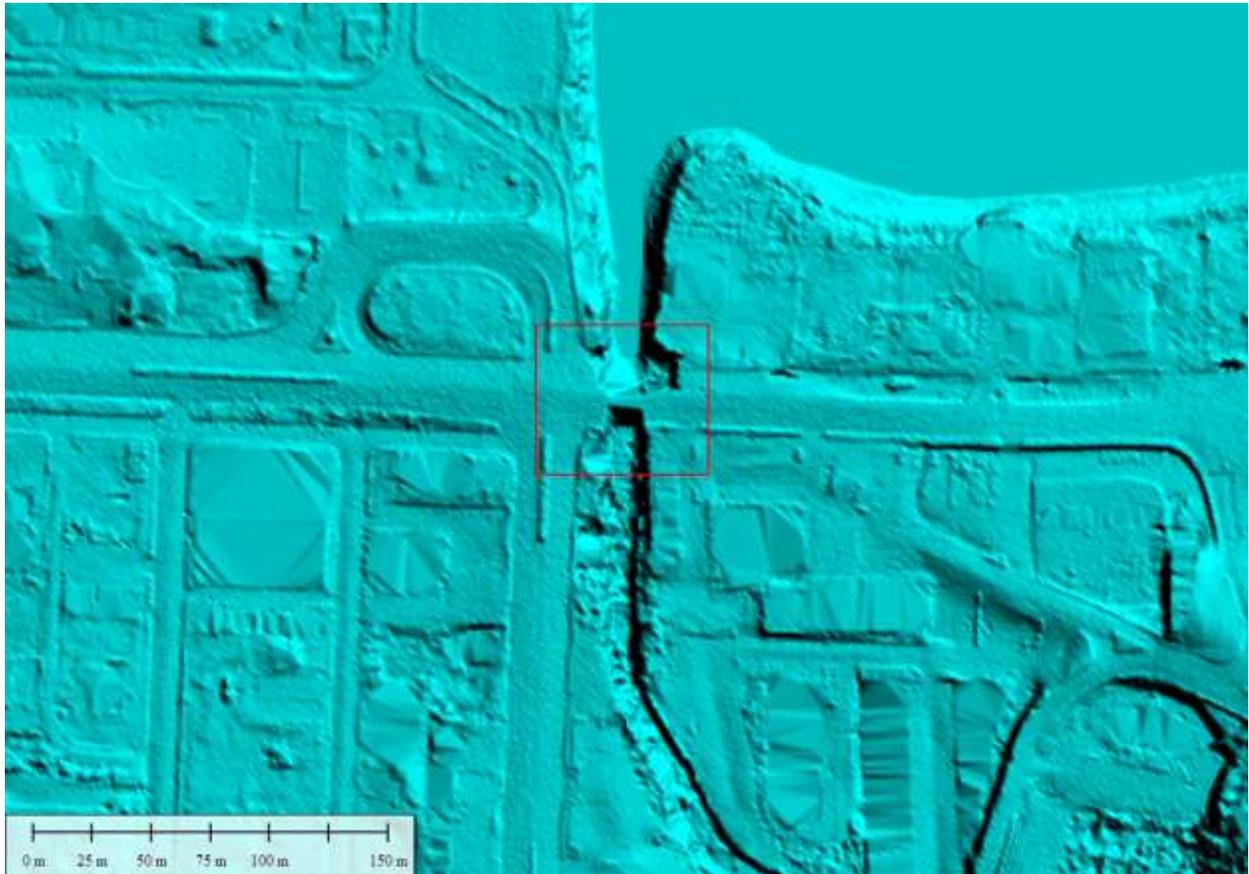
incomplete_bridge_removal_1: The roadway (bridge) over the waterway is not completely removed. There are two of this error-type.

**Error fixed by contractor... (9/12/2013)

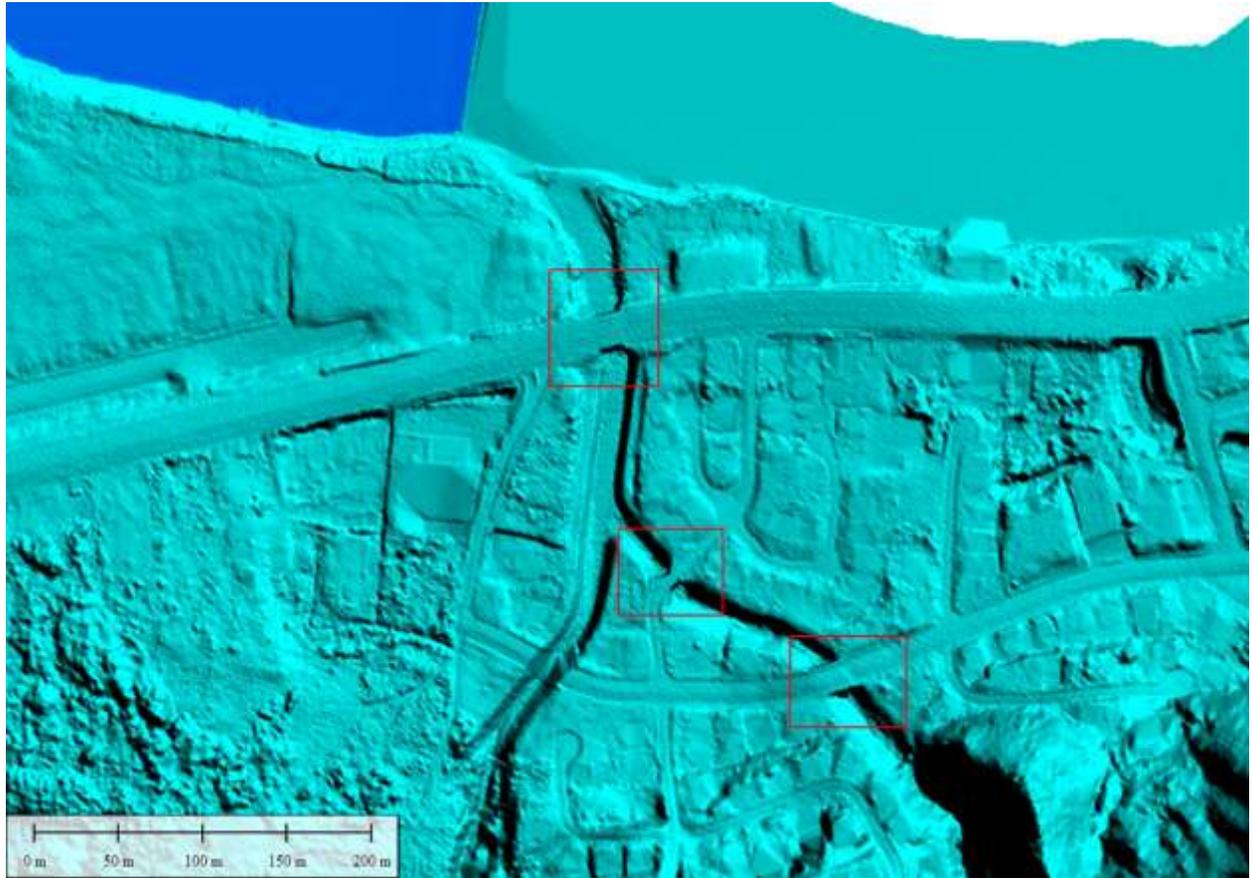
bridge_1-3: Roadways (bridges) over the waterways have not been removed; these are interpreted as bridges and not culverts. There are five of these error-types... three are represented in this image.

**Error fixed by contractor...(9/12/2013)

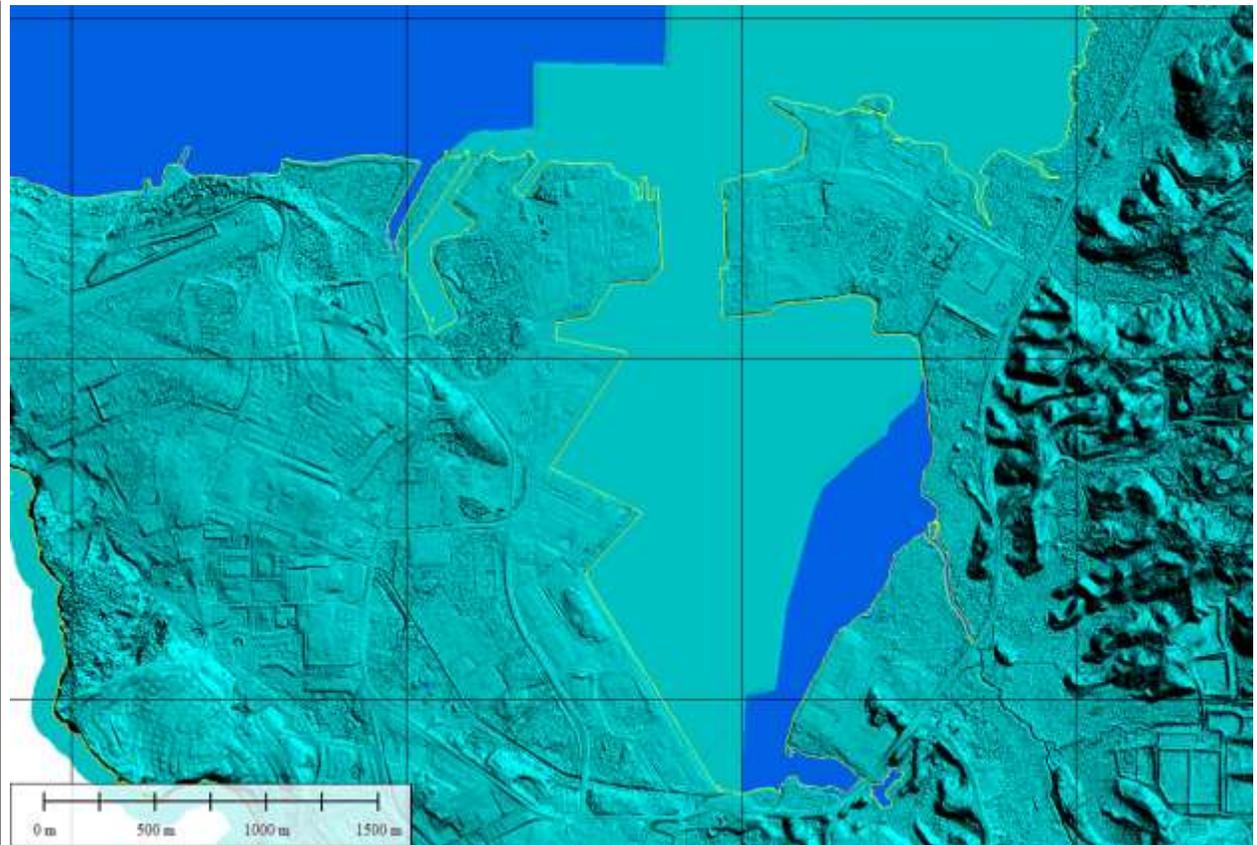
near-shore_water_elevation_differences: Water levels located on the shore of the entire project contain different elevations.

All errors corrected by vendor except the water 'elevation' issues around the coastline of entire island. This lidar was collected over 1.5 years thus tidal variations resulted in irregularities within the coastal regions. According to NGP, USGS Lidar Base Specifications Version 1.0, notes:

- Tidal variations over the course of a collection or between different collections, will result in lateral and vertical discontinuities along shorelines. This is considered normal and these anomalies should be retained.
- Water surface is to be flat and level, to the degree allowable by the irregularities noted above.

**Error not corrected by contractor; see Internal Notes for details...(9/12/2013)

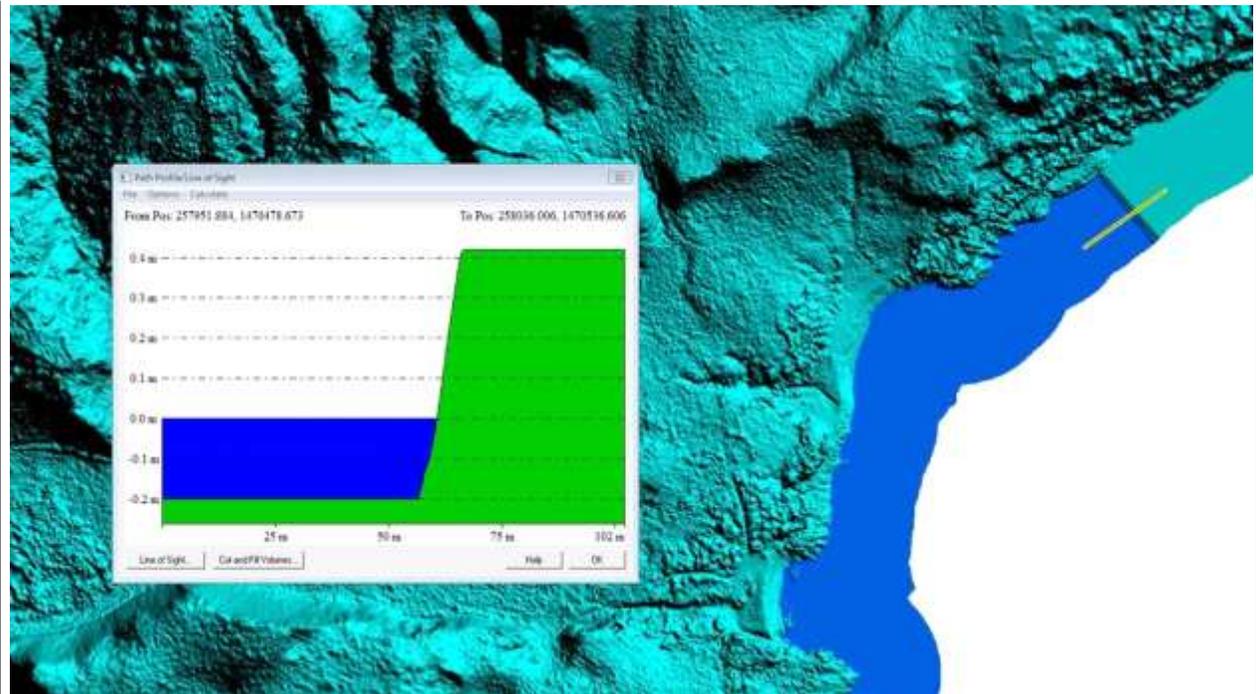
surface_elevation_change: The yellow line is the location of the cross-section in the inset image. This near-shore water level difference is another example of the error-type mentioned in the previous image. This error-type is prevalent around the entire project....but only along the shorelines..not inland ponds/lakes.

**Error not corrected by contractor; see Internal Notes for details...(9/12/2013)

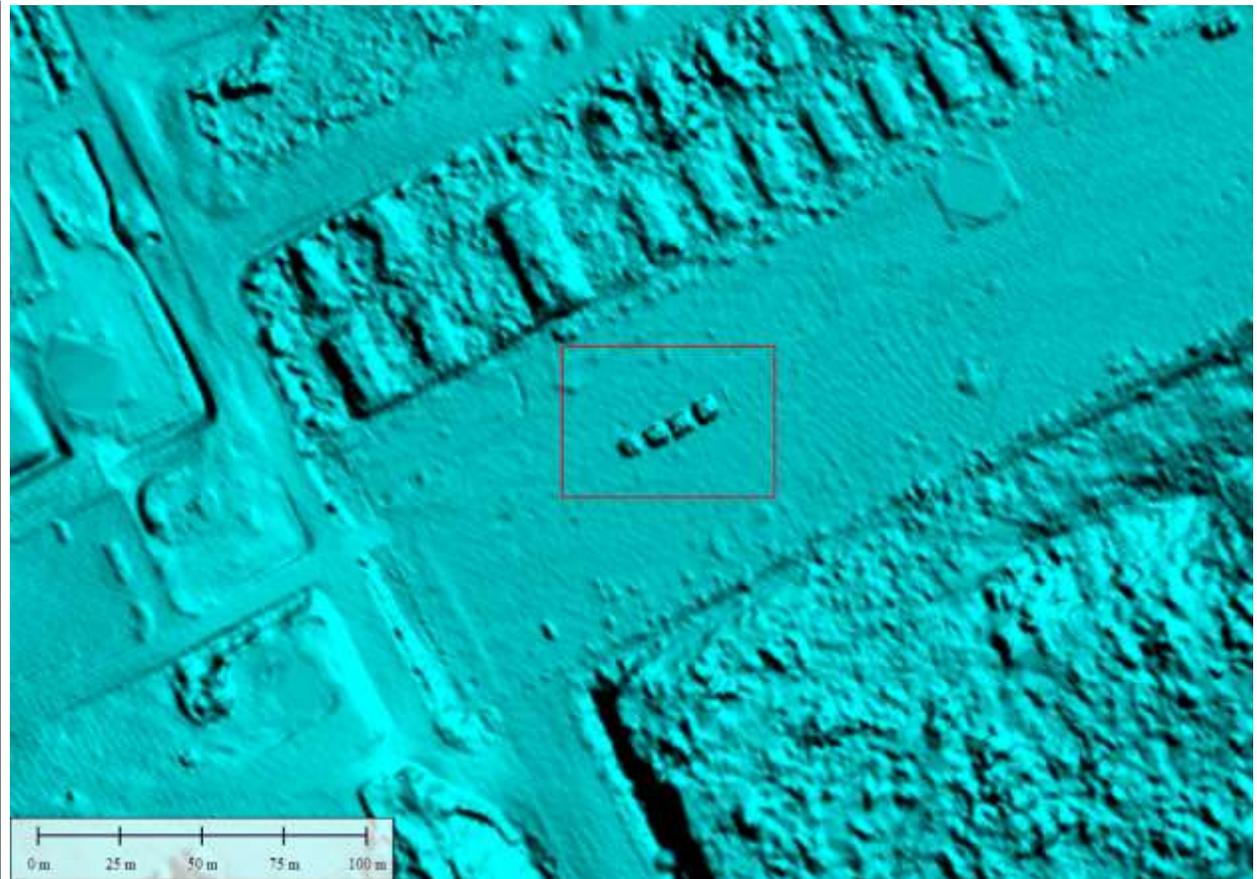
structures_1: Structures within this image are interpreted as man-made and not natural features. These items should be removed from the DEM. This is the only error of this type.

**Error fixed by contractor...(9/12/2013)
