FEMA 339 / March 1999

Building Performance Assessment Report

Hurricane Georges In Puerto Rico

Observations, Recommendations, and Technical Guidance

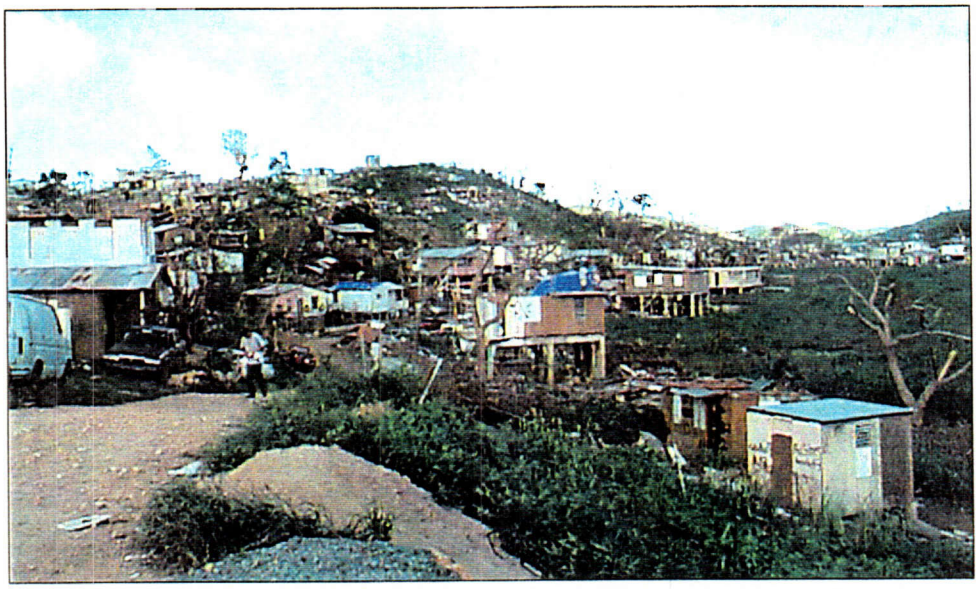
FIGURE 3-1 The abrupt change in topography in this community outside Loiza caused a speedup in the wind that flows over and around the buildings located on the hill beyond. The wind load provisions of Planning Regulation 7 did not account for wind speedup caused by abrupt changes in topography, and therefore underestimated wind loads on buildings situated on hills, mountains, or escarpments.

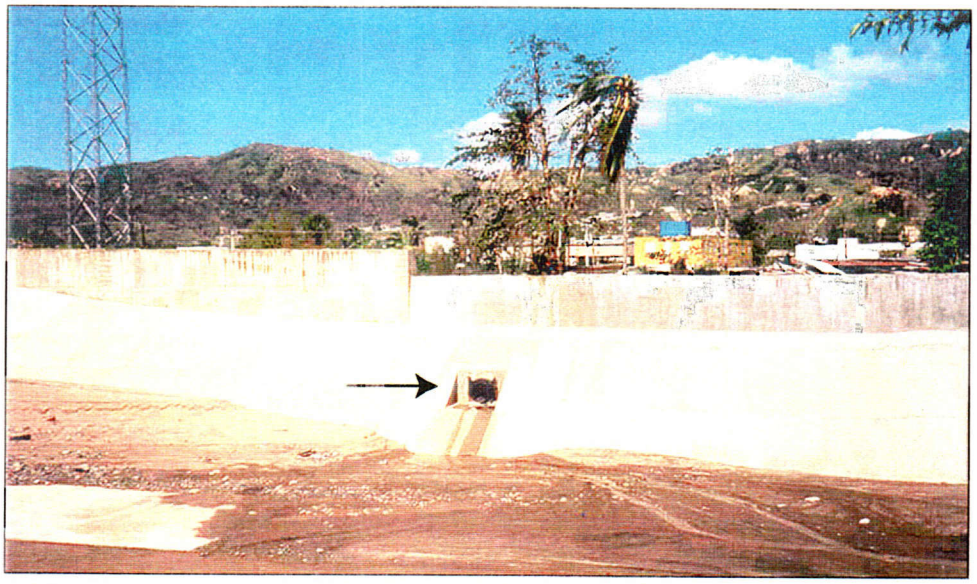
FIGURE 3-4 This flood gate located in Adjuntas prevented backwater from flooding homes located behind it; however, the wall contributed to flooding in the community located on the opposite side of the river, as shown in Figure 3-5.

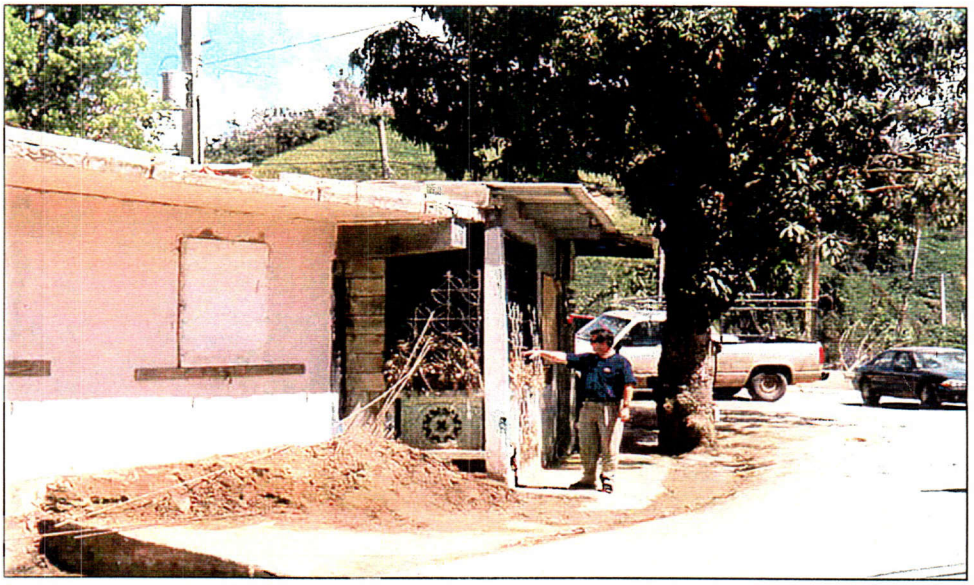
FIGURE 3-5 Residential area on the opposite side of the river from the floodwall in Figure 3-4. The flooding in this area reached a depth of 5 feet.

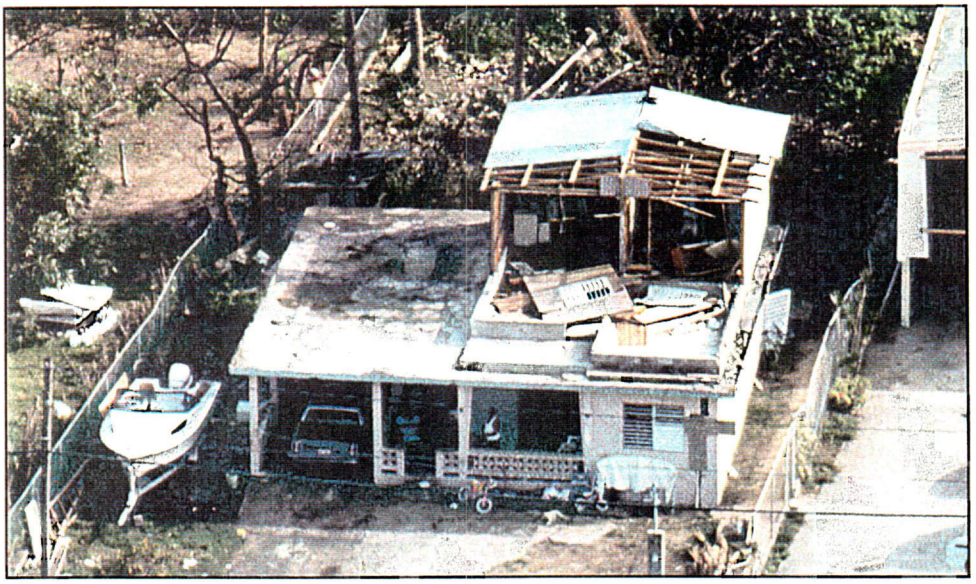
FIGURE 3-21 A combination residential concrete/masonry structure with an elevated second-floor concrete slab and a wood-framed upper level. Note the lack of damage to the concrete/masonry section of the house and the damage to the wood-frame portion.

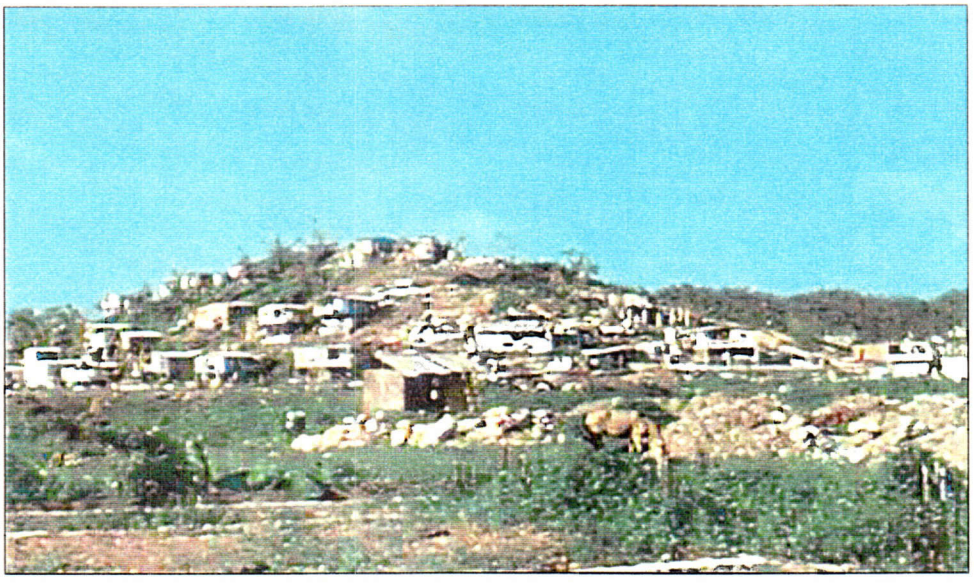
FIGURE 4-3 A residential community constructed of wood-frame structures only. This community located to the north of Canóvanas, experienced significant structural damage and failure to almost all of its buildings. The eye of the hurricane also passed to the south of this community, which is located approximately the same distance from the path of the hurricane as the community in Figure 4-2.

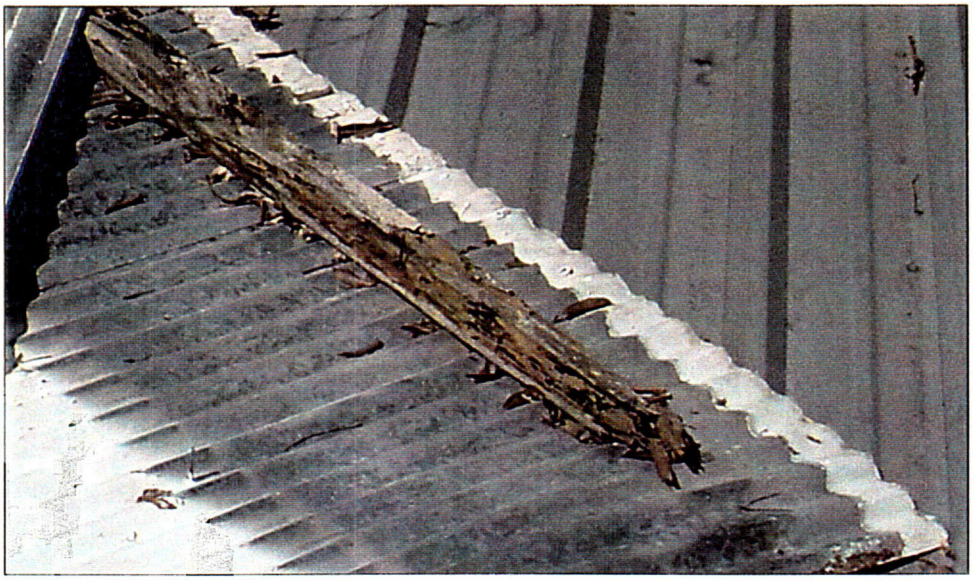
FIGURE 4-8 Termite-damaged wood purlin attached to metal roof panel. The entire roof system of this building failed and is shown in Figure 4-9.

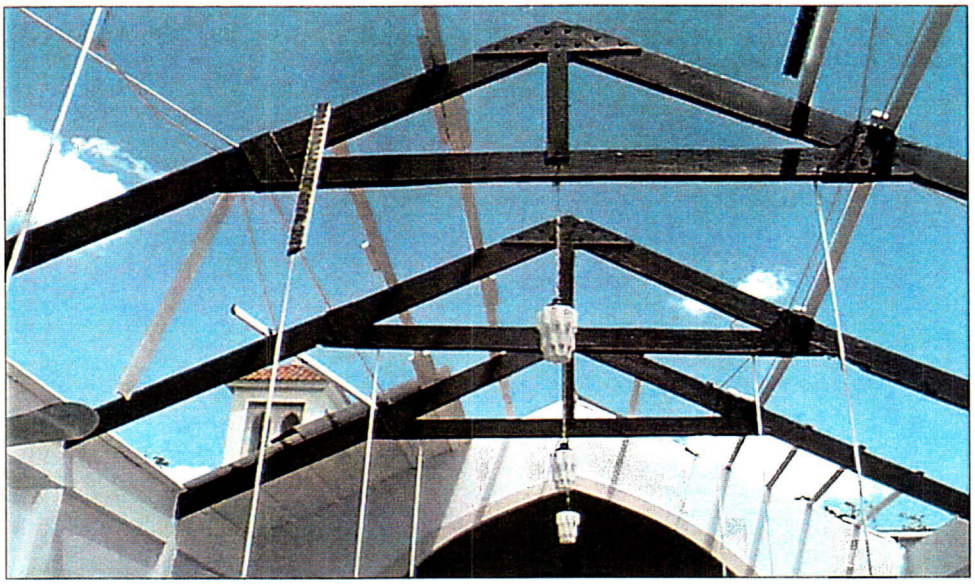
FIGURE 4-9 Masonry wall church that lost roof purlins and its corrugated metal roof. Nails were the only connections used to resist wind loads. The gable ends of this church were unsupported except for purlins resting in the masonry.

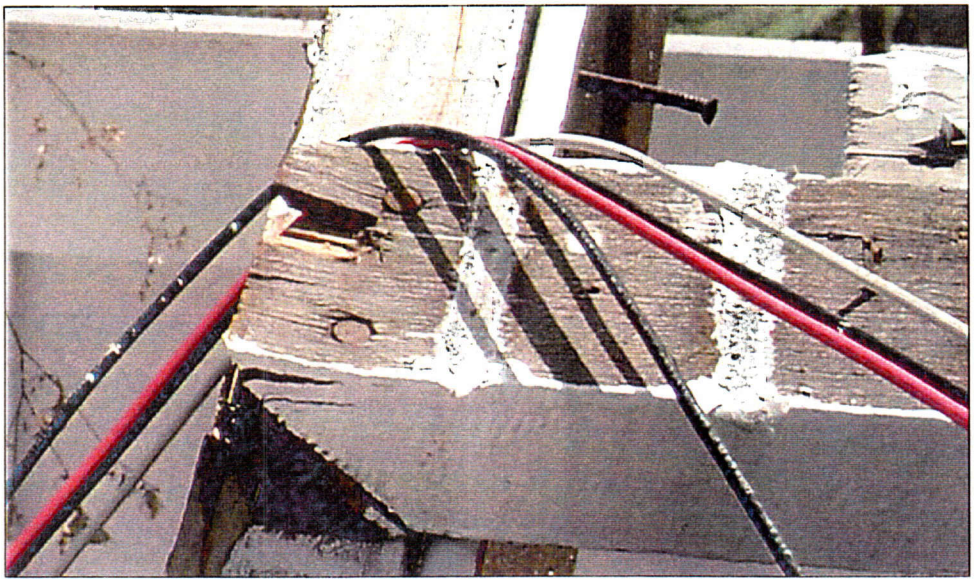
FIGURE 4-10 Nailed roof structure connection from church in Figure 4-9.

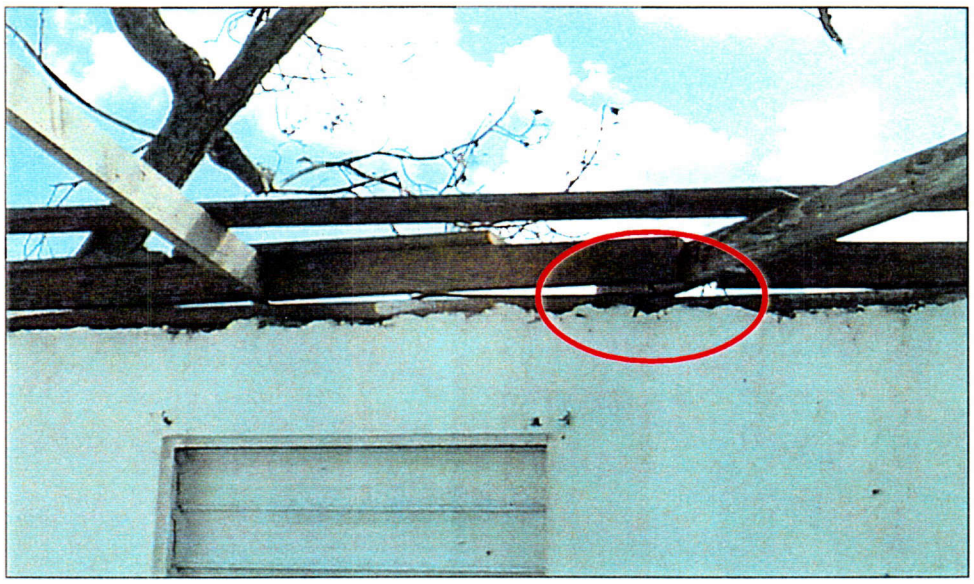
FIGURE 4-11 Typical nail withdrawal failure in a wood-frame structure supported by a masonry wall with little uplift capacity at the connection.

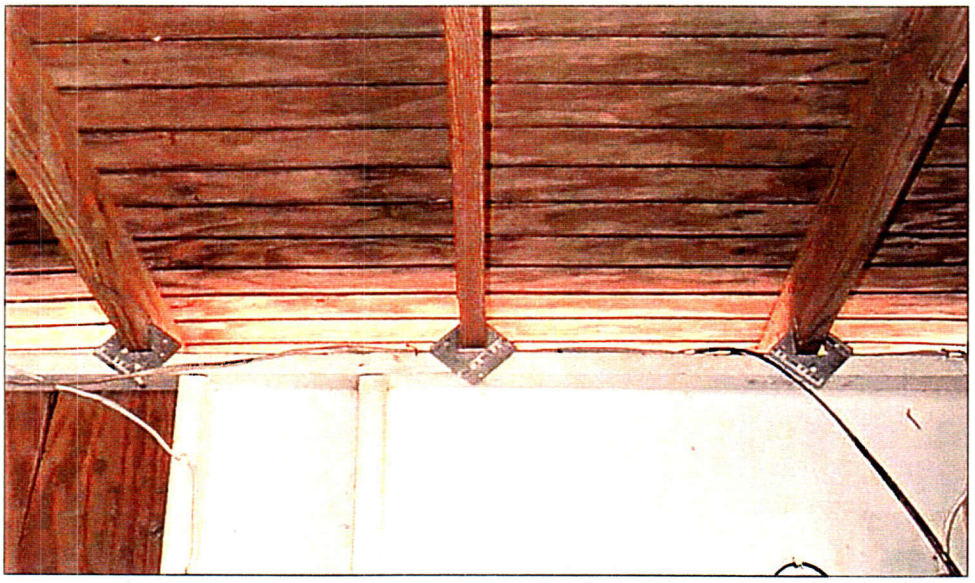
Some residents installed hurricane clips as part of their mitigation efforts after hurricanes in 1995 and 1996. Figure 4-12 shows positive mitigation efforts implemented in a wood-frame house on the island of Culebra in 1996, as observed after Hurricane Georges. Utilization of clips and straps, however, was not typical in wood-frame buildings in Puerto Rico.

FIGURE 4-12 Hurricane clips installed in a wood-frame house on Culebra.

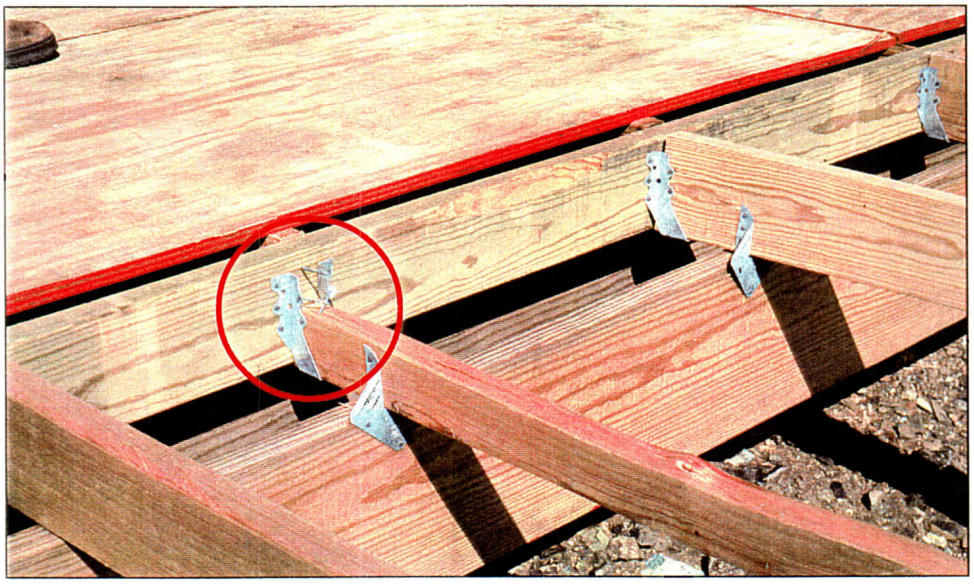
Traditional and inadequate nailing techniques were used on this structure while state-of-the-art clips, brackets, and fasteners were found lying beneath the building. Clips and hangers that were used did not employ the proper nails and failure resulted (Figure 4-13).

FIGURE 4-13 Example of the failure of wood member in the floor joist hanger due to the use of improper nails. The hurricane clip was used to secure the floor joist to the support beam. This house was located on the island of Culebra.

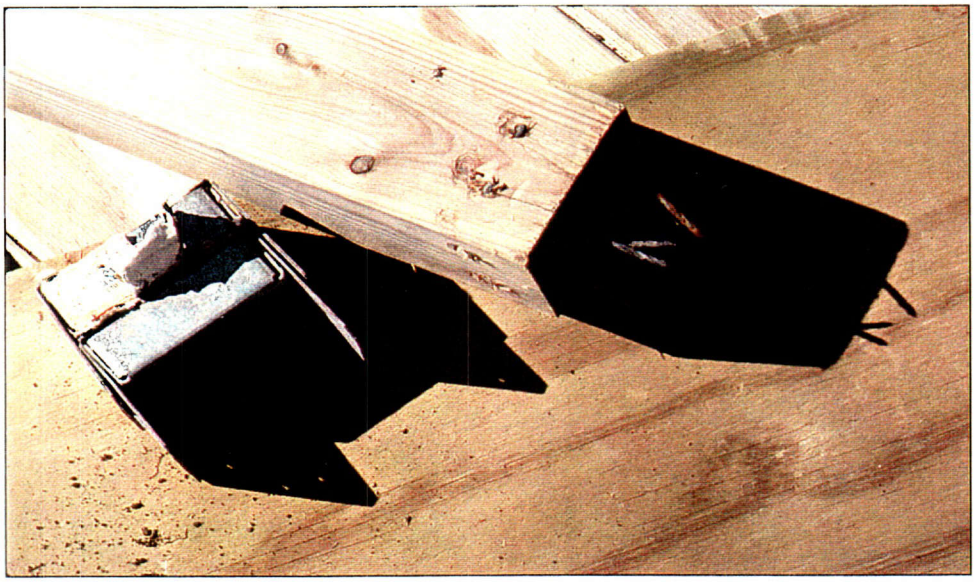
FIGURE 4-15 Wood wall column that failed at connection to sill plate. This building was only two months old but was only partially constructed with clips, straps, and fasteners. The proper column fastener in the photograph was found unused beneath the house. This column was from the same house presented in Figure 3-13.

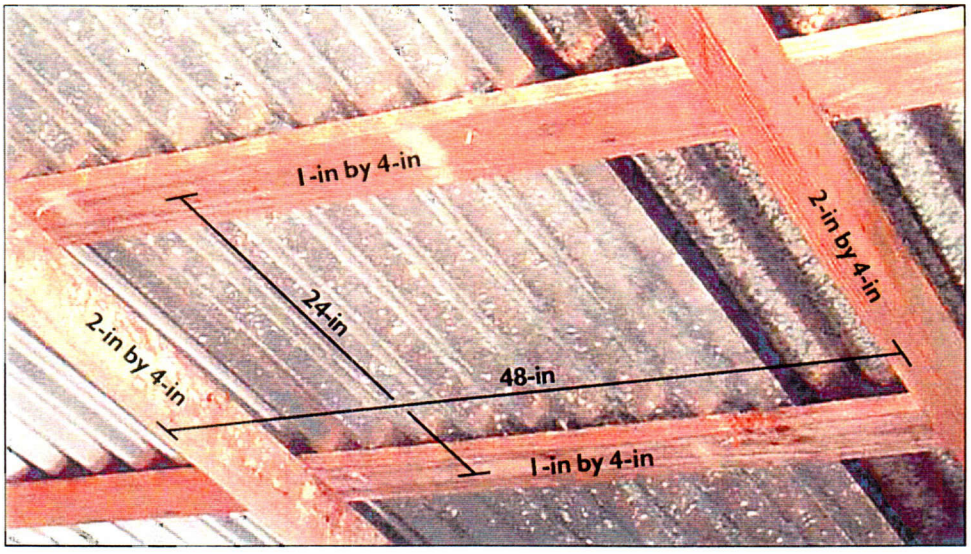
FIGURE 4-16 Typical wooden roof structure with metal roof panels above. Nails connected the metal panels to the nailers and the nailers were nailed to the joists.

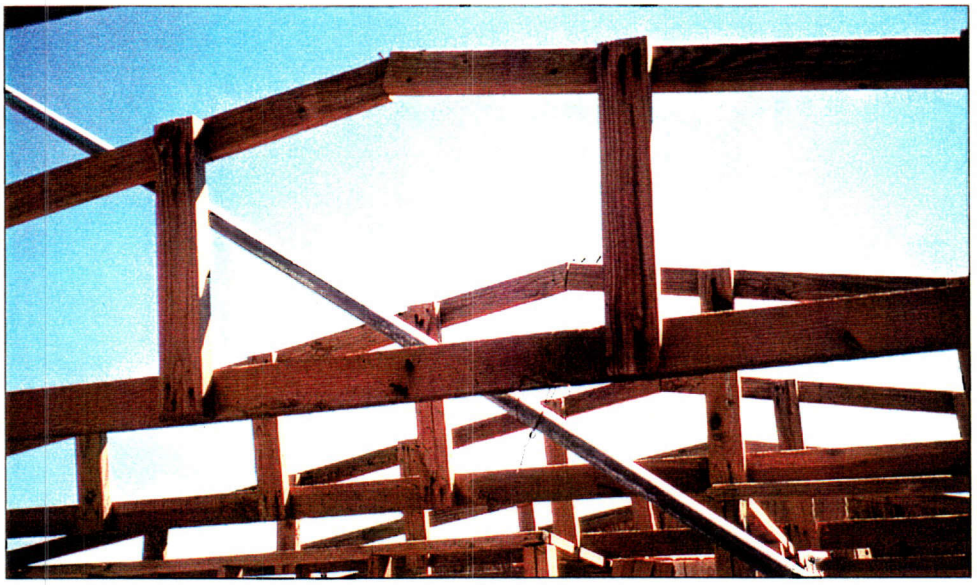
FIGURE 4-17 Example of a self-built, wooden roof truss.

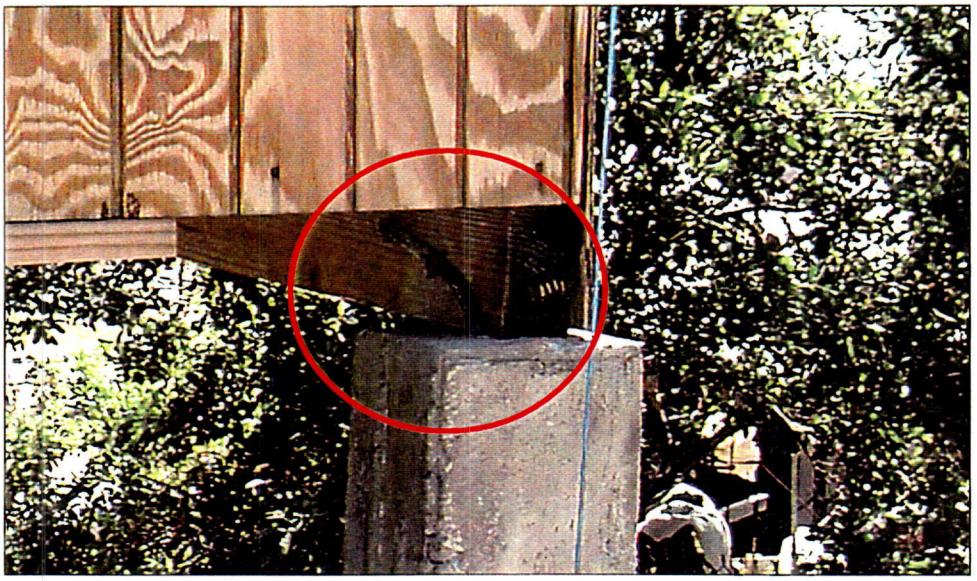
FIGURE 4-18 Example of a non-engineered connection between the building foundation (concrete column) and the floor system. The wooden floor beam is connected to foundation rebar with an improper nailed connection.

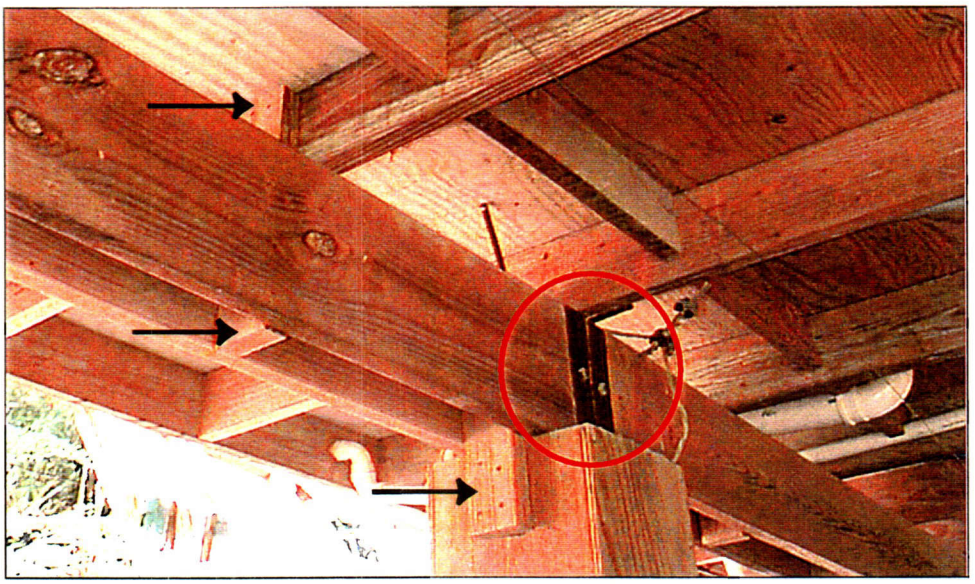
FIGURE 4-19 Example of an engineered connection between the floor beam and a concrete column (concrete column is enclosed in plywood). Vertical members (identified by arrows) provide continuous load path from floor joist to floor beams. Floor beams are connected to concrete columns with metal straps (circled). This house was located on the island of Culebra.

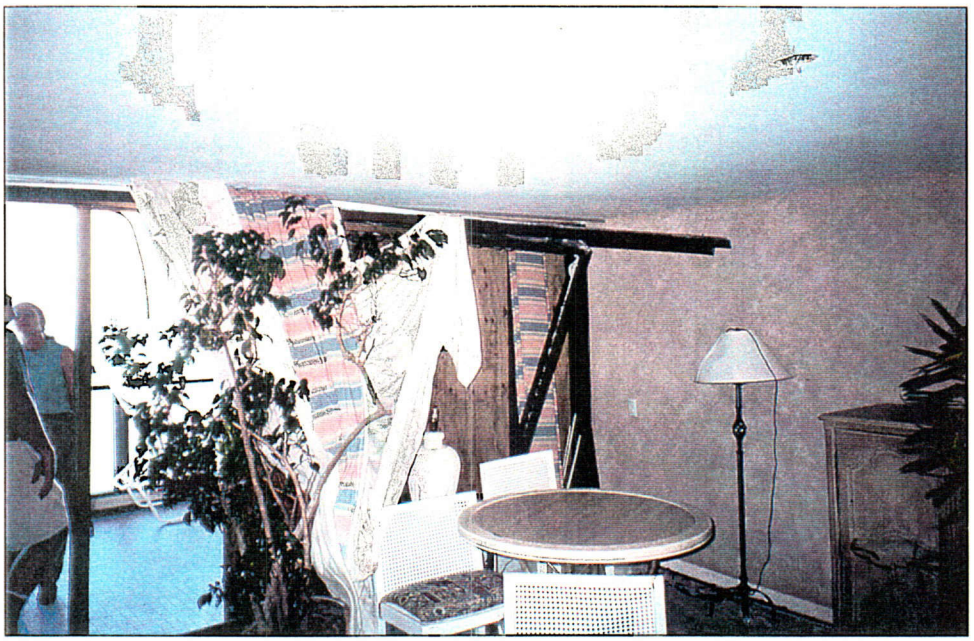
FIGURE 5-1 This sliding glass door and window assembly in a hotel room was 7' 2" high and 14' long. The head of the frame was attached with four pairs of #12 or #14 screws in plastic sleeves. The sleeves pulled out and the entire length of the frame was pushed inward, resulting in substantial glass breakage. This building was located on Isla Verde in San Juan.

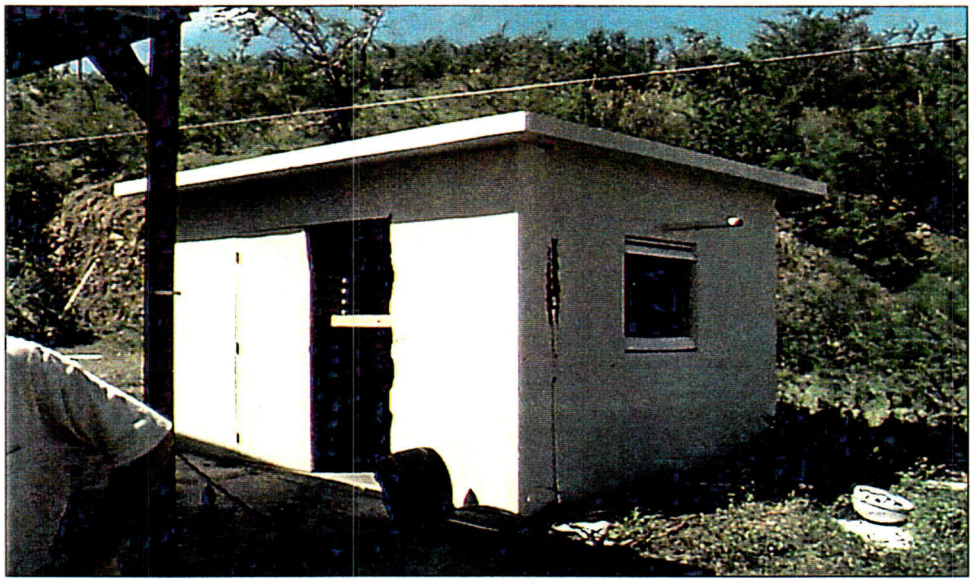
FIGURE 5-3 A missile traveling right to left struck the window louver. The door frame was attached by fasteners into wooden plugs that had been set into holes drilled into concrete. Once the louver failed, the door frame failed.

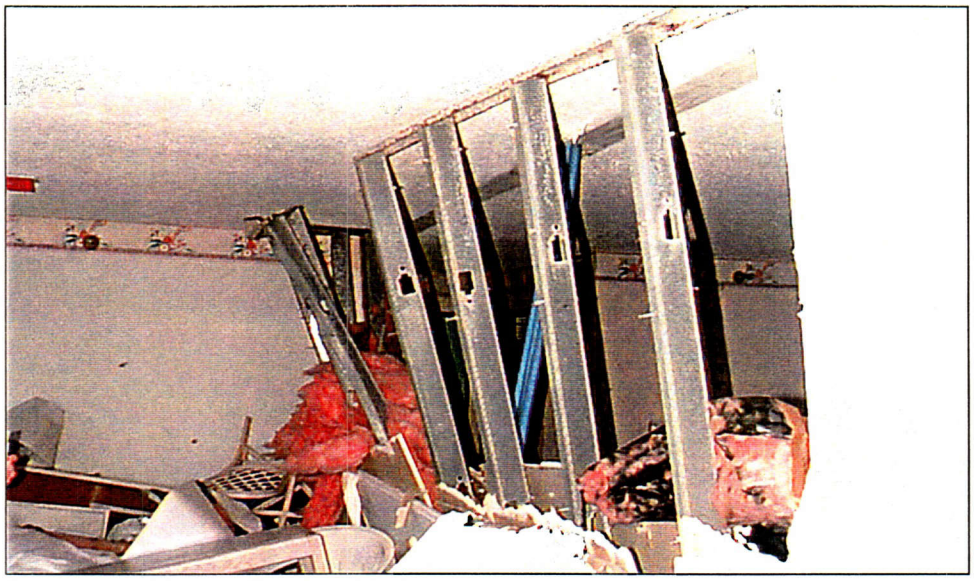
FIGURE 5-5 The gypsum wallboard was blown off this interior partition after the exterior non-load bearing wall was blown away, allowing an uncontrolled, rapid increase in internal air pressure.

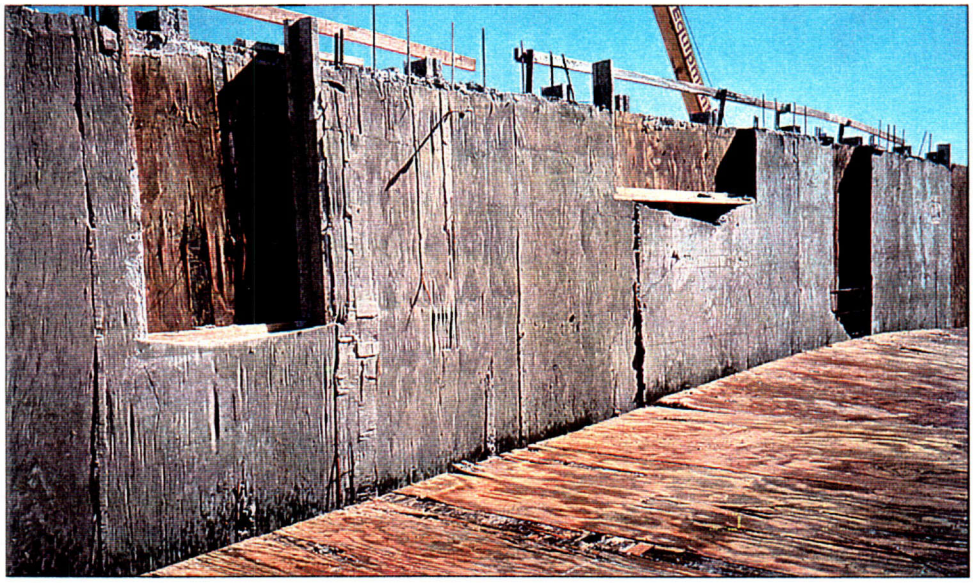
The loss of stucco applied over cast-in-place concrete was the most common problem observed with wall coverings (Figure 5-9). Rather than cast concrete with a relatively flat and smooth surface, traditional practice in Puerto Rico has been to cast the concrete rough, as shown in Figure 5-10, and apply a stucco finish.

FIGURE 5-10 This house is under construction. The surface of the concrete is very rough because the plywood form (which is lying down on the ground) was used repeatedly. The rough texture will be compensated for with a stucco surfacing.

While stucco loss had only minor effects to the buildings where it was applied, the windblown debris could have traveled substantial distances and damaged other buildings. This was a particular problem when stucco debris was blown off of tall buildings. Instead of relying on stucco to provide an attractive wall surfacing, the quality of the cast-in-place concrete and CMU construction should be improved so that the concrete or CMU can be left exposed or painted. This would eliminate the missile problems that resulted when stucco was blown away and became airborne.

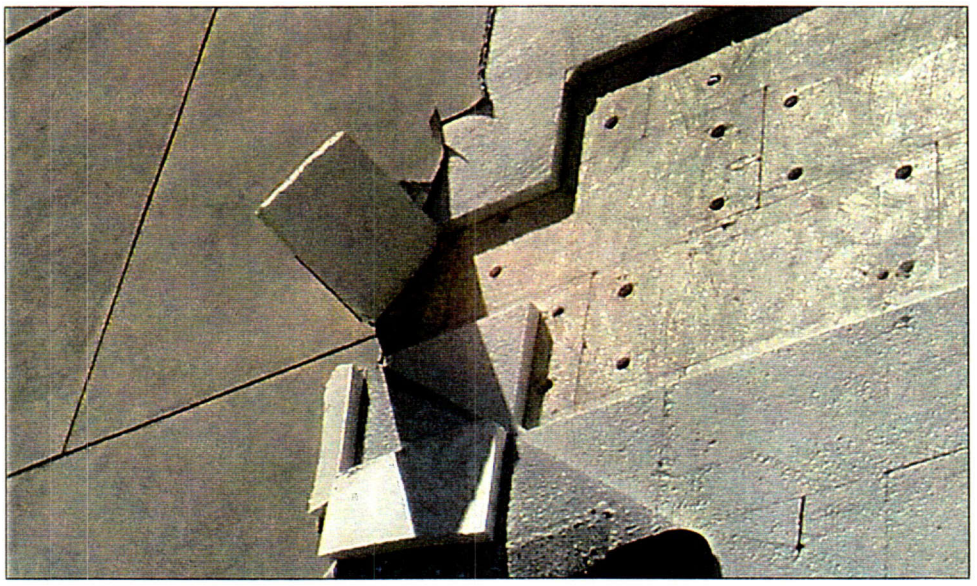
FIGURE 5-11 At this EIFS covering, the synthetic stucco appeared to be well-adhered to the outer EPS layer, but there appeared to be minimal bonding between the two EPS layers. In at least the lower portion of the wall, the first layer was attached with mechanical fasteners deeply recessed into the foam. The delamination occurred near the corner of the building, where the suction pressures were high.

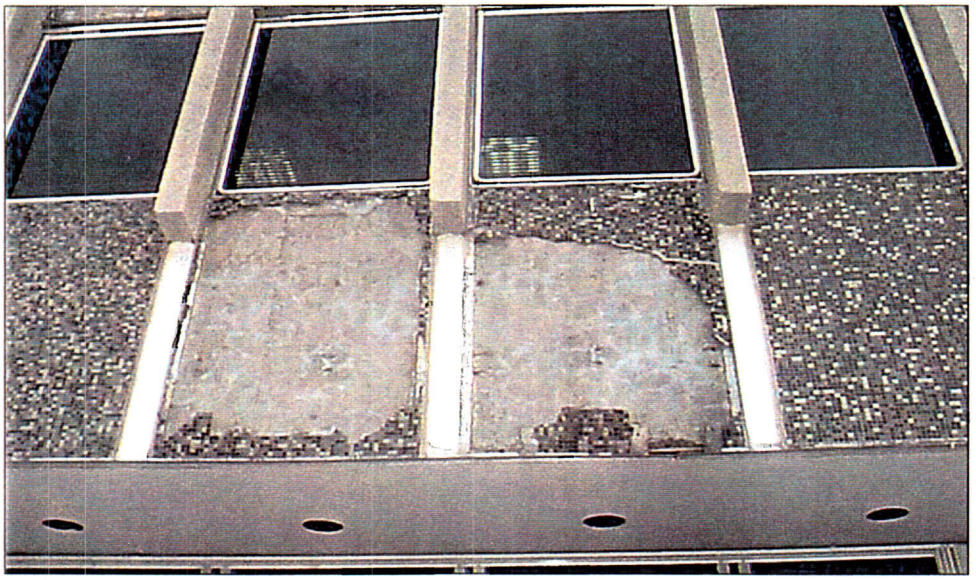
FIGURE 5-12 A mortar skim coat was applied over the concrete, and the ceramic tiles were set in to the mortar. The primary failure plane was between the mortar and concrete.

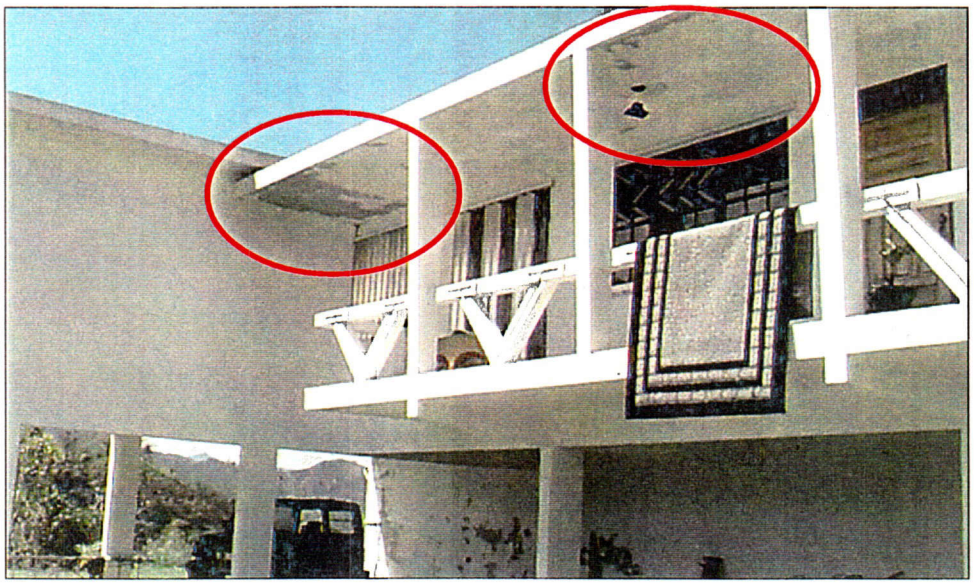
FIGURE 5-13 This house was located on a mountain top that experienced very high wind conditions. The paint scoured off at some of the soffit areas and along the recessed wall.

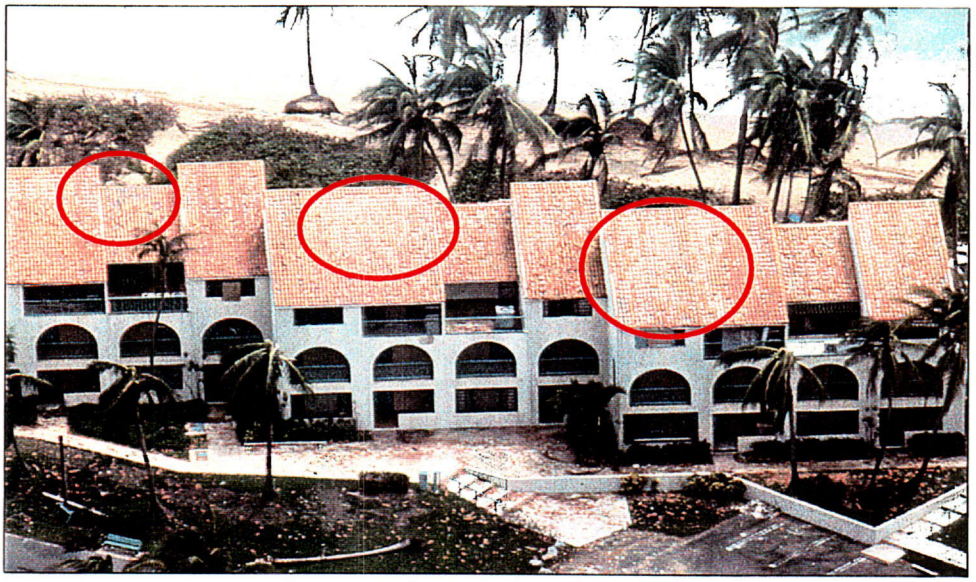
FIGURE 5-20 These tiles were heavily damaged, although the wind speed at this location was not very high. As can be seen in the foreground, the roof covering generated a substantial number of missiles. Because of the relatively low wind speed, the tile debris did not travel very far.

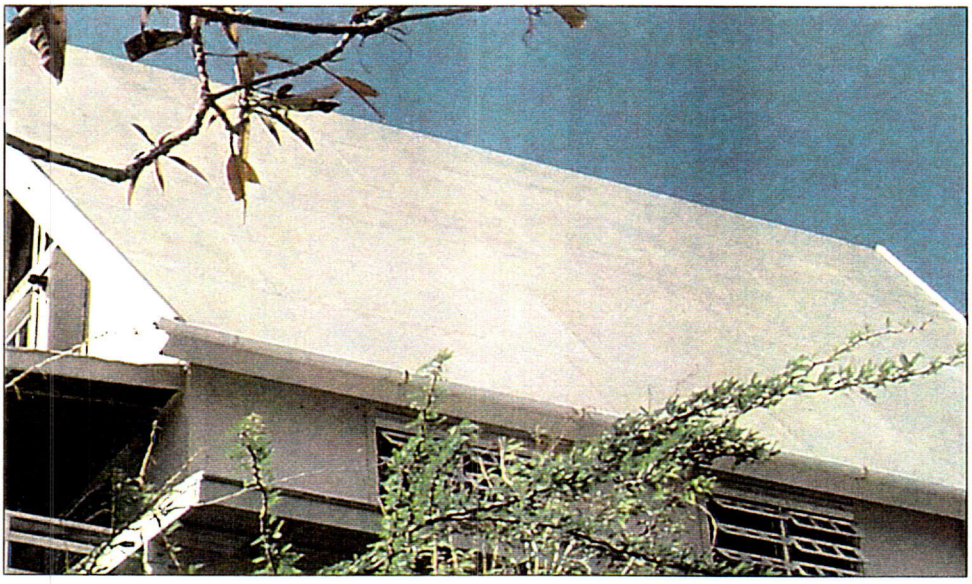
The BPAT observed only a few liquid-applied membranes over plywood. As long as the roof structure did not fail they provided excellent wind performance (Figure 5-21).

FIGURE 5-21 This house had a liquid-applied membrane over plywood roof sheathing. This type of roof system typically offered excellent wind performance provided the plywood does not lift. This house was located on the island of Culebra.

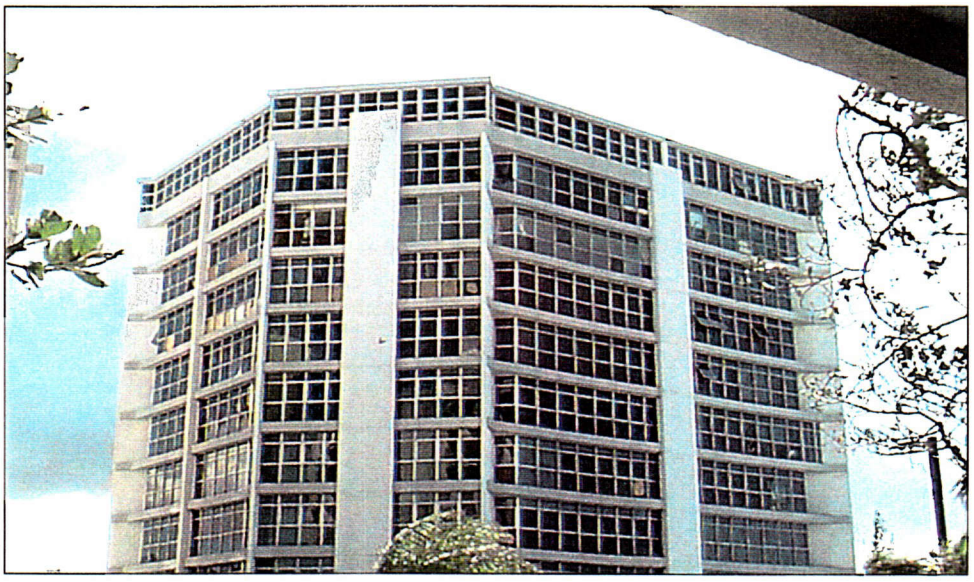
FIGURE 5-23 The windows in this building were broken by aggregate from the built-up roof of a nearby building (Figures 5-24 and 5-25).

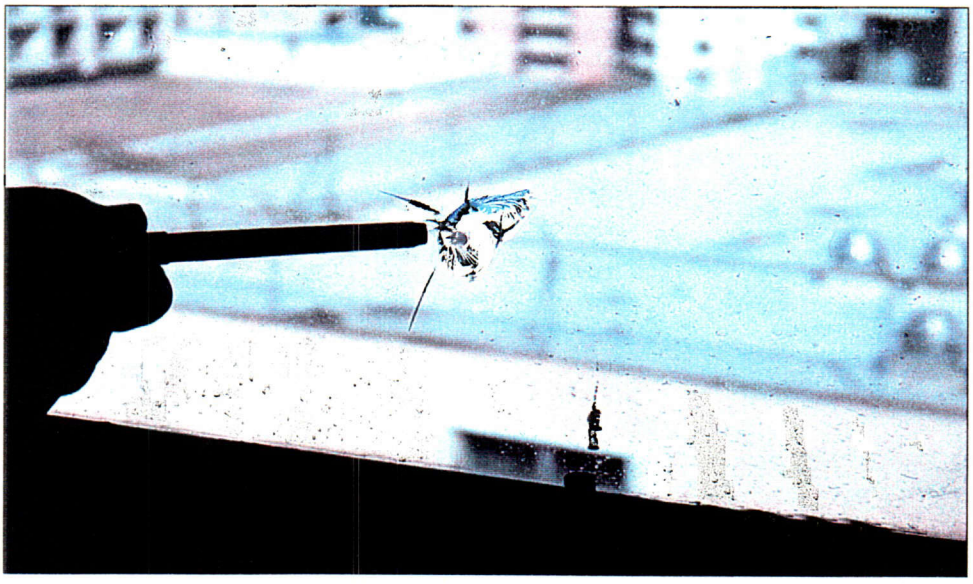
FIGURE 5-25 Although some annealed panes broke into shards, others just broke at the impact point.

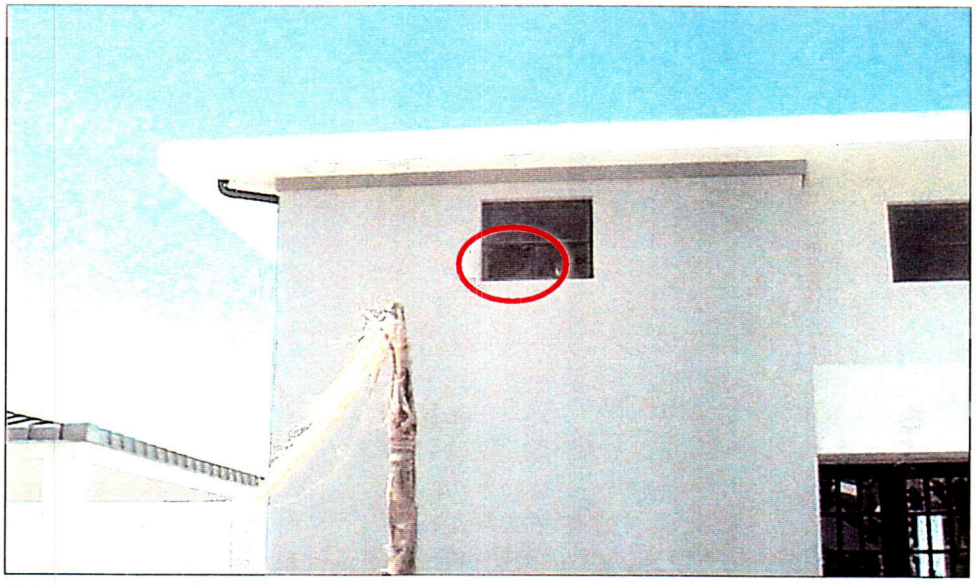
FIGURE 5-27 One pane in this window was broken by a missile, perhaps from the palm in the foreground.

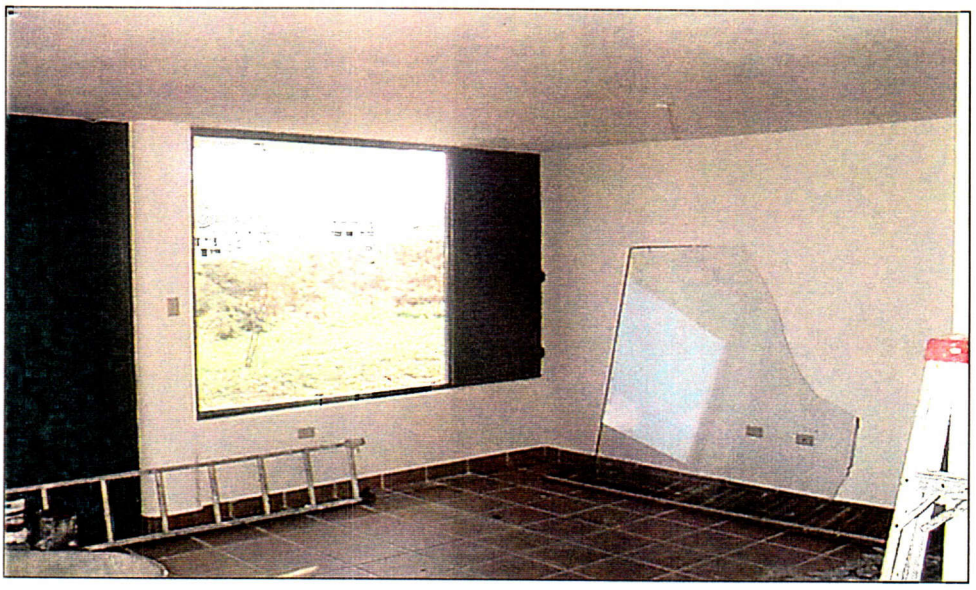
FIGURE 5-28 This large window, which was removed and leaned against the wall after the storm, was broken by a missile, most likely a tree limb.

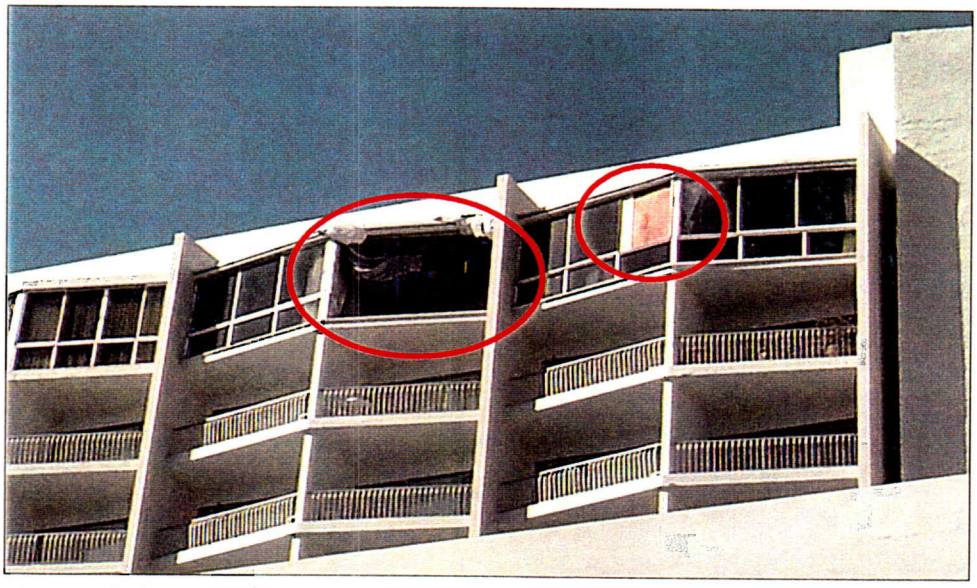
FIGURE 5-29 The glass and frames were blown out at the center room on the top floor. At the room to the right, one of the glass panes was blown out.

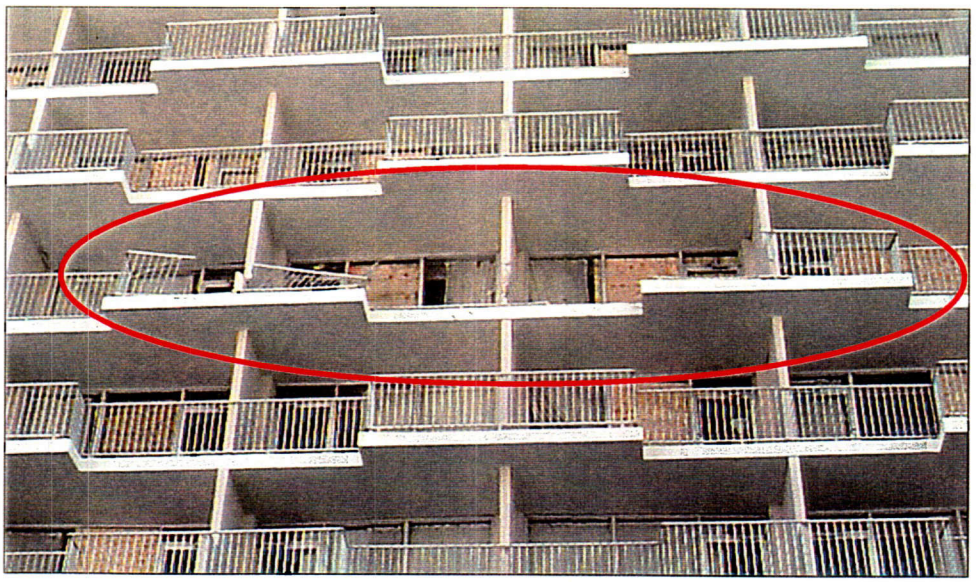
FIGURE 5-31 High-energy missiles from a nearby building damaged several railings of this building.

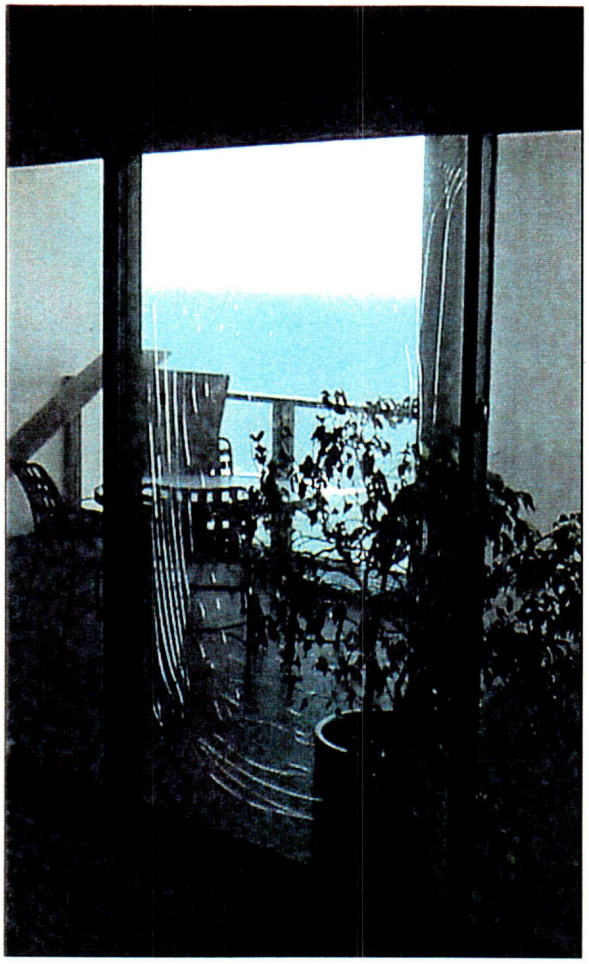
FIGURE 5-32 The broken light in the center is laminated. A sliding glass door located to the left had tempered glass, which was blown out of the frame.

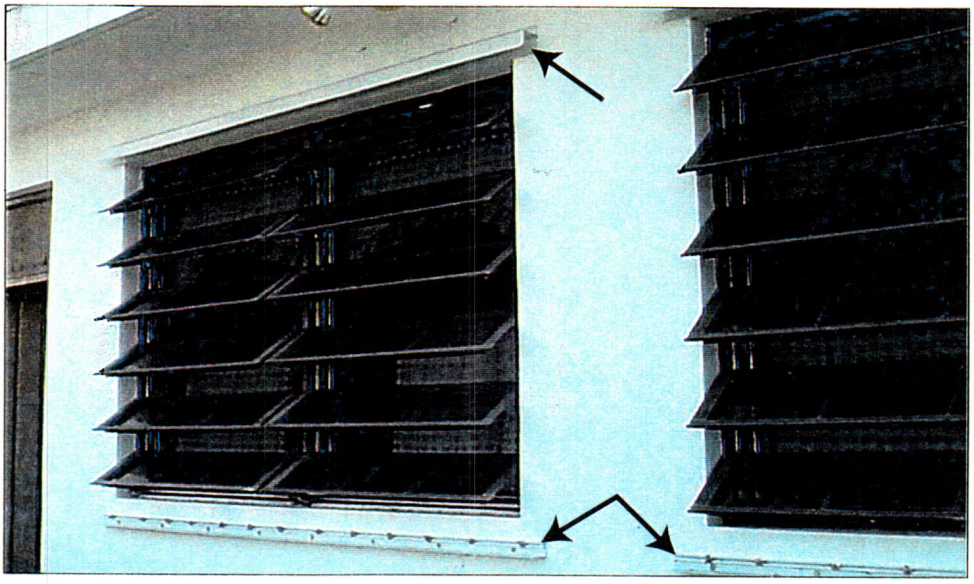
FIGURE 5-34 These windows were equipped with permanent head and sill shutter tracks, which were attached to the wall with closely-spaced fasteners (Figure 5-35).

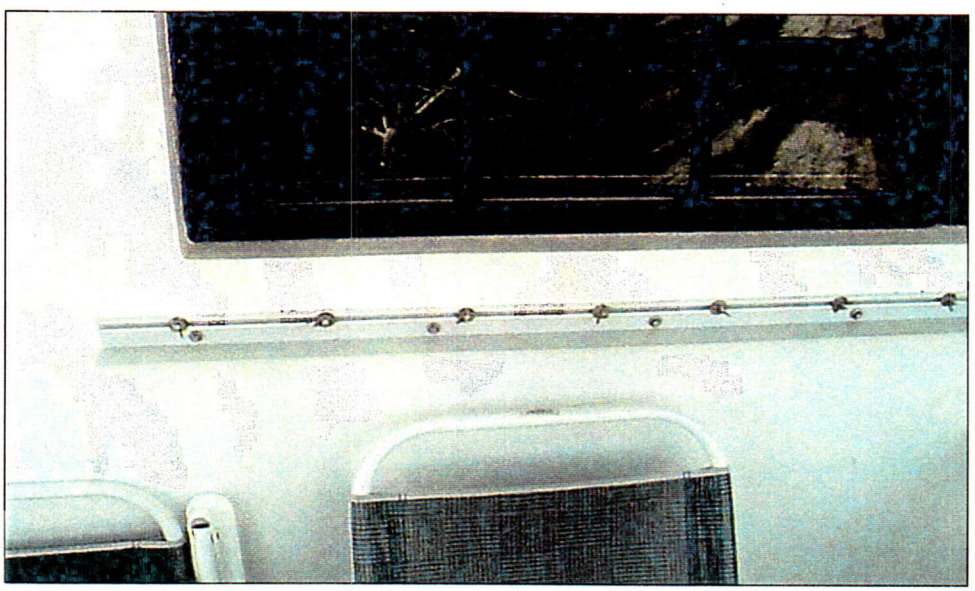
FIGURE 5-35 Close-up of Figure 5-34. The steel shutter panels were designed to be locked into the track with wing nuts spaced 6-in on center, a more reliable attachment than that shown in Figure 5-36.

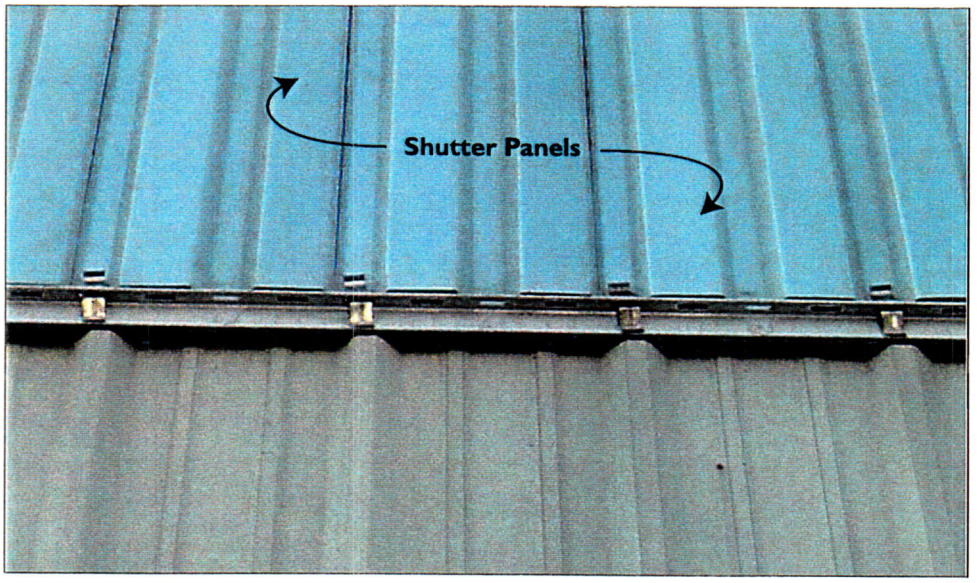
FIGURE 5-36 Looking up at a shutter panel held in place by clips (a metal wall panel occurs below the shutter track). These clips were spaced 12-in on center. Clips are not as reliable as the bolted attachment shown in Figure 5-35.

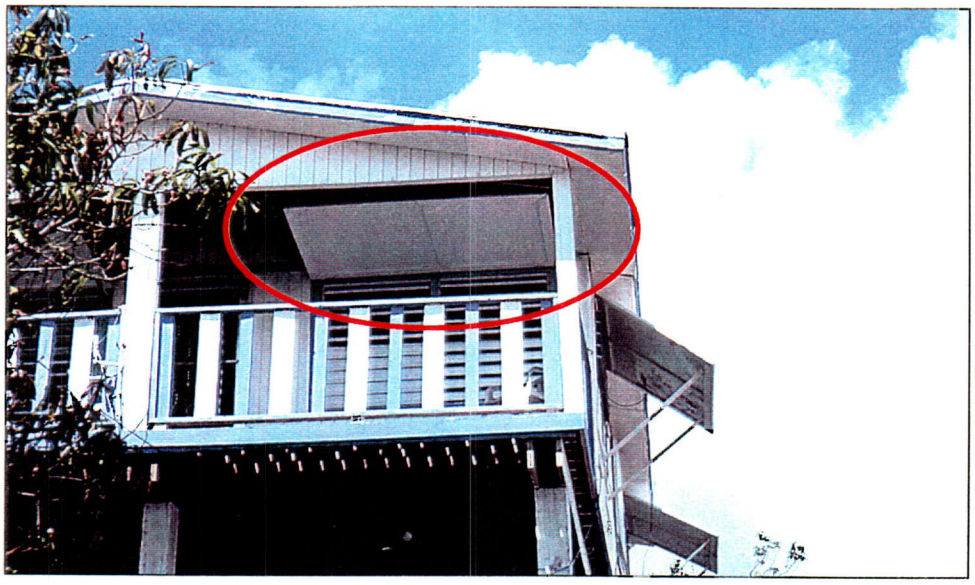
FIGURE 5-38 This house had hinged plywood shutters. The front shutter protects a Miami window.
