FEMA 339 / March 1999

Building Performance Assessment Report

Hurricane Georges In Puerto Rico

Observations, Recommendations, and Technical Guidance

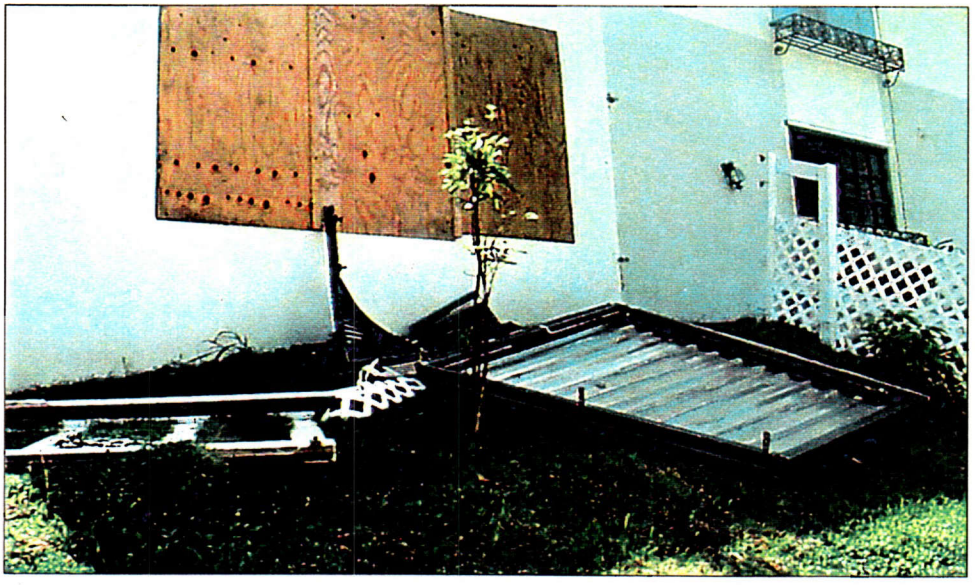
FIGURE 5-40 The window lying on the ground was protected by a shutter. However, the shutter was attached to the window frame. The window frame fasteners were over-stressed and the entire assembly failed. Attachment of the shutter directly to the wall framing is a more reliable method of attachment.

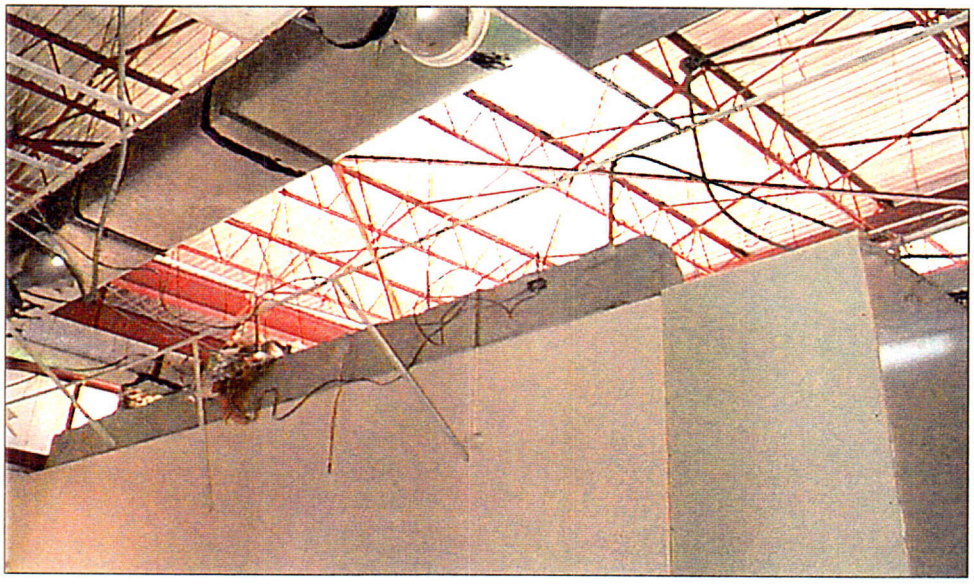
FIGURE 5-41 Part of the exterior envelope of this building blew away, resulting in damage to the acoustical ceiling. This revealed a lack of seismic resistance of the ceiling system, light fixtures, and ductwork.

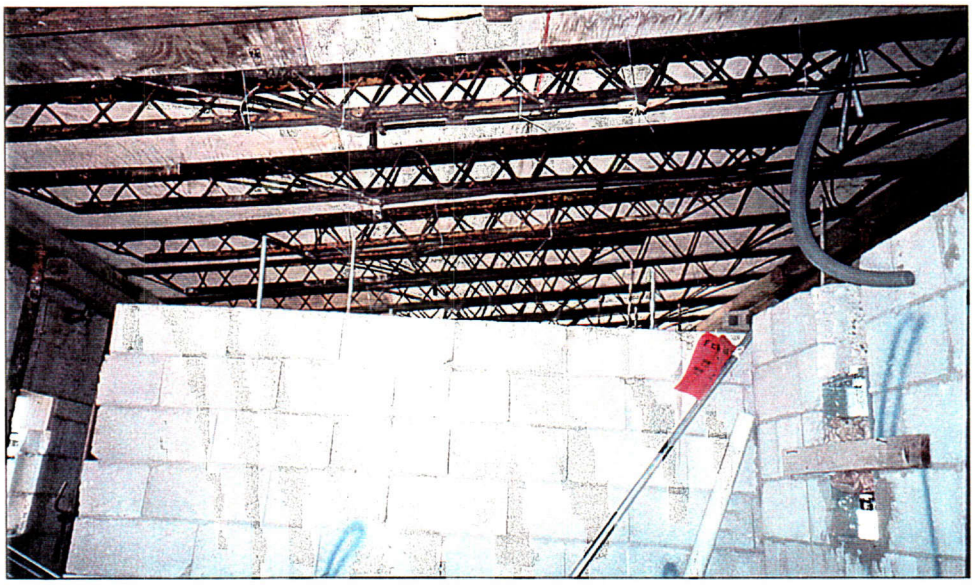
FIGURE 5-42 An interior view of a house under construction (the steel joists are supporting formwork for the concrete slab). The CMU partition is inadequately reinforced and is not supported or laterally braced at the top of the wall.

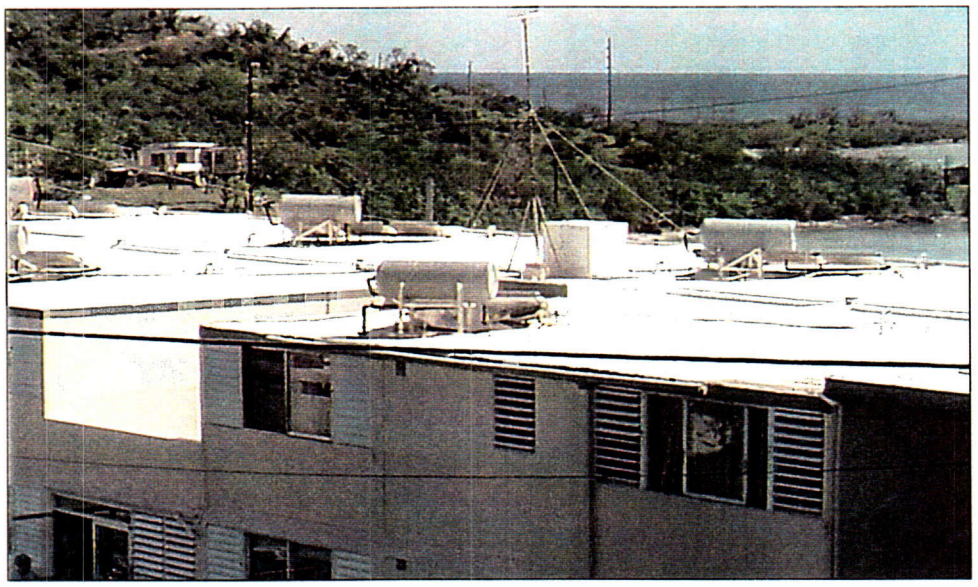
FIGURE 6-2 This roof had several solar hot water heaters that successfully weathered Hurricane Georges. However, the unit in the foreground was damaged.

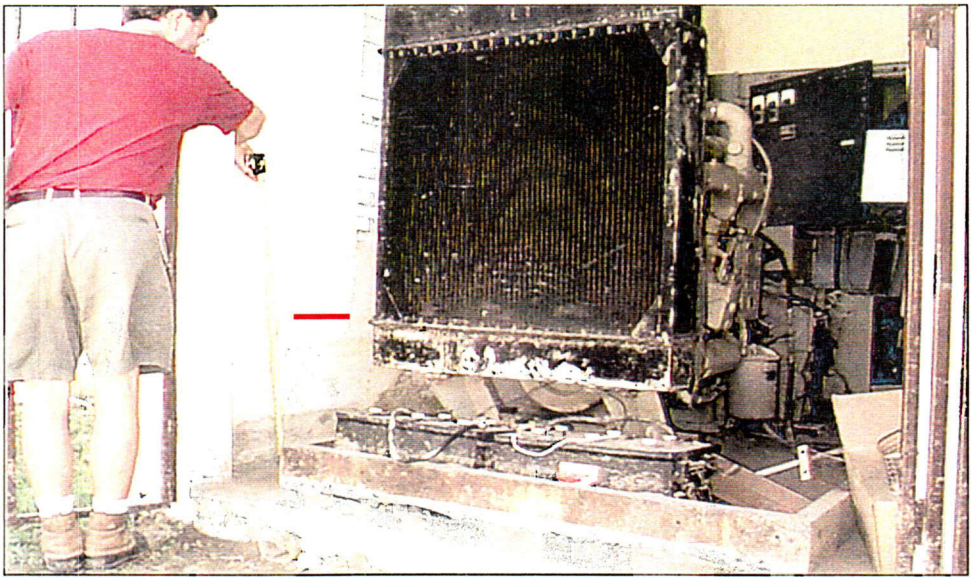
FIGURE 6-3 Flood water entered this generator room and reached a height of about 2 feet, as indicated by the red line. This facility is located in Jayuya.

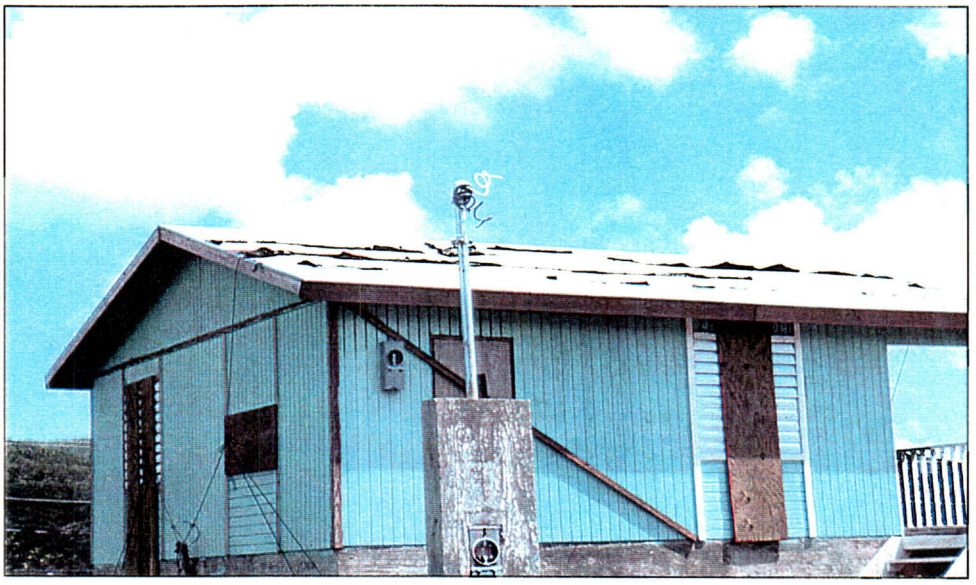
Several residences in Puerto Rico have overhead electrical service to a service mast mounted on a free-standing concrete pylon. From the service mast to the building, the service was underground, as shown in Figure 6-4. The advantage of this type of service mast versus one mounted through the roof is that if the mast deflects or is torn away, the roof is not damaged.

FIGURE 6-4 This service mast is mounted on a concrete pylon. This form of service connection was successful in eliminating roof damage when the overhead service blew down.

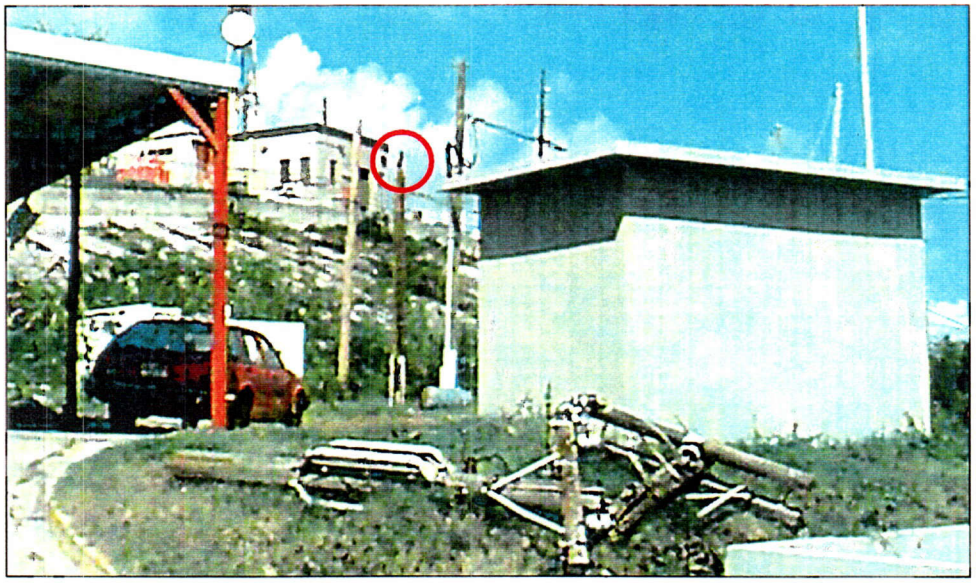
FIGURE 7-1 Damaged wood pole. The portion of the wood pole in the foreground broke from the pole (circled) in the back of the picture.

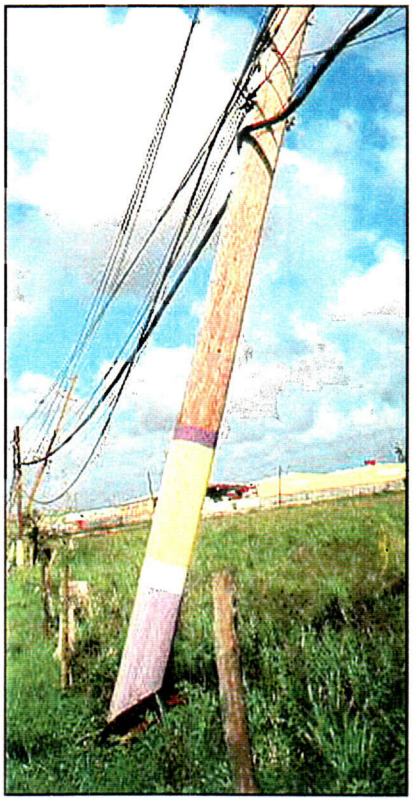
FIGURE 7-2 Leaning wood pole due to inadequate embedment.

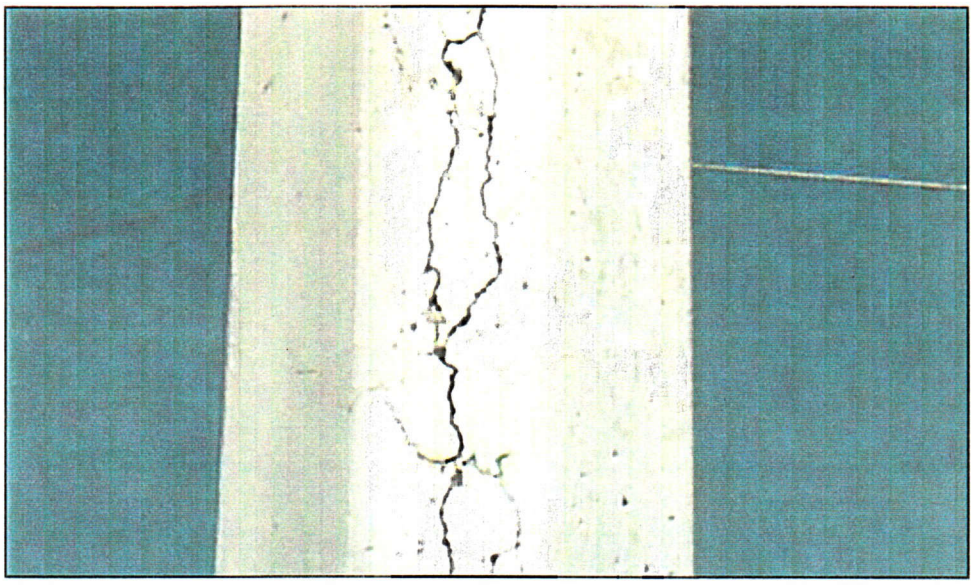
FIGURE 7-3 Observed crack in concrete pole that appears to be a quality control problem.

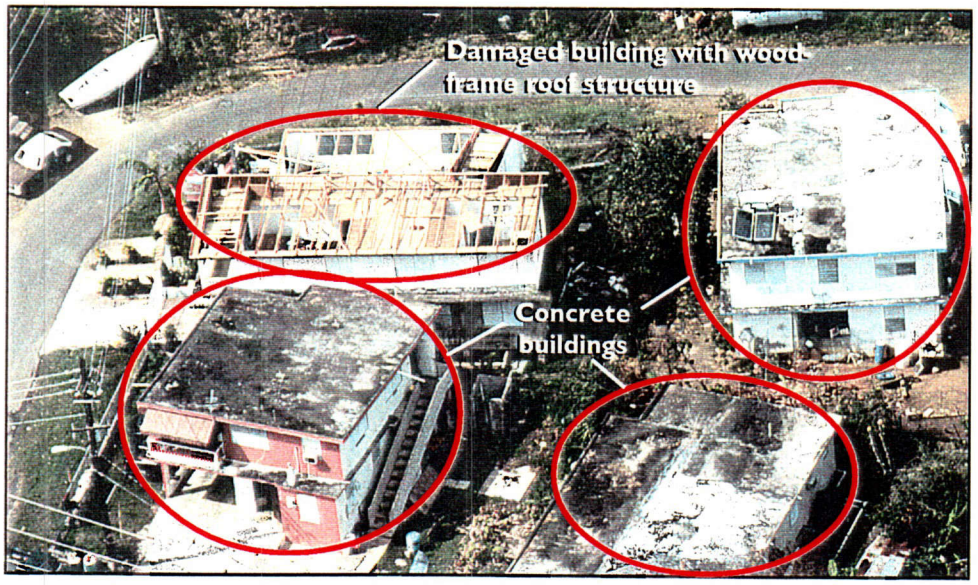
FIGURE 8-1 The three concrete/masonry buildings in this photo appeared to be undamaged. However, the building with the wood-frame roof structure experienced significant damage.
