LiDAR Quality Assurance (QA) Report  
Louisiana LiDAR ARRA Project - Region 2  
October 11, 2011

Submitted to:  
USGS

**Dewberry**

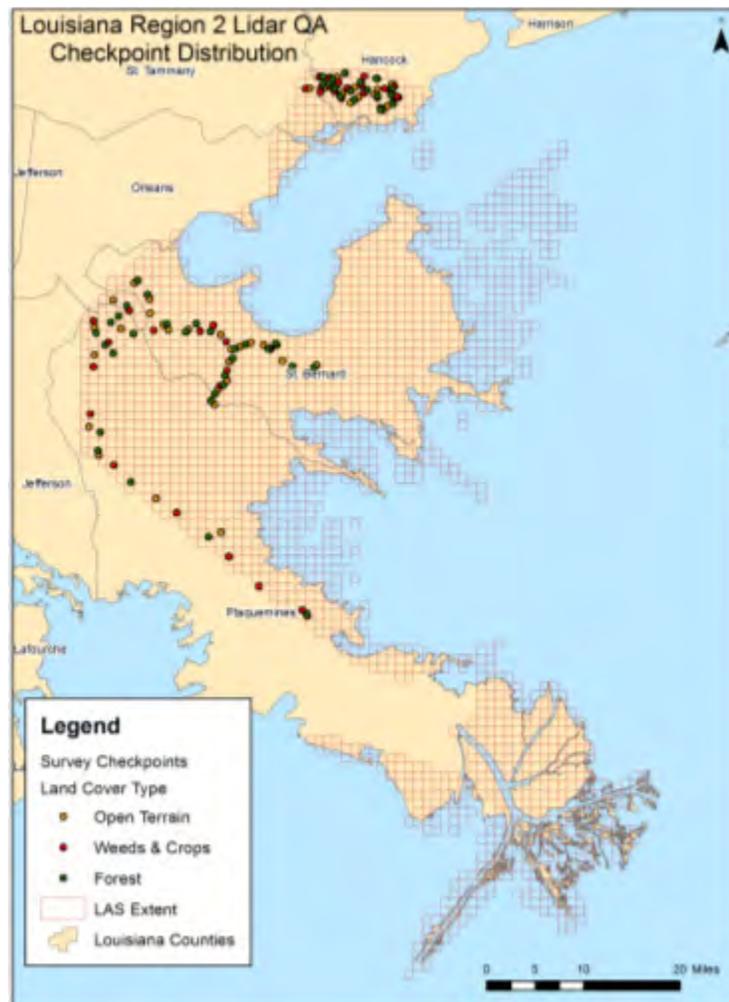
Figure 2: Checkpoints distribution for Louisiana Region 2

One of the first steps in assessing the quality of the LiDAR would be a vertical accuracy analysis of the ground models in comparison to surveyed checkpoints. Dewberry & Davis, LLC provided 119 checkpoints for the entire project area extent (Figure 2).

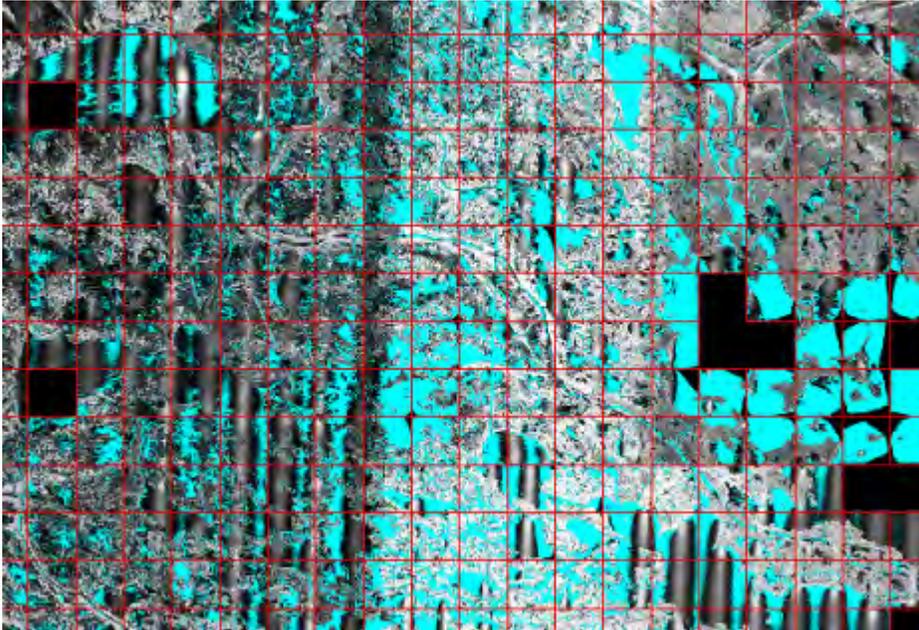
Each tile was queried to extract the number of LiDAR points. Woolpert Inc. collected the LiDAR at with a nominal point spacing of 2 pulses per square meter. The expected total number of points per tile should be approximately 4.5 million. The mean within the project area of each tile is approximately 1.57 million. The large discrepancy between the expected number of points per tile and the actual number of points per tile is due to the large areas of tidal water prevalent in almost every tile (Figure 3). Dewberry did not identify any issues with point density during the manual qualitative review of the LiDAR.

*Figure 3 - Intensity images generated from full point cloud data. All areas that are bright blue indicate that there are no points in those areas because it is water. Large areas of water with no point returns will decrease the number of points per tile.*
