MEMORANDUM

SUBJECT: SOUTHEAST WISCONSIN 2015 LIDAR (SEWI_5)

Review Comments on September 23, 2015

Washington County LiDAR Review

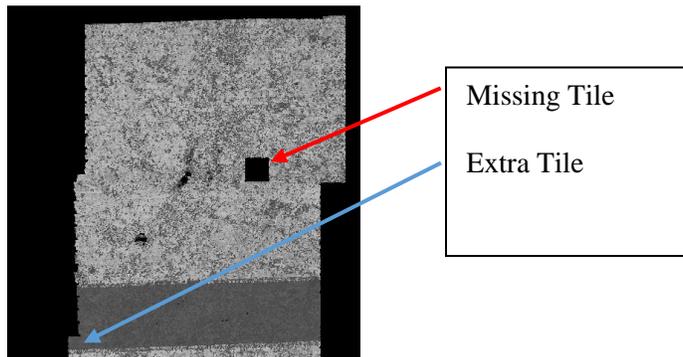
3. Classified LAS Files Review
 - Missing Tile “Id15_BE_2485_505.las”
 - Included an extra tile “Id15_BE_2414_435.las” – not required for Washington County

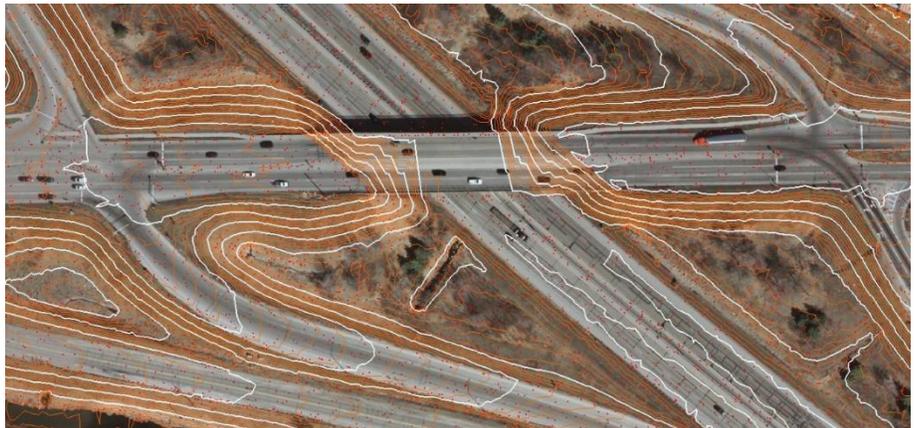
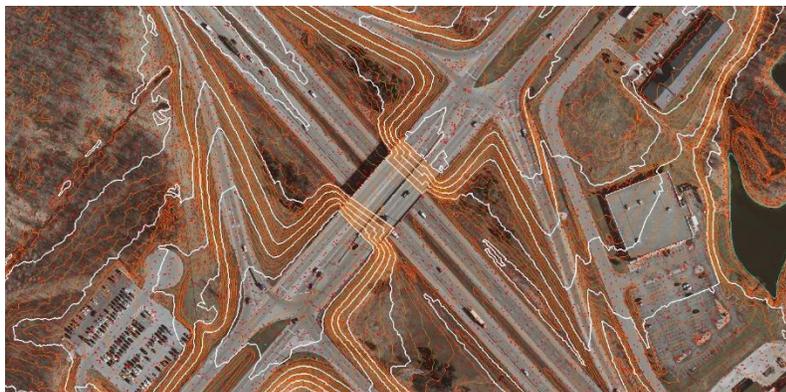
- Data delivered in wrong format
- Data provided on wrong datum
- Bridge Contouring issues – need breakline along each side to enforce the triangulation down to the road and/or water surface. See samples below on erratic contouring along removed bridge points.

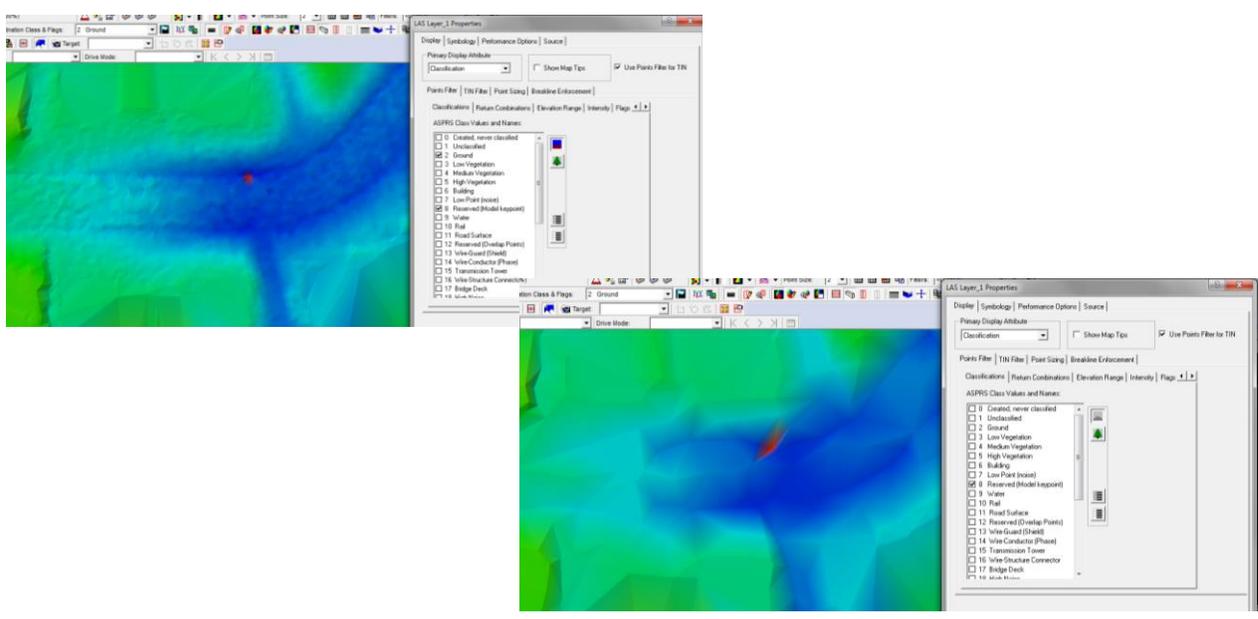
- Additional comments that require no action at this time:
 - Appears that Line Strings were used to generate the contours. Suggest using soft line strings in the contouring option to make easier transitions and less hard turns in the contouring process. Understand that the file sizes would slightly increase.
 - Model Keypoints – Points were generated but concerned that the points were generated based on a 2ft contour option instead of a 1ft. It appears that the Contour Keypoint algorithm was utilized with the settings of 2ft and 20ft which might be too general based on the screen capture below. Might look to reset contours keypoints to a 1ft option and possible 10ft to better characterize the topography with a greater accuracy.

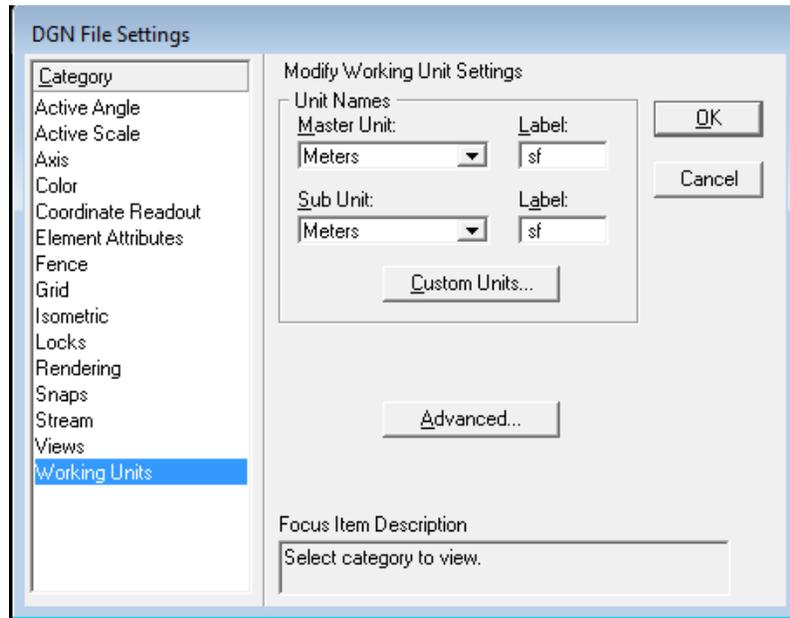
- Data provided in wrong format
- Data also provided on wrong datum
- Quick review comment – Design file had wrong working units assigned. See screen capture below for future reference but is no factor since the data format will change:

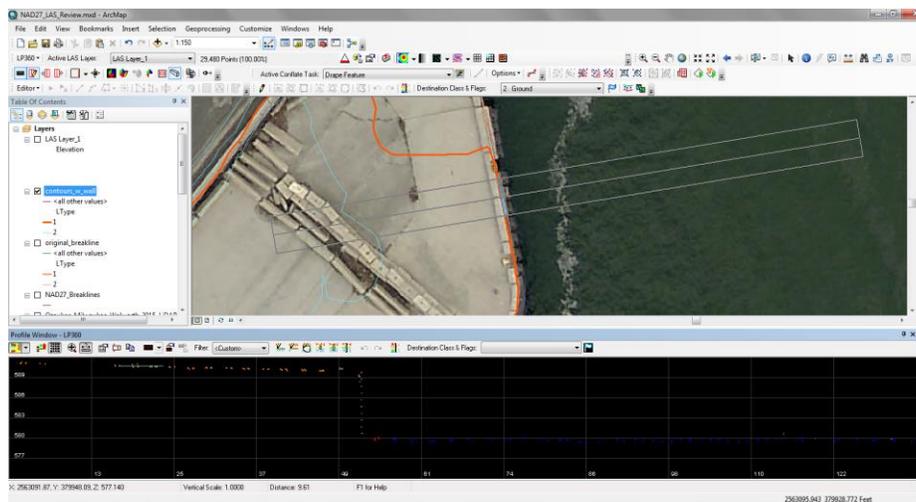
- Breaklines especially near walls have significant issues. The first issue is horizontal alignment accuracy. Most wall breaklines were collected well inside of the wall surface itself (i.e. breakline is placed in the water). The horizontal placement ranges anywhere from 3 – 10 feet off of apparent location which is cause numerous issues on the contour generation. Shown below is a location with both horizontal error and how the contouring looks when the breakline is enforced. The measured horizontal error on this sample below is 4.6 feet. The second major issue is the need to create a second breakline due to the significant vertical change and assurance of proper contouring around these features in meeting National Map Accuracy Standards. This second breakline allows proper enforcement and characterization of the topology around these specific wall features. The screen capture below shows what the contours look around this area. The Commission edited the existing line to locate it at the base of the wall itself and placing the breakline at the water surface of 580.0. The second breakline was created using LP360-retaining wall conflation tool.

- Below demonstrates how the wall contours would look with use of the second breakline and proper enforcement..

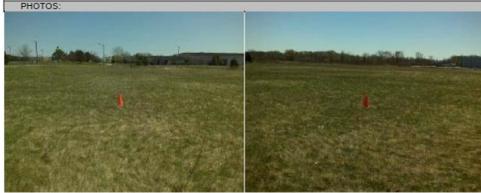
3. Each point location and quality data sheet had associated images of the type of land cover feature it supported. Based on the images, it was found that several images were inconsistent with the type of feature they were supporting. The first example found on the second page of this report documents that the land cover category specified was “Tall Weeds”, and Examples 2 and 3 were considered “Forest” points.

Please review associated images to ensure proper labeling of land cover types prior to completing the Vertical Accuracy Report according to FEMA guidelines.

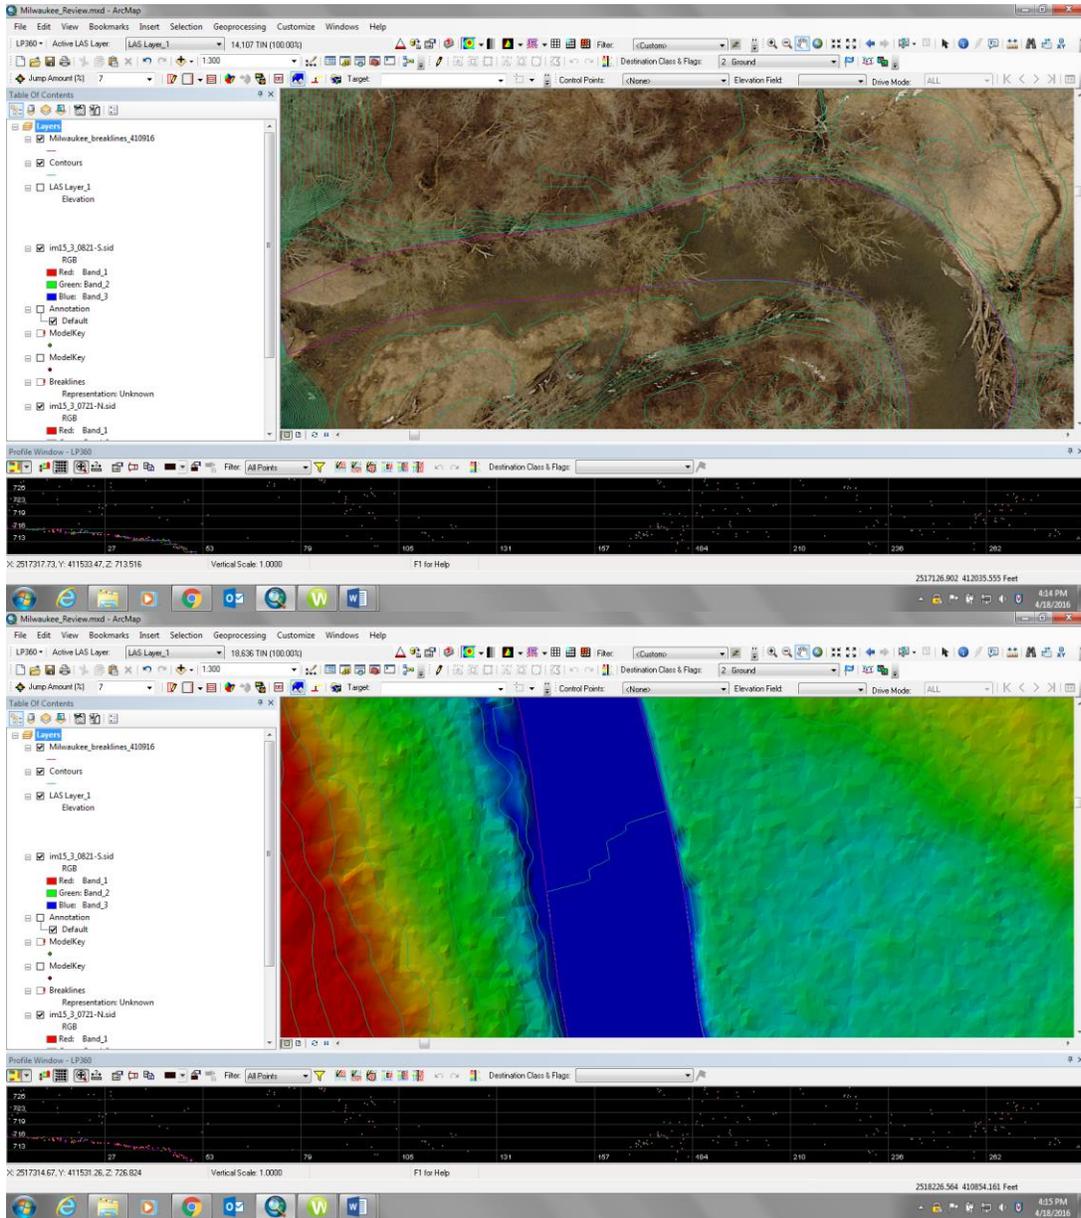
Milwaukee County – NAD27 / NGVD29

Points outside of breakline. Shoreline has points cleared but the breakwater wall did not have any points cleared away from breakline.
