Oregon Department of Geology & Mineral Industries
800 NE Oregon St, Suite 965
Portland, OR 97232

Harney Basin Lidar Project Lidar QC Report – November 1st, 2016

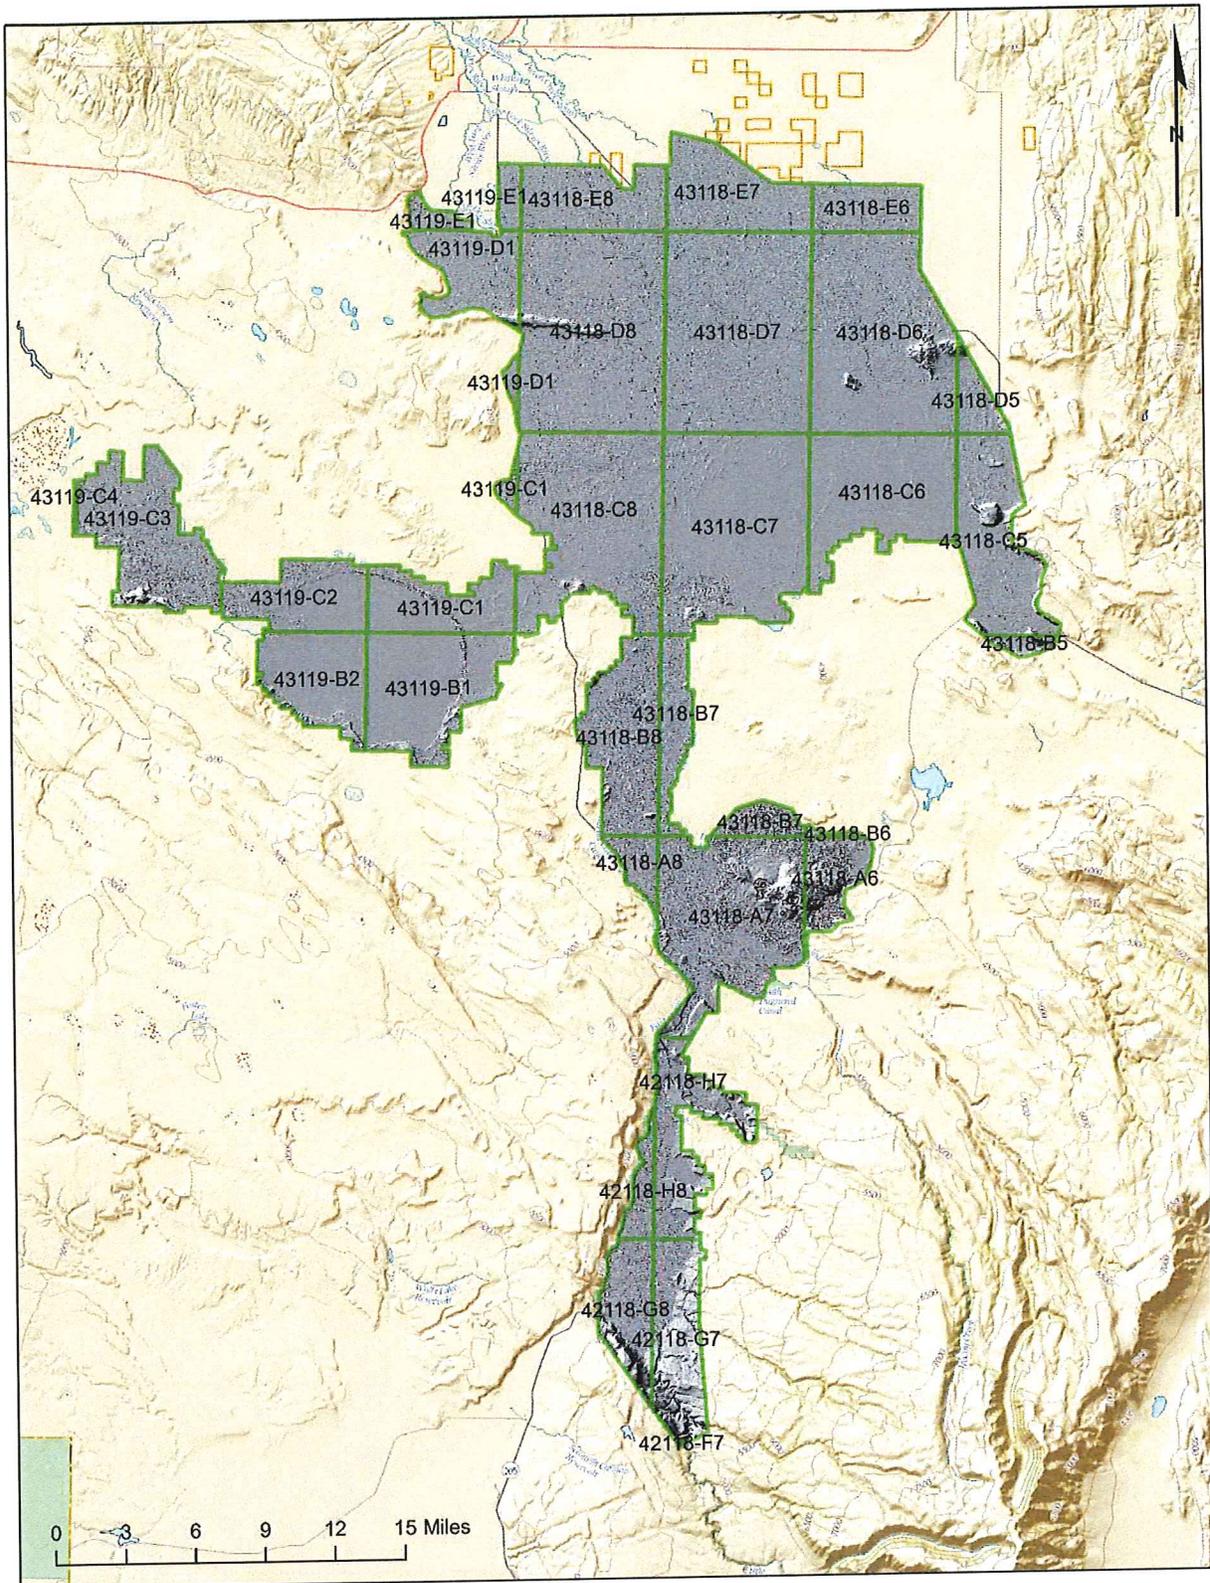
Figure 2: Harney Basin collection area. Data is referenced to USGS 7.5 minute quadrangles within the extents of the Harney Basin project.

The Harney Basin project area was collected from October 15th 2014 through March 1st 2015. The total area of delivered data equals 633.82 square miles (405,647 acres). This delivery contains data for 31 USGS 7.5 minute quads (listed by Ohio Code #) within the boundary of the Harney Basin survey collection area (Figure 2).

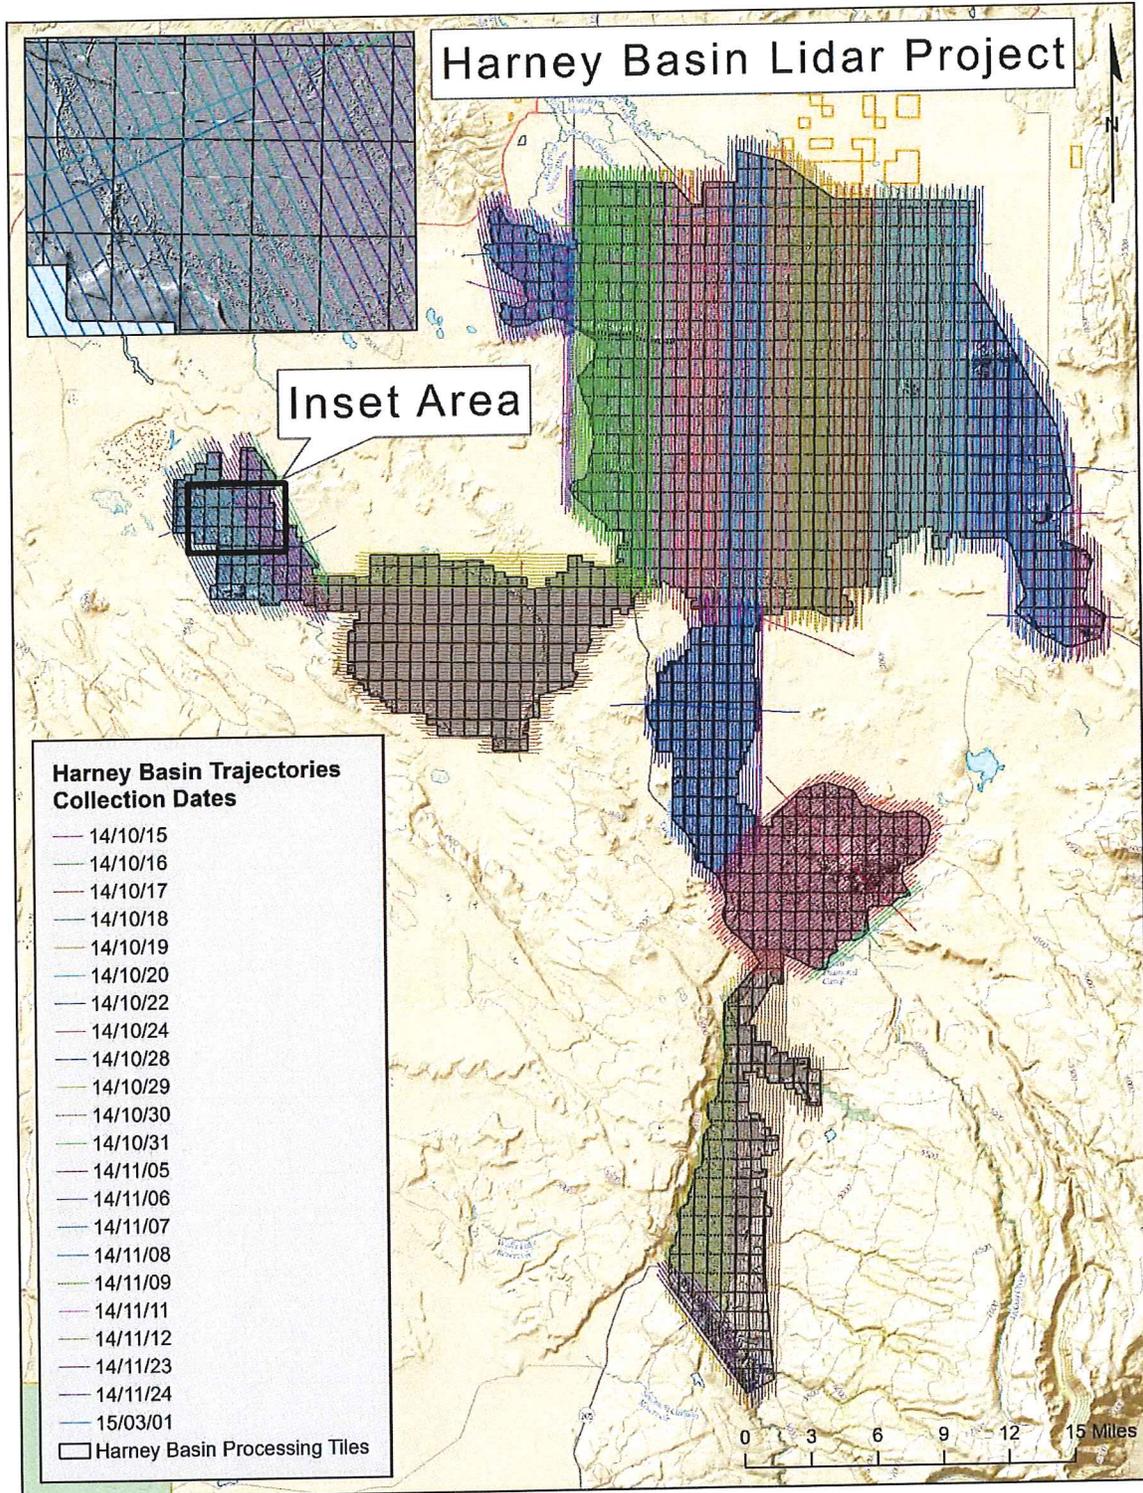
Figure 3: Spatial distribution of flight lines and processing tiles used in the consistency analysis.

To quantify the magnitude of this error, 3908 (out of 3908) delivered data tiles (100%) were examined for vertical offset between flight lines. Data tiles with less than 1000 points were not used in analysis. Each tile measured 750 x 750 meters in size (Figure 4). The average number of points used for flight line comparison was 34,345,547 per tile (Table 8a). Error measurements were calculated by differencing the nearest point from an adjacent flight line within 1 meter in the horizontal plane and 0.2 meters in the vertical plane. Each flight line was compared to adjacent flight lines, and the average magnitude of vertical error was calculated. 448 flight lines (out of 554) total flight lines (81%) were sampled and compared for consistency.

Results of the consistency analysis found the average flight line offset to be 0.02 meters (0.07 feet) with a maximum error of 0.06 meters (0.18 feet) (Table 8b). Distribution of error showed 99.6% of all error was less than 0.05 meters (0.25 feet) and 100% less than 0.07m (0.30 feet) (Figure 4 and 5). These results show that all data are within specification.

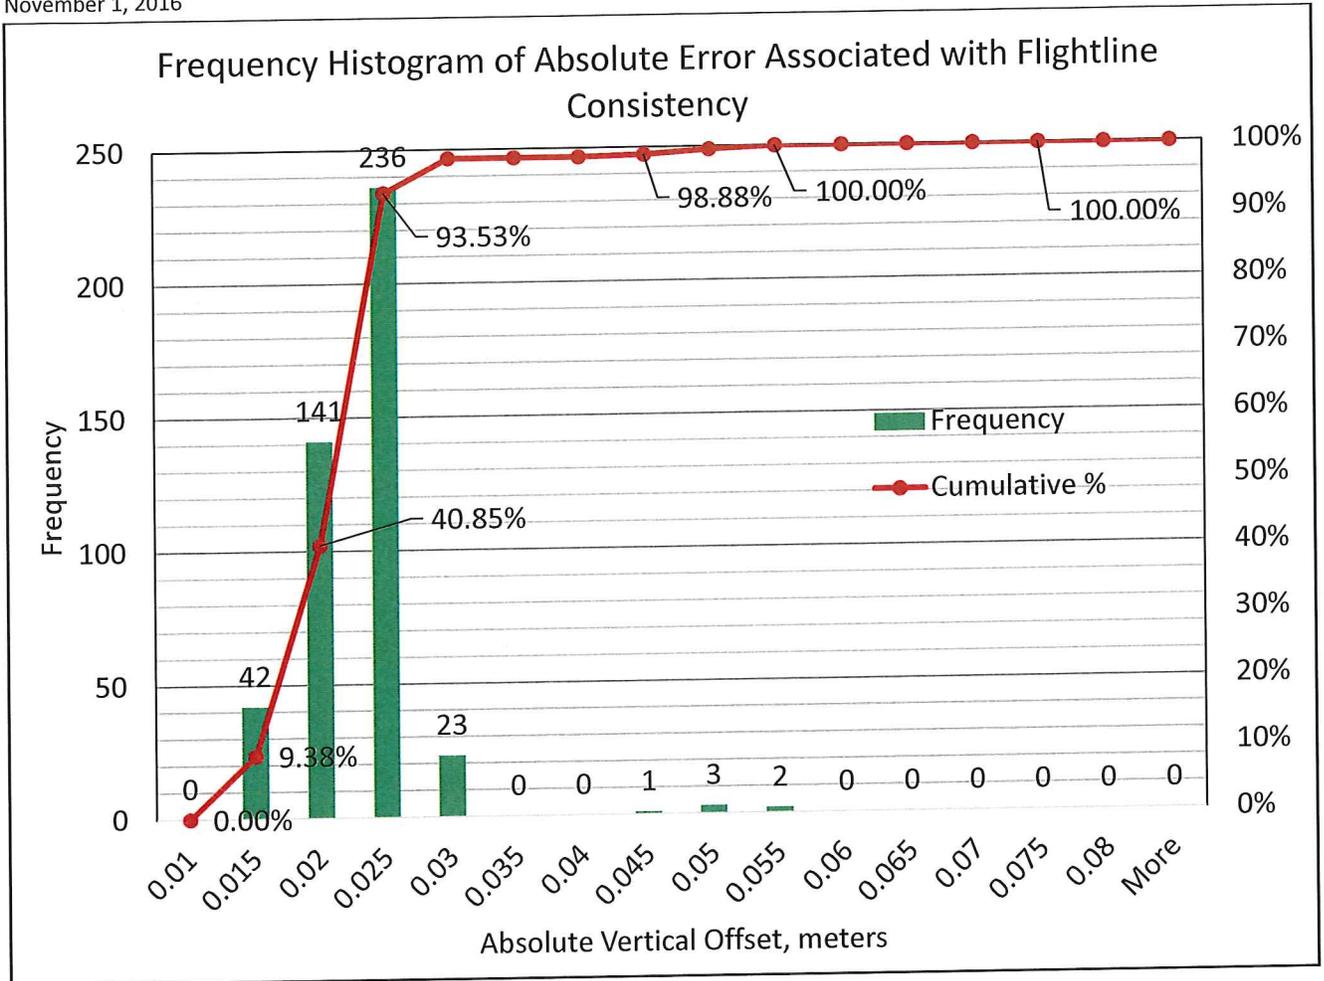
Figure 4: Flight line Consistency Histogram in meters

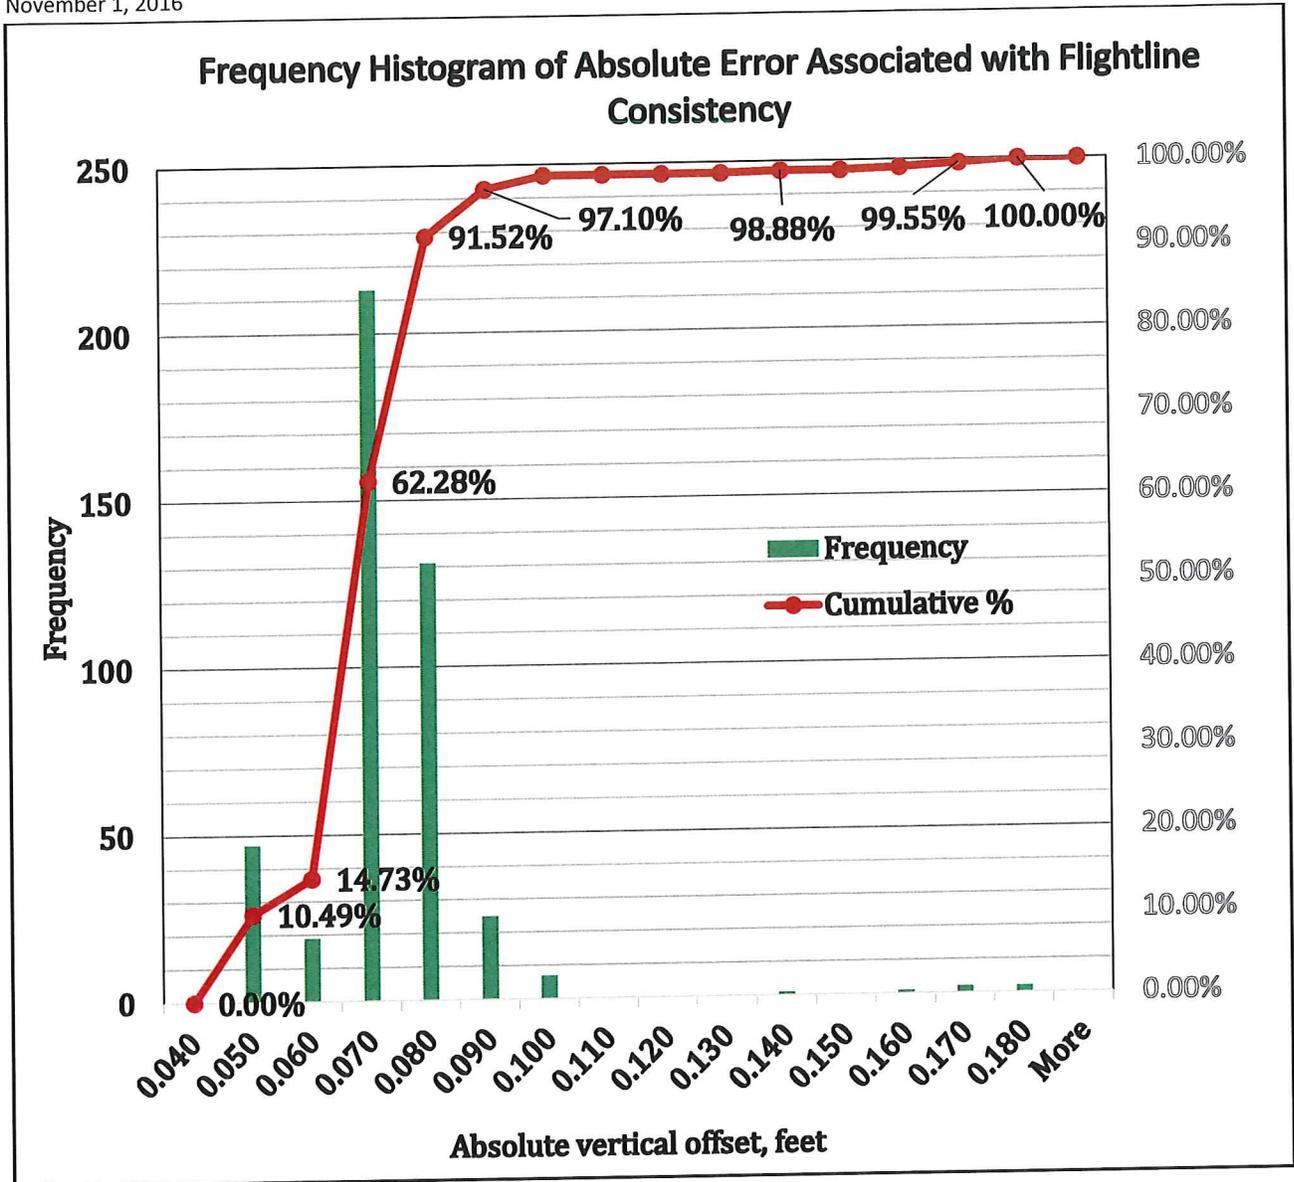
Figure 5: Flight line Consistency Histogram in feet

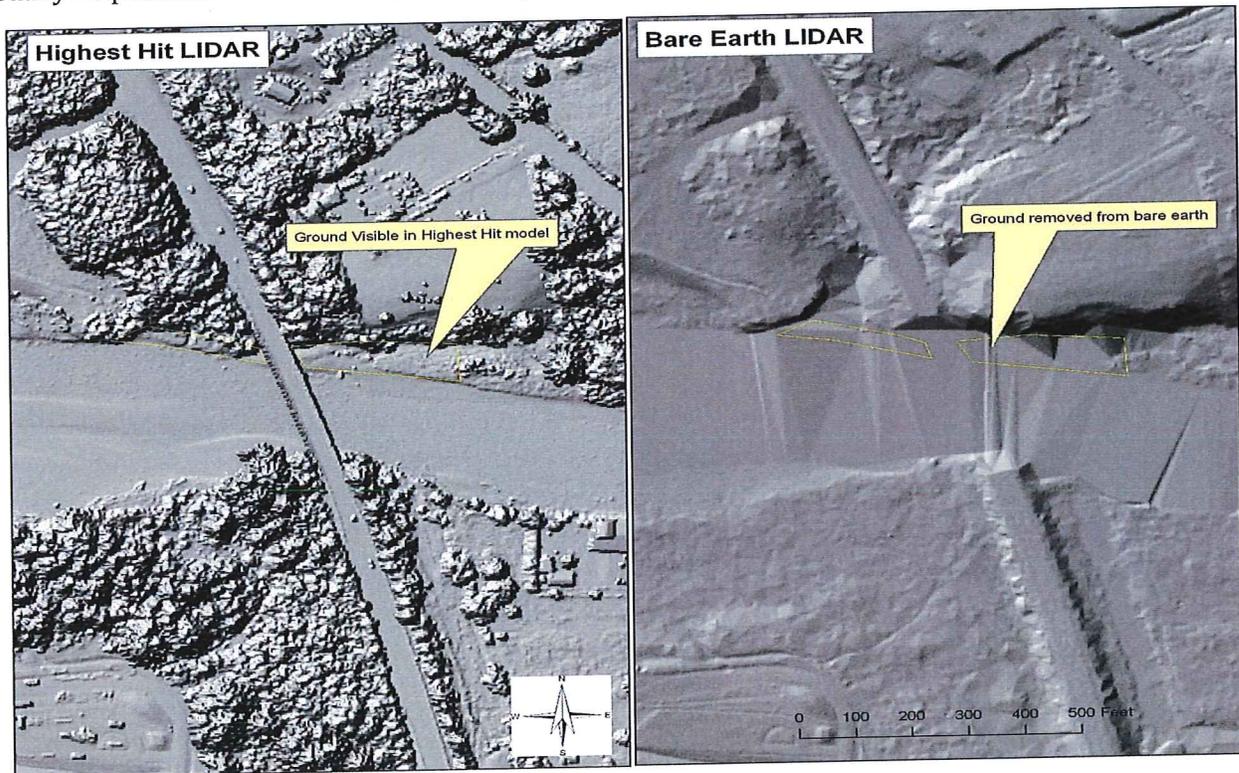
Figure 6: Example of missing ground in LiDAR bare earth data. Ground is clearly visible in highest hit model, but has been removed from the bare earth model. This type of classification error is common near water body features

Lidar 3ft grids were loaded into ArcGIS™ software for visual analysis. Data were examined through slope and hillshade models of bare-earth returns. Hillshades of the highest hit models were used to identify areas of missing ground (Figure 6). Both bare-earth and highest hit models were examined for calibration offsets, tiling artifacts (Figure 7), seam line offsets, pits (Figure 8), and birds.

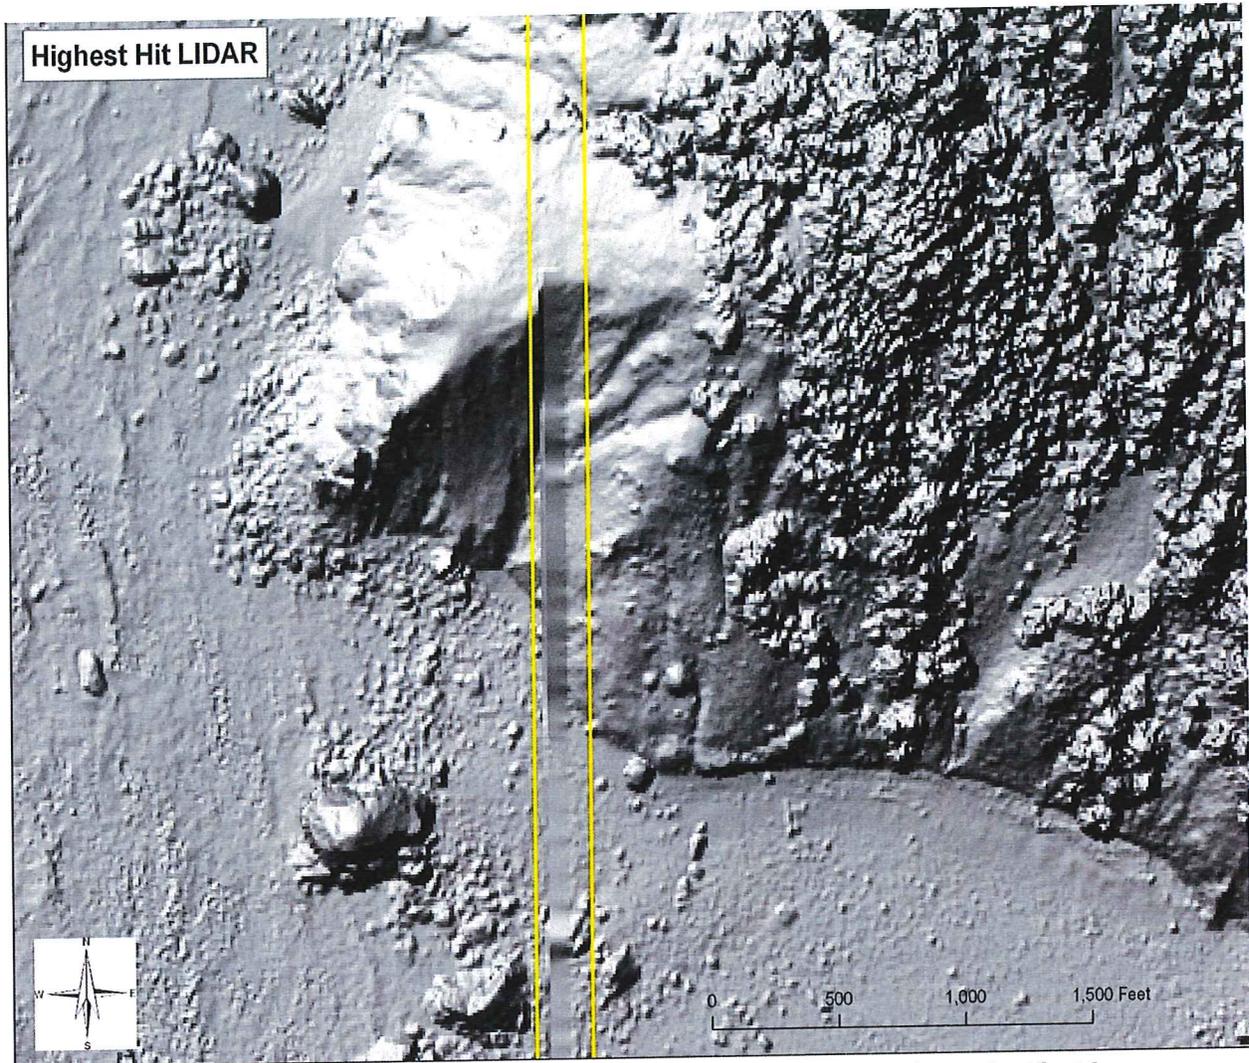
Figure 7: Example of tile artifact found in highest hit LiDAR data. Artifact is a seam line error created due to misclassification of ground at edge of LiDAR processing tiles.

Calibration offsets typically are visualized as a corduroy-like pattern within a hillshaded LiDAR model. These offsets present themselves along steep slopes and typically stand out more in highest hit models than bare earth. Tiling artifacts are a result of missing or misclassified data along the edge of LiDAR processing tiles. These artifacts present themselves as linear features typically 1-2 grid

cells in width, and are present in both the highest hit and bare earth models (Figure 7). Seam line offsets occur where two distinct days of LiDAR data overlap. Errors occur as a result of improper absolute vertical error adjustments. These errors are typically visualized as a linear stair step running along the edge of connecting flight lines. Pits and birds refer to uncommonly high or low points that are the result of atmospheric and sensor noise. Pits (low points) typically occur where the laser comes in contact with water on the ground (Figure 8). Birds (high points) typically occur where the laser comes into contact with atmospheric¹.

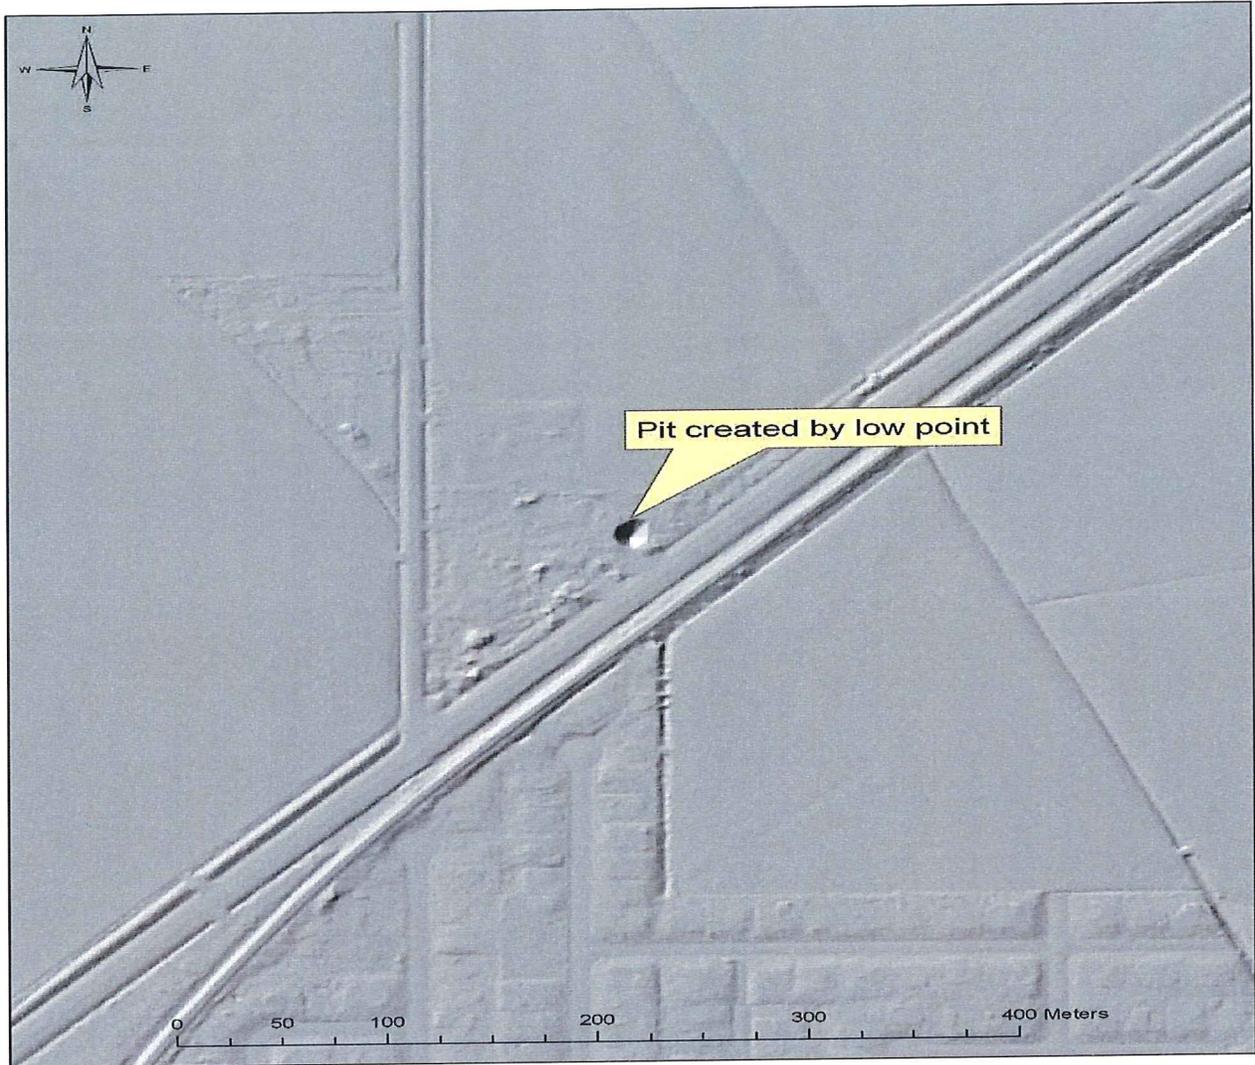
Figure 8: Example of “Pit” caused by low point in ground model. Pits are caused when standing water absorbs the LiDAR pulse. Pits are evident in ground model as the lowest point elevation is assigned to the grid cell value. Inversely the pit is not observable in the highest hit model as the highest point elevation is assigned to the grid value.

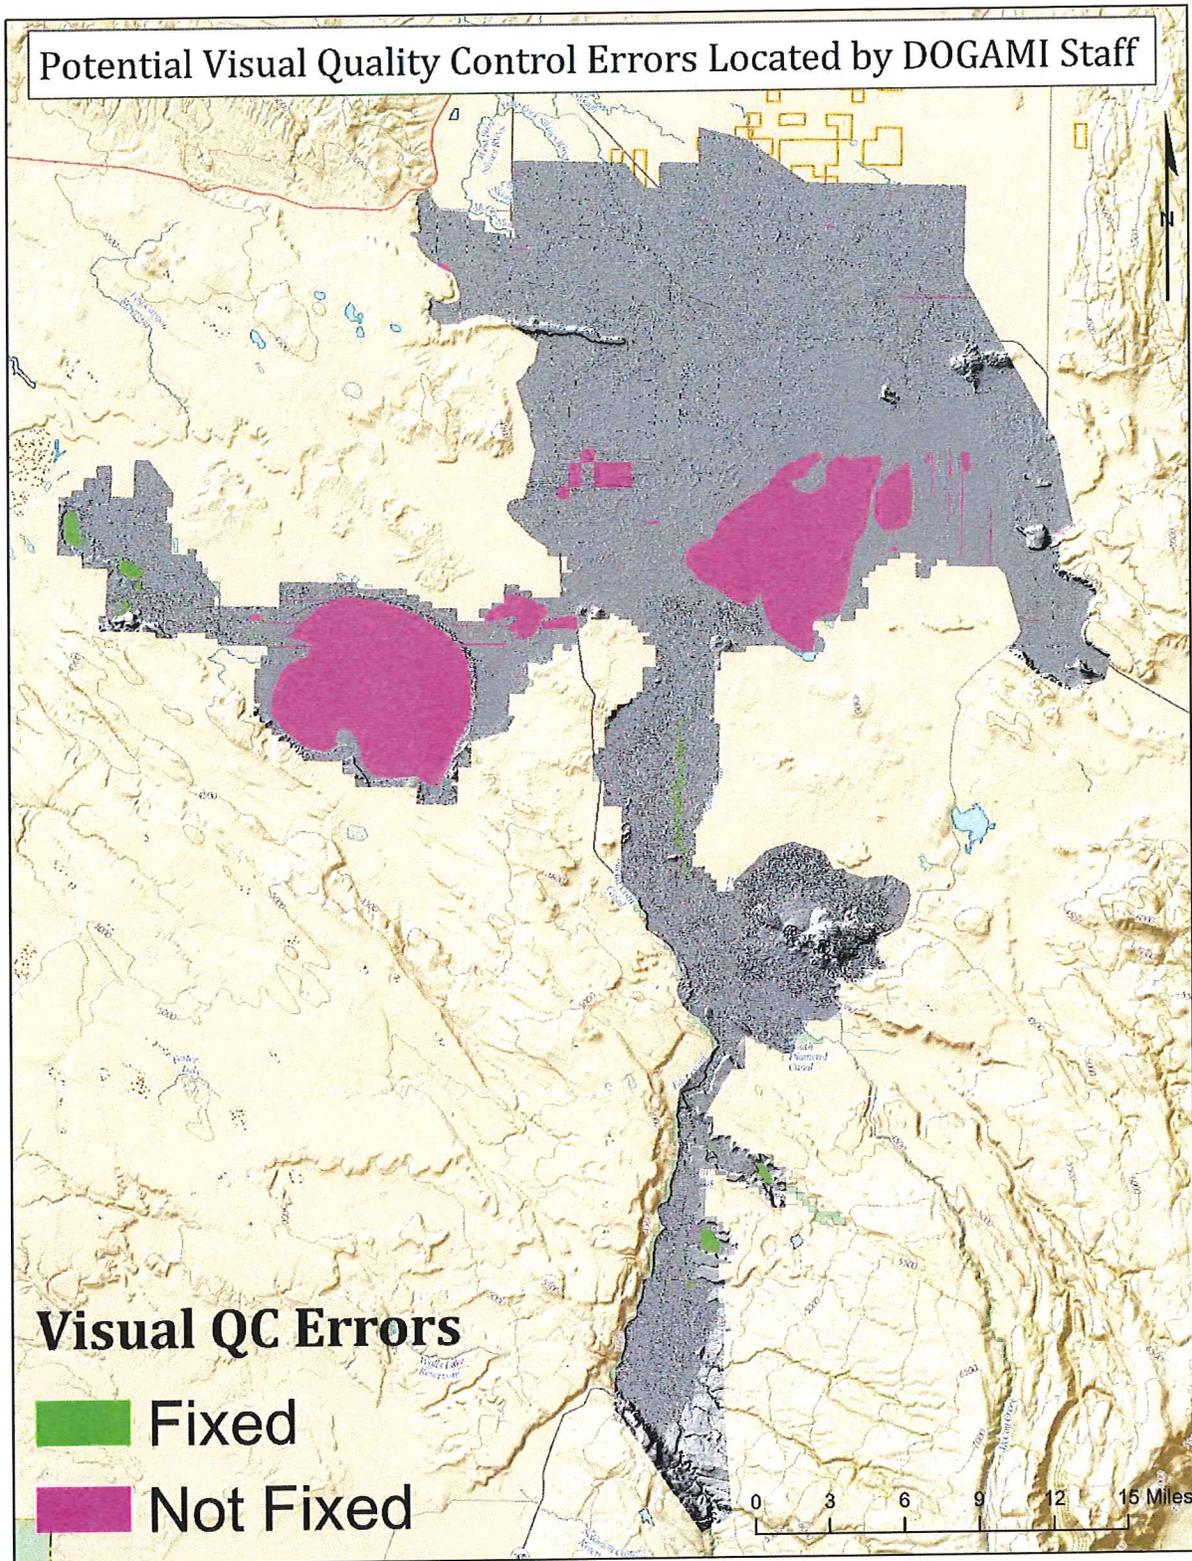
Figure 9: Spatial distribution of visual QC errors located by DOGAMI staff.

During visual analysis of Harney Basin raster data, 163 observed errors were digitized for spatial reference and stored in Esri™ shapefile format. Each feature was assigned an ID value and included a brief description of the observed error. The shapefile was then delivered to the vendor for locating and fixing errors. Upon receiving the observed error locations, the vendor performed an analysis to conclude whether the error was valid and provided comments on how the data was adjusted. 62 out of the 163 observed errors (38.0%) were adjusted and the data was reprocessed to accommodate fixes. Some of the reported errors by DOGAMI staff were not fixed by the vendor because either there was not enough data to improve the digital elevation model or the QC call was not valid (call to remove bridge points from ground when the feature was actually a culvert). Errors that were not fixed by the vendor were reviewed by DOGAMI staff to ensure justification was valid. Final sets of LiDAR 1 meter grids were loaded into ArcGIS™ software and re-examined to ensure edits were made and visually inspected further for completeness (Figure 9).

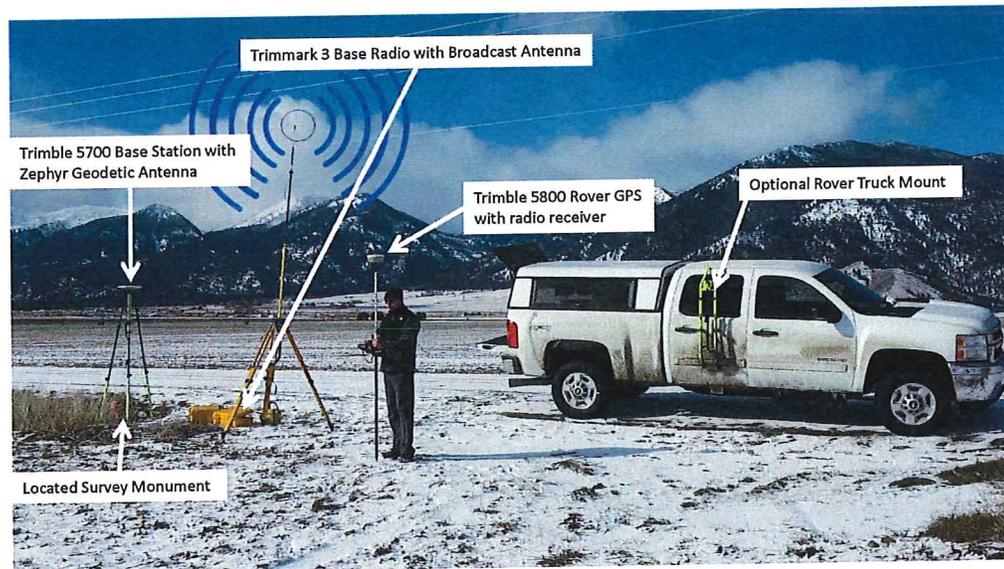
Figure 10: The Trimble 5700 base station antenna located over a known reference point outside Baker City. Corrected GPS position and elevation information is then transmitted by a Trimmark III base radio to the 5800 GPS rover unit.

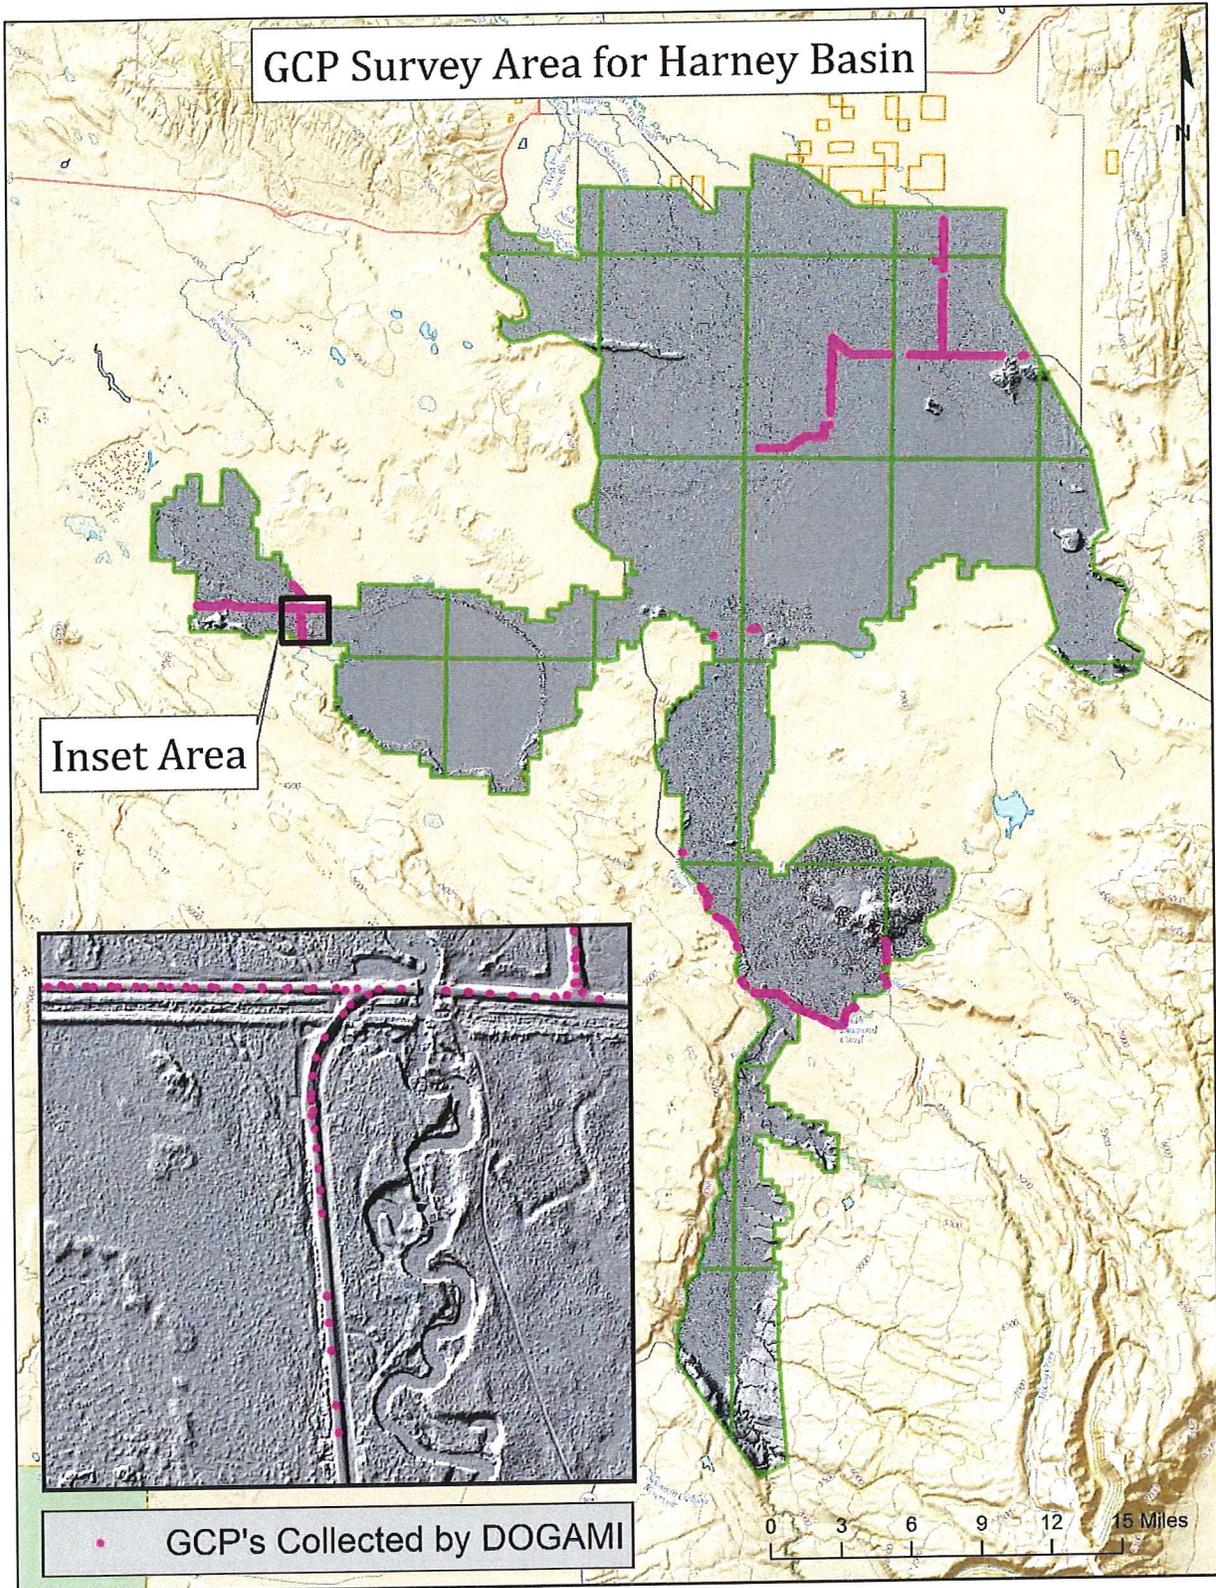
Figure 11: Locations of GCPs surveyed by DOGAMI staff. Data was used to test absolute accuracy for the Harney Basin project area.

A total of 1909 measured GCP's were obtained in the Harney Basin project area (Figure 11) and were compared with the LiDAR elevation grids (Figure 12). The data delivered to DOGAMI was found to have a mean vertical offset of 0.032 meters (0.107 feet) and an RMSE value of 0.0579 meters (0.1901 feet). Offset values ranged from -0.1526 meters (-0.5007 feet) to 0.1125 meters (0.3691 feet) (Table 09, Figure 12, and Figure 13).

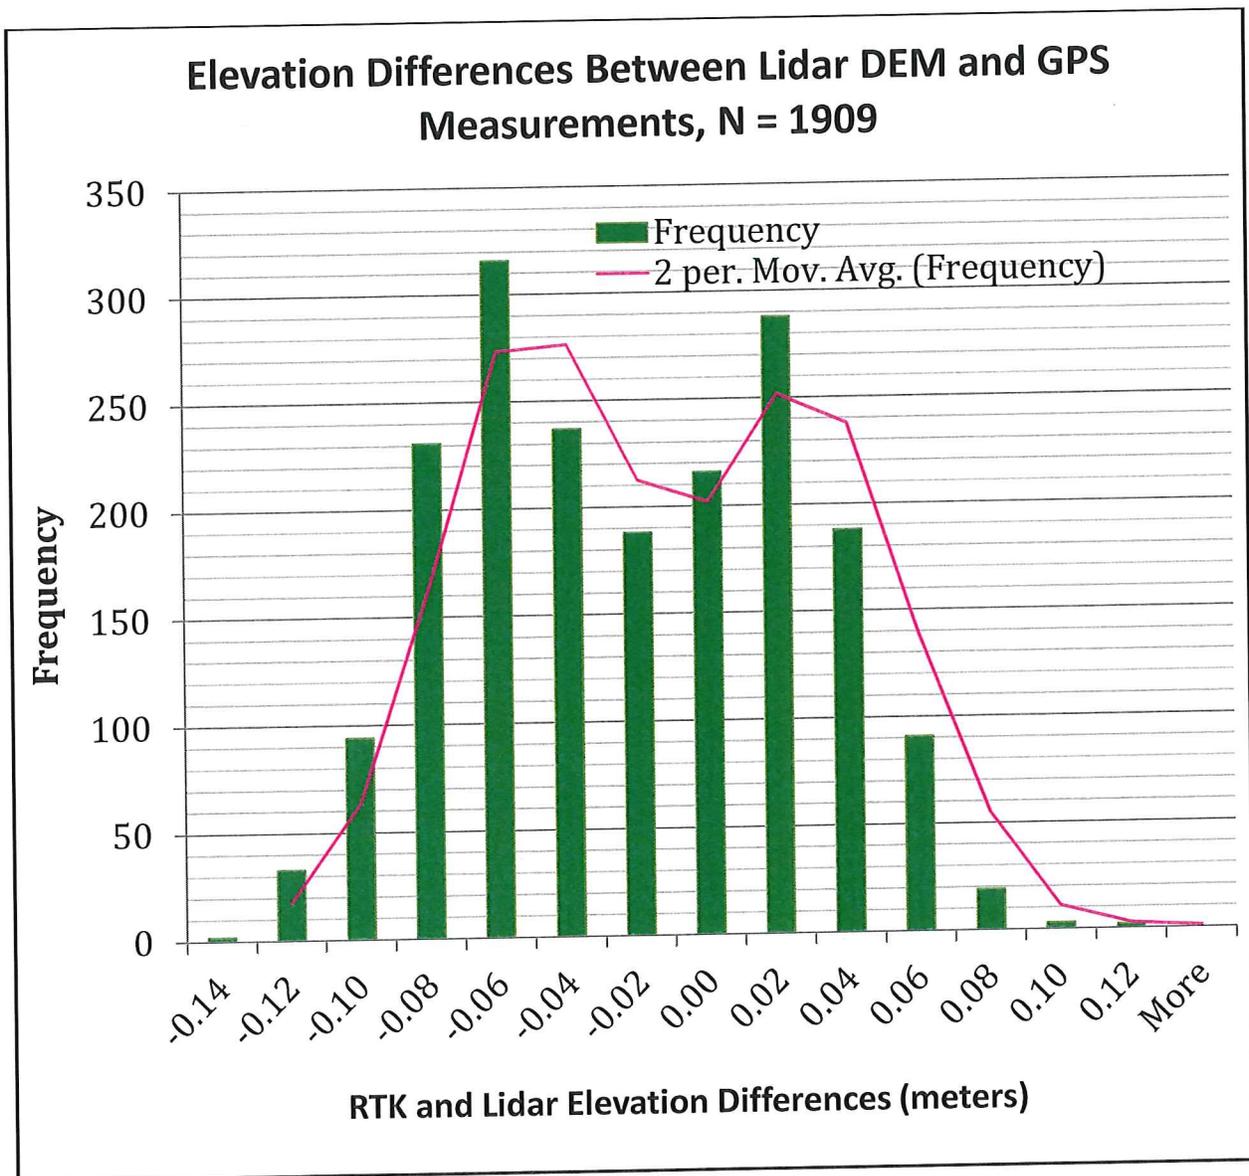
Figure 12: Histogram of absolute vertical accuracy in meters.

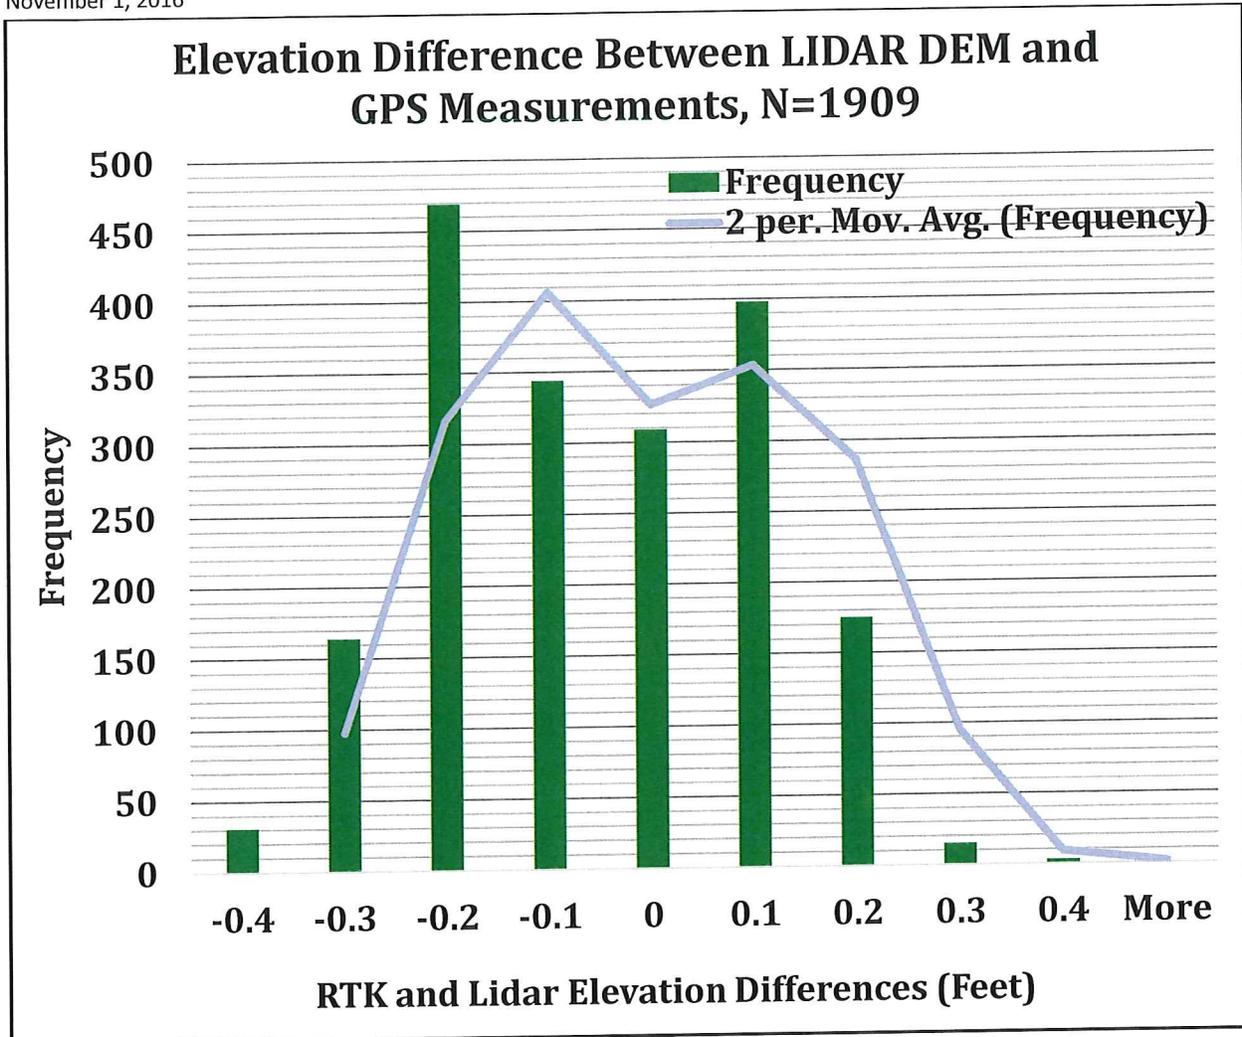
Figure 13: Histogram of absolute vertical accuracy in feet.

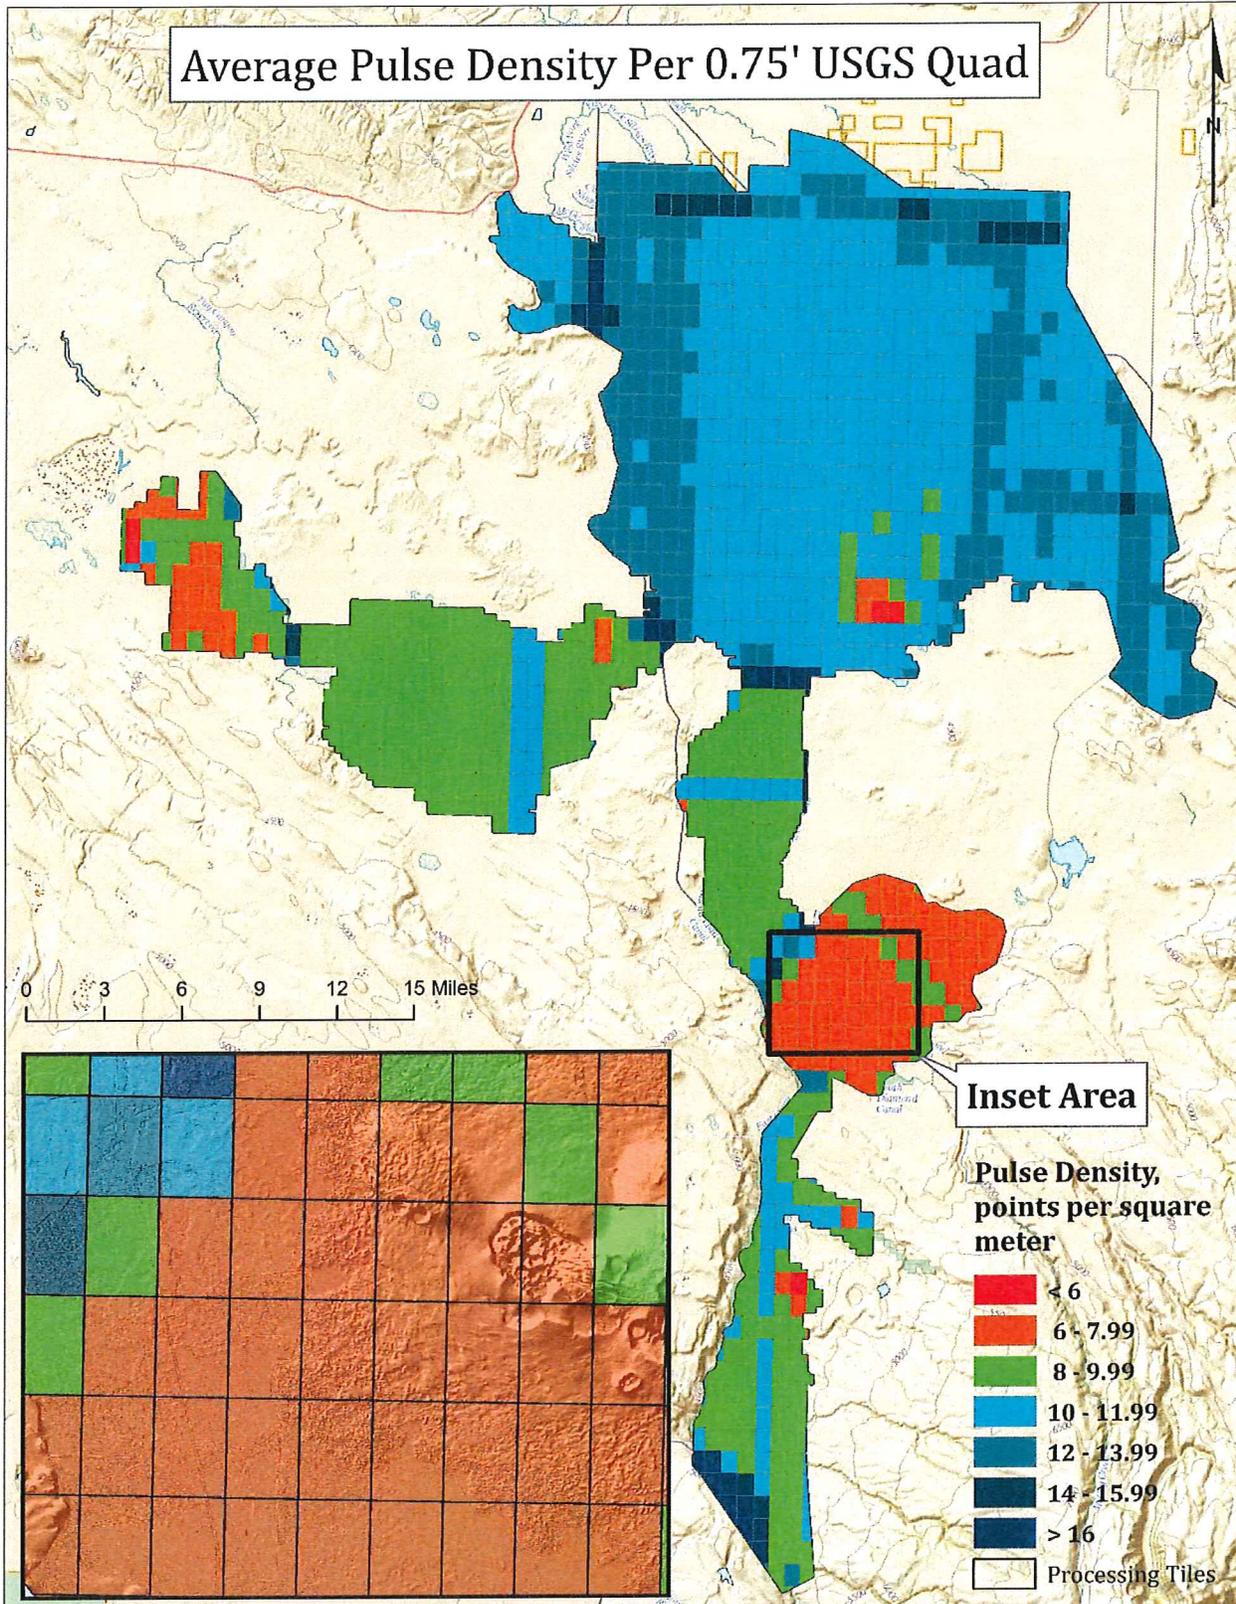
Figure 14: Pulse Density of 1/100th USGS 7.5 minute quadrangle LAS tiles.

The all-return LAS points are comprised of multiple returns from each laser pulse. These multiple returns are created when a laser pulse encounters multiple reflection surfaces as it travels toward the ground. Pulse density was measured by parsing out first-return points from the all-return LAS files. First-return points are used to assess pulse density because multiple returns from a single pulse would introduce bias into the statistics. DOGAMI staff used Bentley® Microstation software to filter the LAS point files and output new LAS files that only contain first-return points. Statistics were calculated on the newly created files using the ArcGIS 3D analyst tool called "Point File Information." This tool calculated the total number of first return points for each LAS file. Each Las file's first return point count was then compared to the size of each LAS file to determine the overall pulse per square meter. Using the 1/100th USGS 7.5 minute quadrangle extents, DOGAMI staff created polygons that graphically depict the pulse density of the project area (Figure 14).

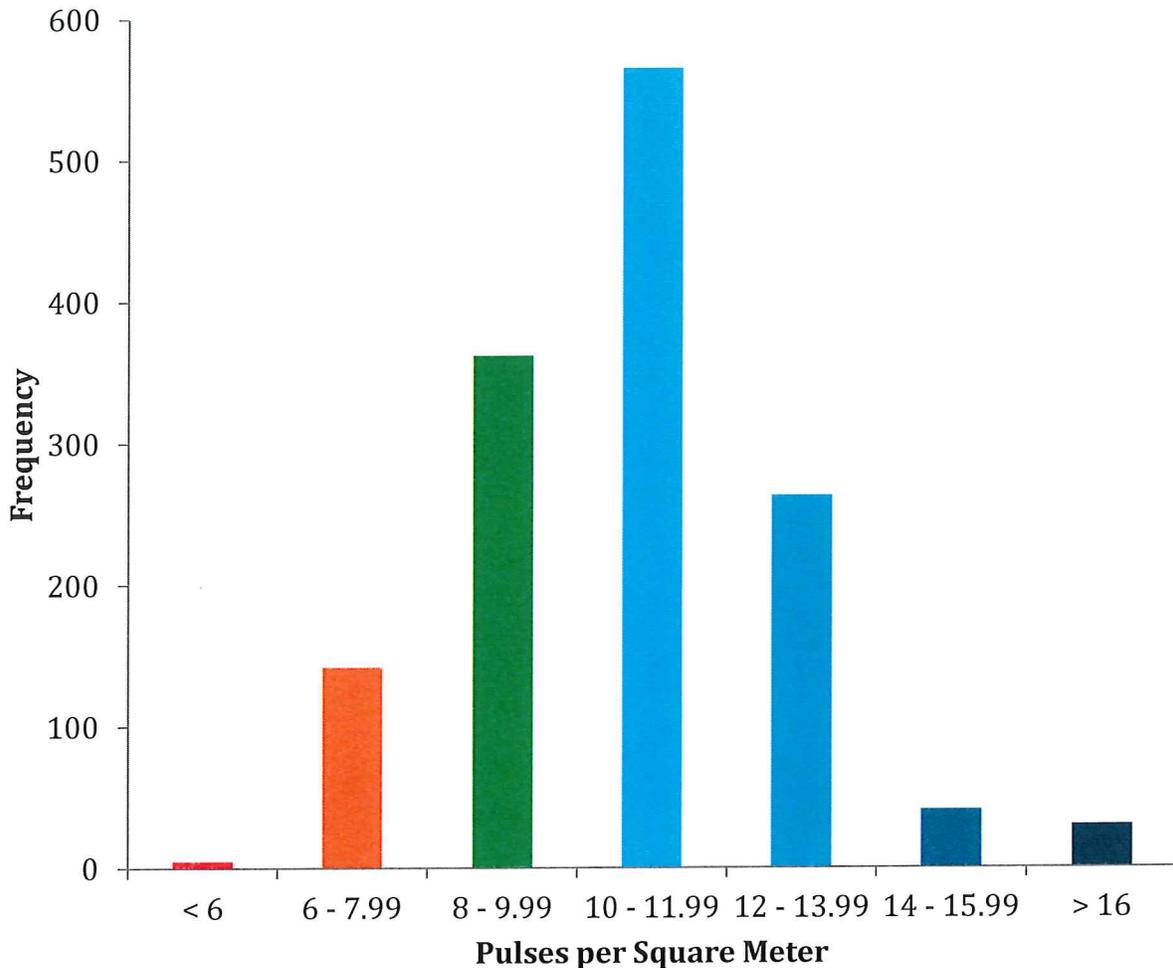
Figure 15: Histogram of Average Pulse Densities for Harney Basin.

To quantify pulse density of Harney Basin, 1408 all-return LAS files (100%) were parsed into first-return point files and compared to their data extents. Results of the pulse density analysis found the average pulse density to be 10.81 pulses per m² (Table 10. Certain types of surfaces (dense vegetation, water) may return fewer pulses than the laser originally emitted; therefore density values can vary according to terrain and land cover. Pulse densities for Harney Basin LAS tiles ranged from 3.40 pulses per m² to 21.67 pulses per m² (Figure 14). 1261 LAS tiles out of 1408 (90%) have a pulse density of ≥ 8.00 pulses per m² (Figure 15). These results show that all data are within tolerances of pulse density according to the contract agreement.
