Oregon Department of Geology & Mineral Industries
800 NE Oregon St, Suite 965
Portland, OR 97232

Harney Basin Lidar Project Lidar QC Report – November 1st, 2016

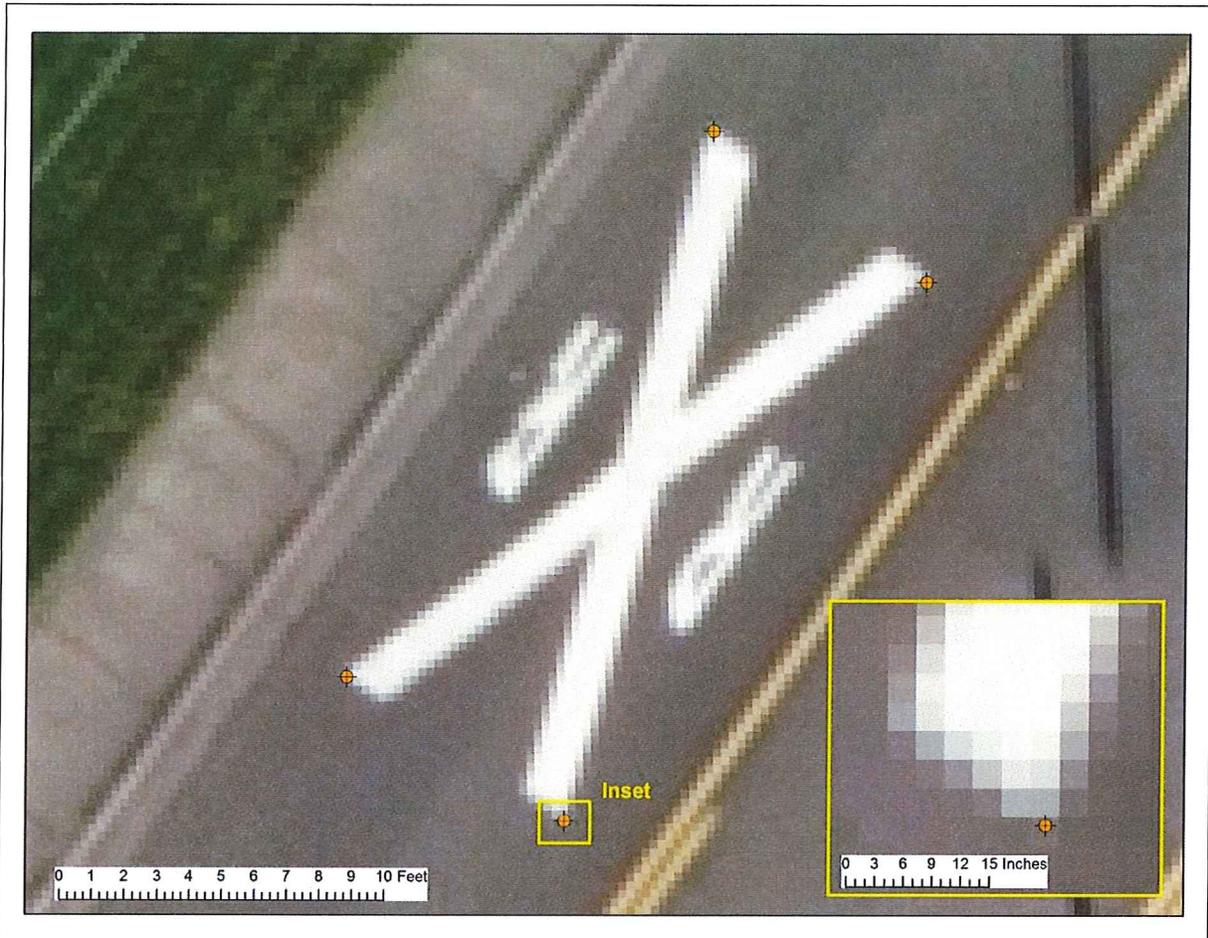
Figure 16: Aerial Target feature used to ortho-rectify imagery.
